Hydrogen release during unloading

European Conference on
Plant & Process Safety

13th September 22

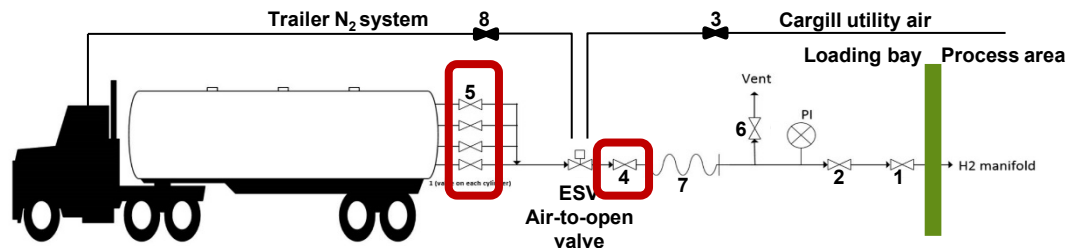
1. Closed valves 1 and 2
2. Closed valve 3 (ESV supplied with Cargill's air)
3. Disconnected compressed air hose from ESV
4. Partially closed valve 4
5. Driver left the 11 valves (5) open
6. Opened vent valve 6
7. Verified no pressure with pressure gauge
8. Disconnected hose (7)
9. Connected trailer N₂ to ESV
10. Opened valve 8 – ESV opened → **Jet fire of H₂ at 80 bar**

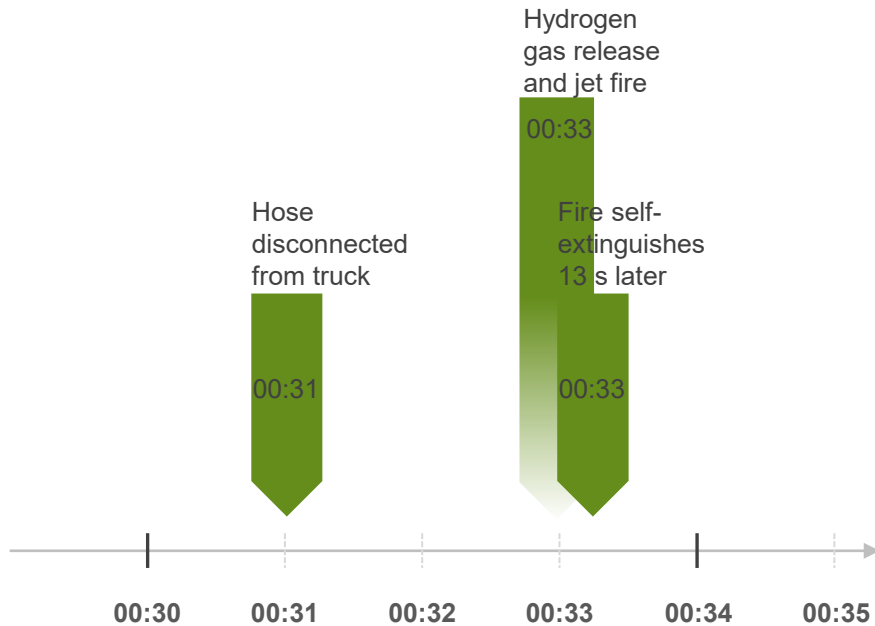
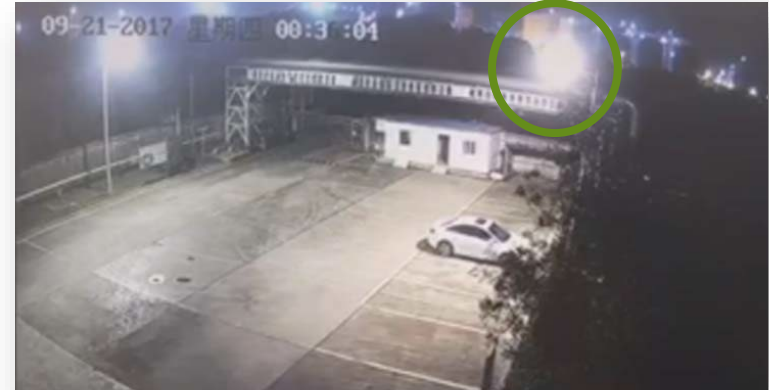
Picture 1: Snapshot from CCTV

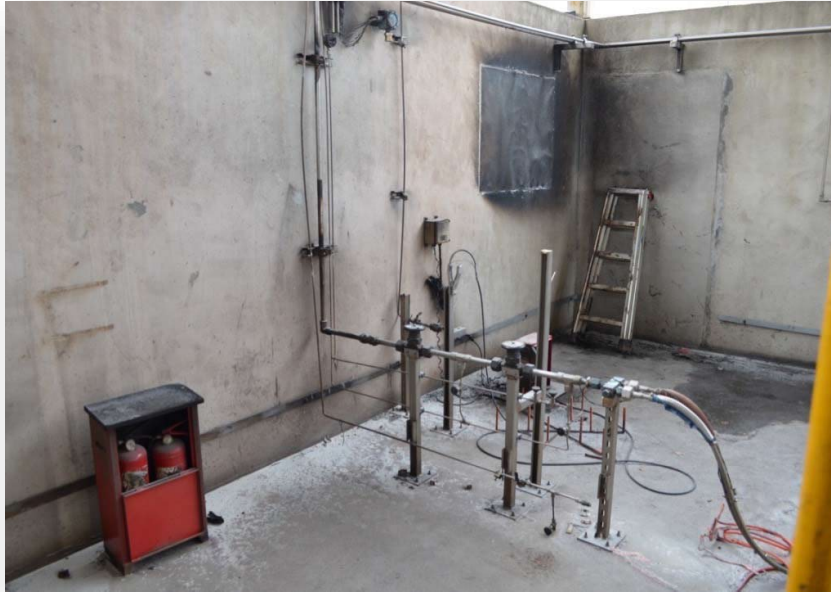
Picture 2: unloading bay after the jet fire

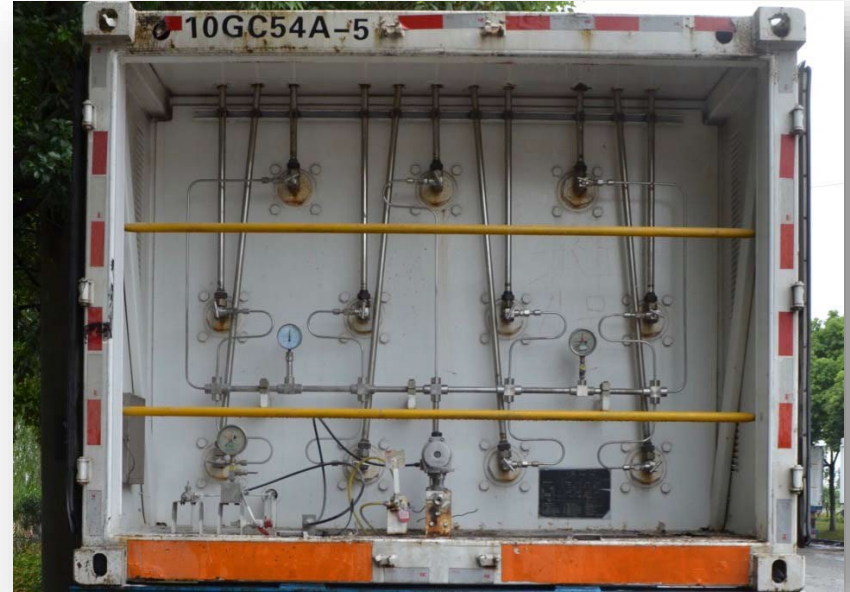
Picture 3: cylinder valves on the truck (left open the day of the event)

- The valves on each of the 11 gas cylinders were found in open position, contrary to the procedure
- Valve 4 found partially open – the driver did close it but not fully
- The procedure (outdated) at this location differs from the standard practice followed by the supplier at other locations – addition of the ESV

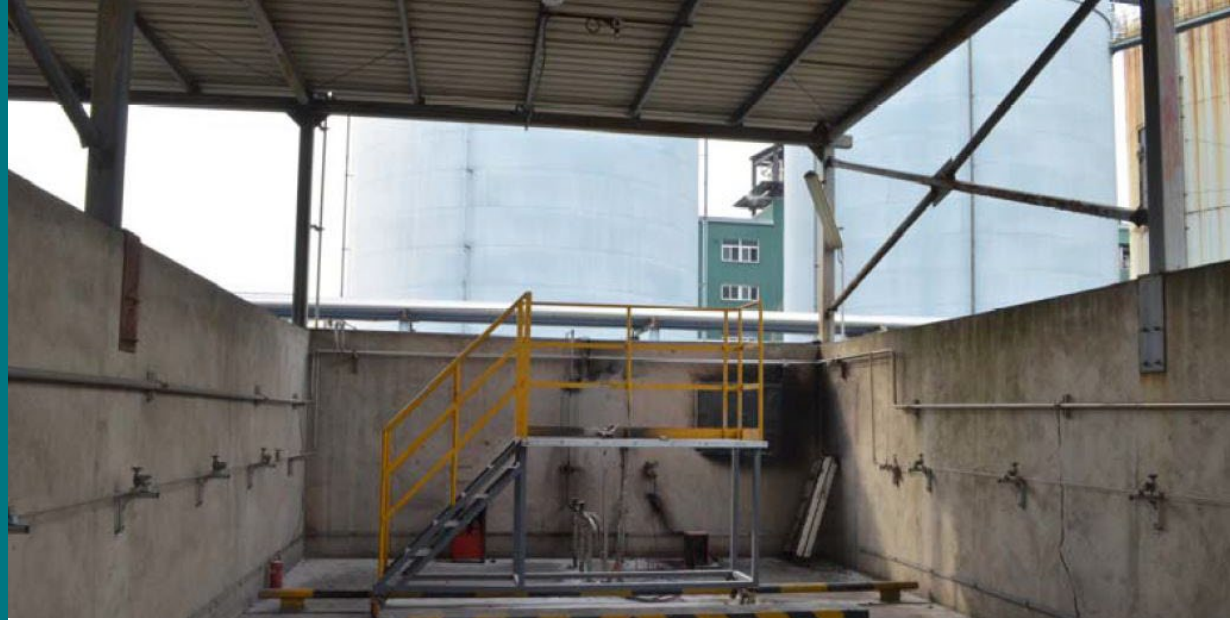
Trailer bay design contributed to the consequences

- Personnel in **line of fire**
- **Limited egress route** from the platform
- Roof and walls make the accessibility of the **emergency responders** more difficult

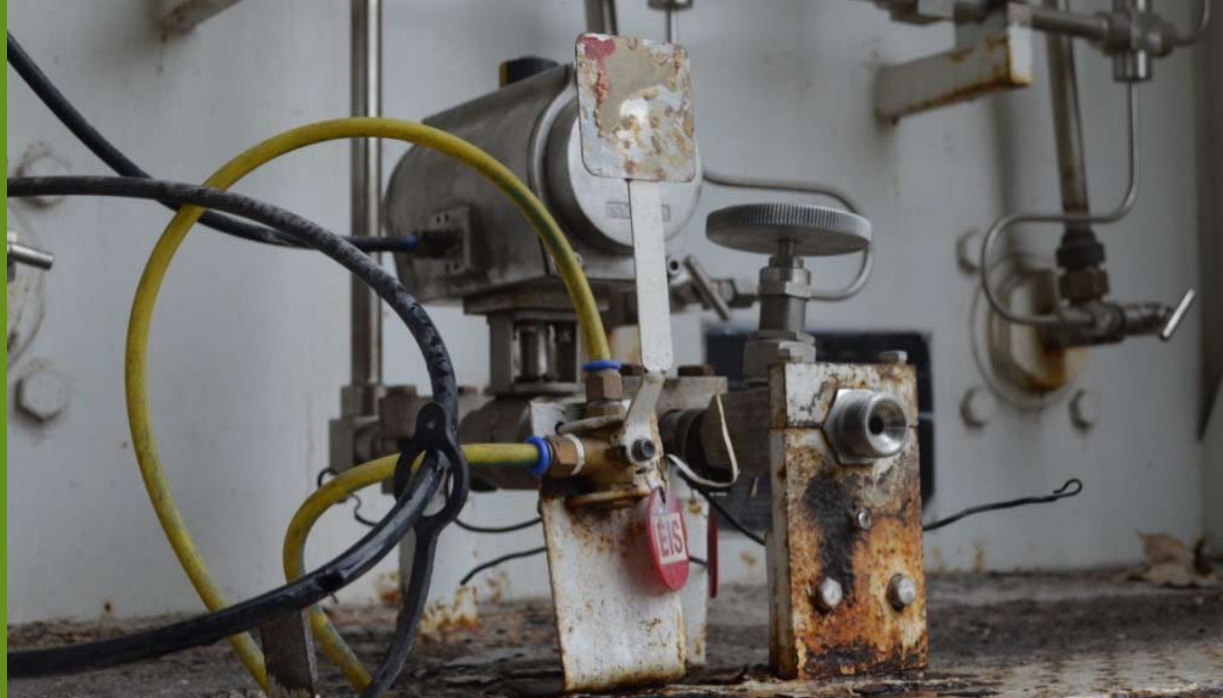
Management of Change system not followed after the PHA

The new ESV is recommended in the PHA but not subject to **MOC process**. A strong MOC process considers the operational and human factors impact of a new safeguard being installed. The verification step in the procedure was jeopardized.
