— Refrigerant R-507 – MRU piping release

- Facility: Polyethylene (PE) Operations
- Incident Date: June 3rd, 2020
- Incident Type: Process Safety Incident - Tier-2 (API RP-754)
- Location: Mechanical Refrigeration Unit (MRU) - Indoors
- Impact: None (besides non-hazardous chemical release to atmosphere)

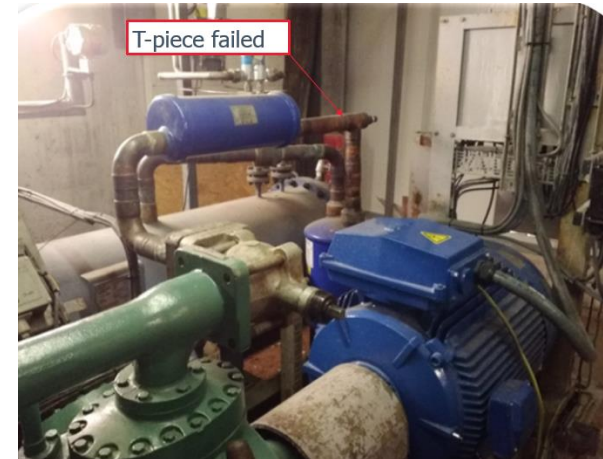
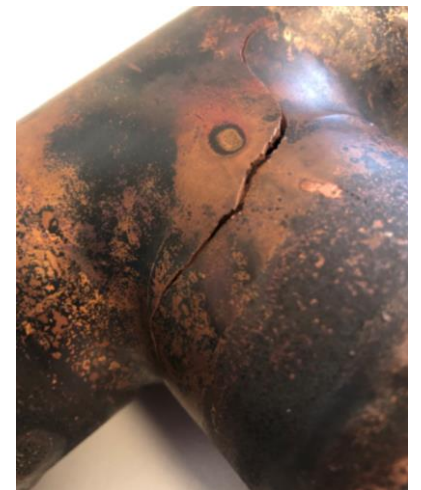
- **Leak** – Indoor release of **346 kg R-507** refrigerant from a crack in the copper discharge line of refrigeration compressor of MRU-100.
- **Duration** – The event lasted **>2 hours** - multiple factors led to the duration:

- While waiting on the expert to reach the site, the responders cleared the room to reduce risk
 - While the building was unoccupied, the leak rate changed and a visible plume formed but not seen (no people in the building)

- The panel technician did not initially notice the change in the trends.

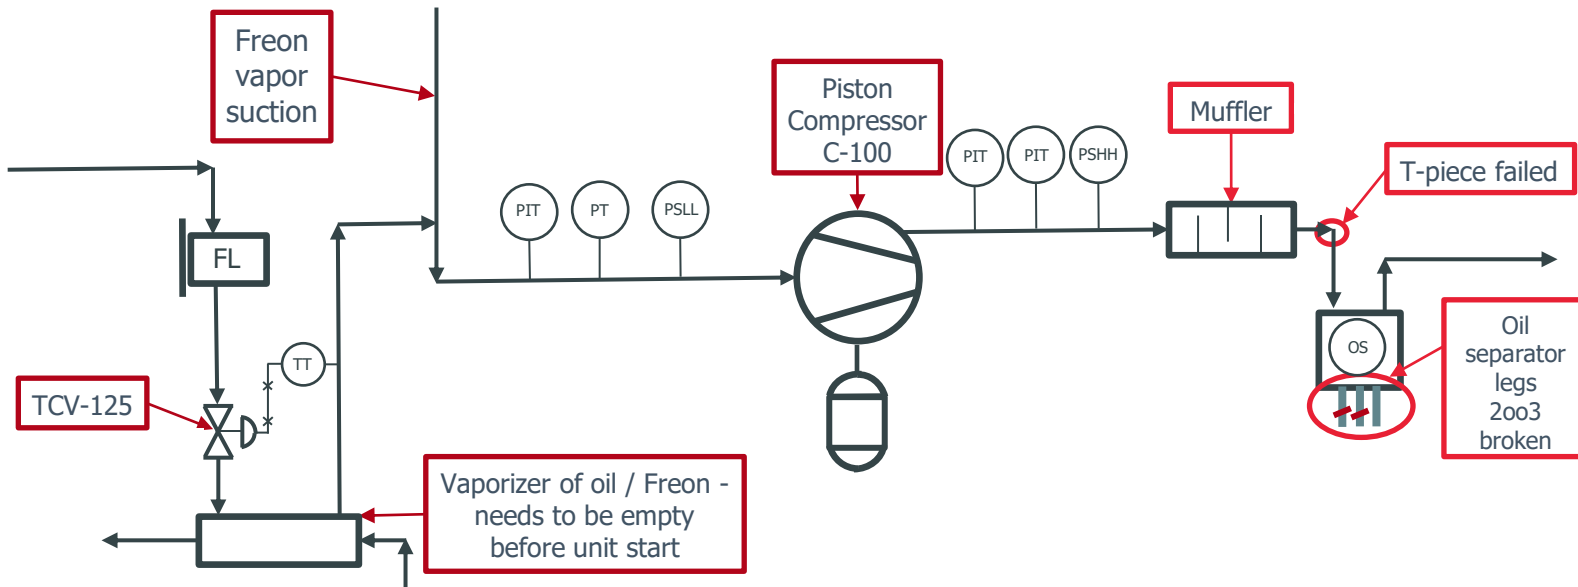
EQUIPMENT MRU 100 – RELEVANT COMPONENTS

- Good Leg
- Broken Leg

TCV-125 – This valve failed in July 2019 → liquid carryover to the compressor → high vibrations. This event likely caused the first leg of the oil separator to break. TCV-125 failed because the MC personnel manipulated it during start-up over the years in a way the valve was not designed to.

Oil Separator – The failed pipe section was completely supported by the compressor and the oil separator (no pipe supports). After the June 3rd release, **2 of the 3 legs of the oil separator were found broken**. Probably the two failures occurred at different times (based on failure point inspection), but unknown. **This was not noticed by either MR or Dow.**

T-piece – **The same T-piece cracked 6 weeks before** (36 kg leak, PS Near Miss). The RCI was still on-going, but it was believed to be caused by a significant vibration event (root-causes eliminated). This **T-piece was replaced** when a new muffler was installed in 2018. Its **thickness was inadvertently changed from 3.0 mm to 1.6 mm.**

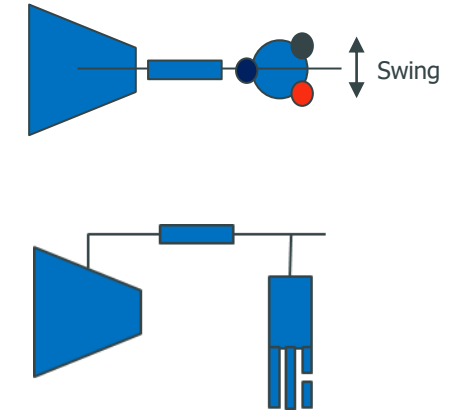
With One Leg Broken

- ✓ Oil Separator Leg #1
 - probably failed due to high vibration in July 2019 due to TCV-125 failure
 - TCV-025 failed because it was operated manually by MC in a way it was not designed for

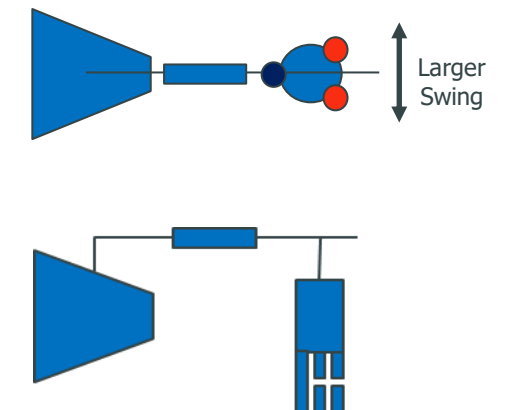
With Two Legs Broken

- The MRU was maintained by MC personnel with no Dow Operations participation (*Operating Discipline*)
- MRU ran with 2 out of 3 legs of the oil separator broken. Compressor vibration + broken legs → material fatigue - **Inadequate Inspection program** (compressor vibration and oil separator supports)

- ✓ Oil Separator Leg #2 –
 - failed sometime between Oil Leg Separator Leg #1 failure and this event, not detected by MC or Dow
 - online vibration monitoring needed?
