Learning from Experience

# *Incident reporting and sharing*

**EPSC Conference**

Jan Weckx

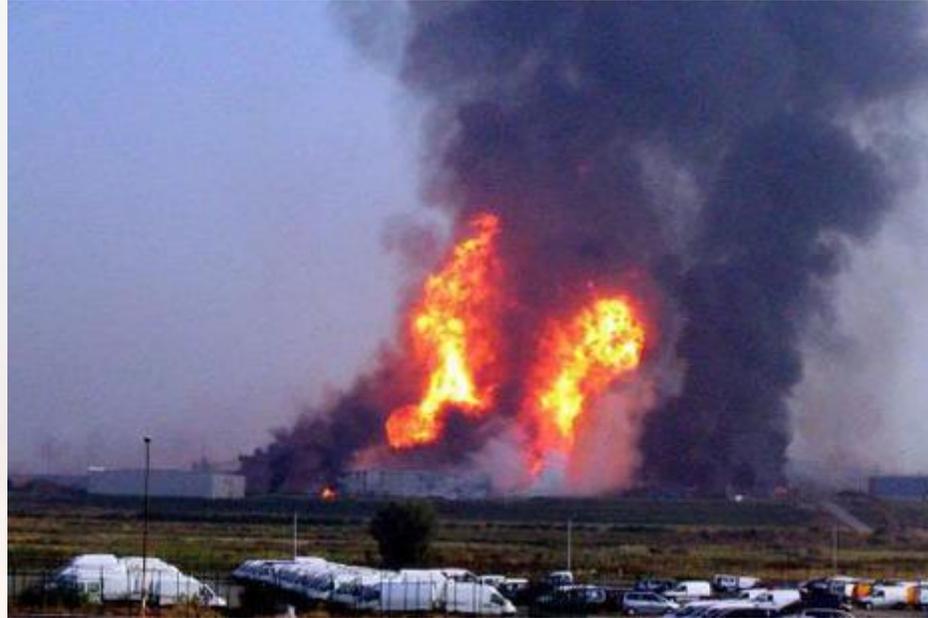
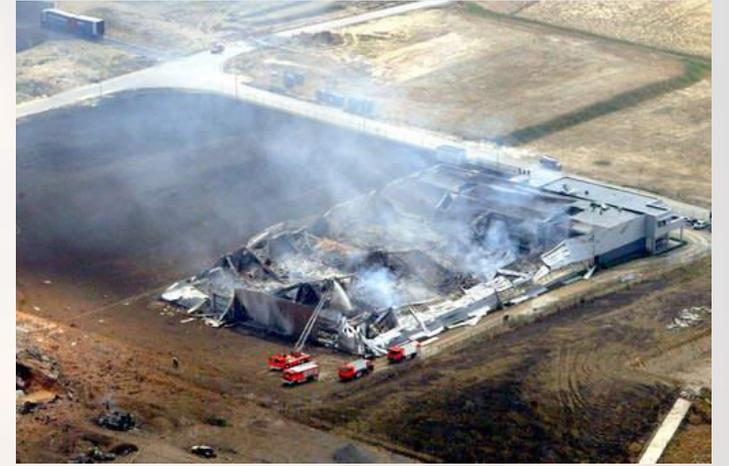
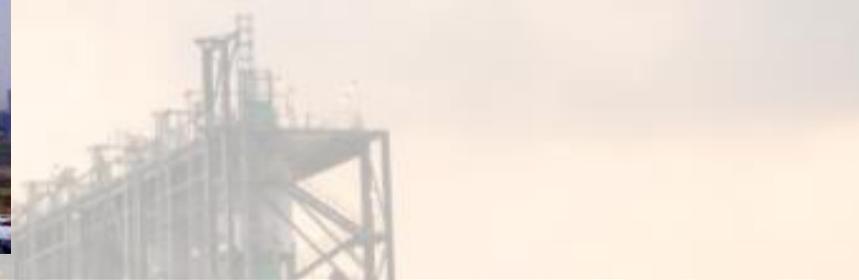
# Ghislenghien 2004

24 dead  
132 injured  
Underground gaspipe damaged during excavation works  
Leak ignited during repair

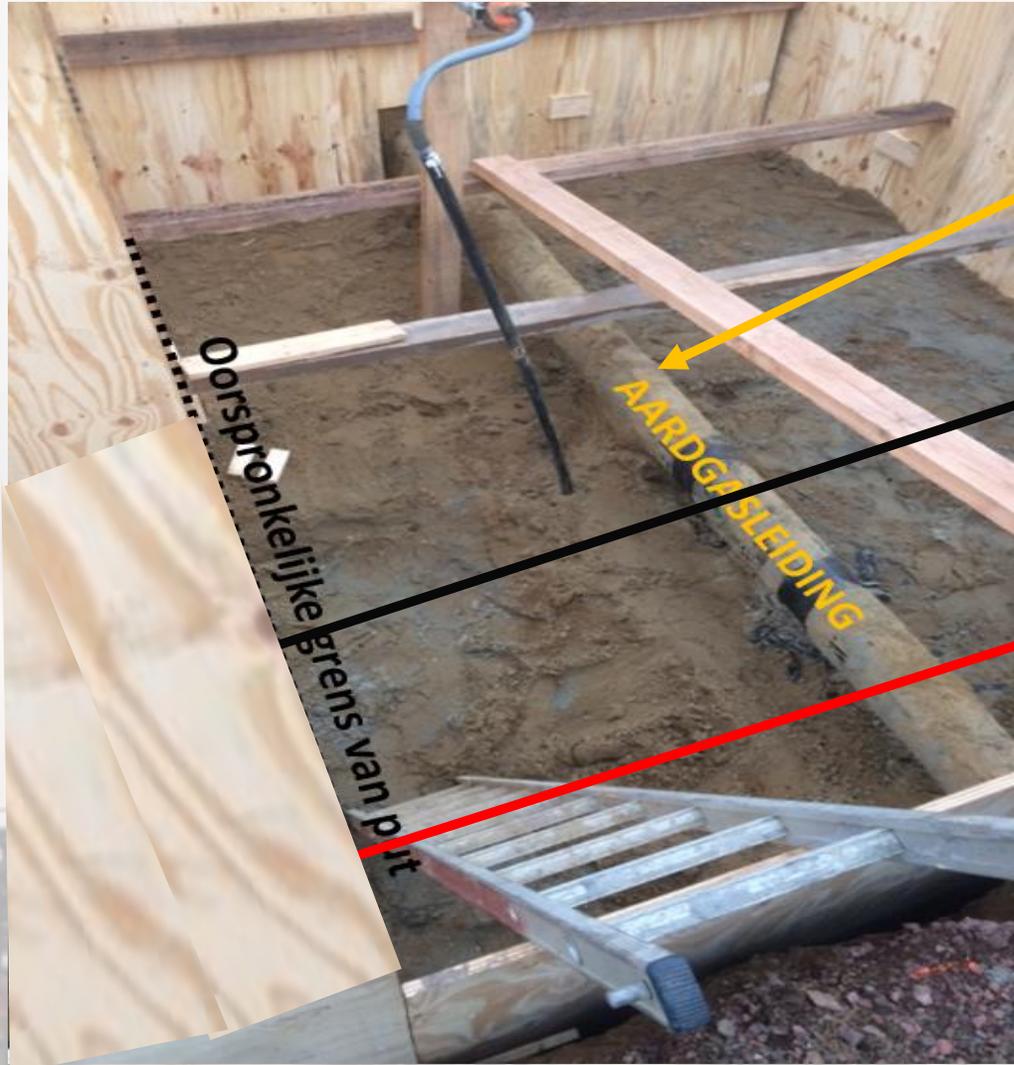
# Situation

Natural gas header

Limit of original excavation

Fire Water header

Excavation contractor not aware of gas header nearby

- // No face to face discussion between contractor and the job owner on drawing office advice
- // Natural gas line poorly visible on copy of print-out plan (yellow color)
- // During Last Minute Risk Analysis with contractor the unit responsible used the fire water plot plan – this showed location of fire water line but not the gas line and was not 100% as built

Root cause : communication deficiencies

Improve visibility of gas lines on plot plans (color)

Improve ESH procedure 011 (excavations)

// Improved communication drawing office advice to job owner / job executor

// Include method for line identification after excavation

// Make sure up to date master plot plan is present at the excavation works

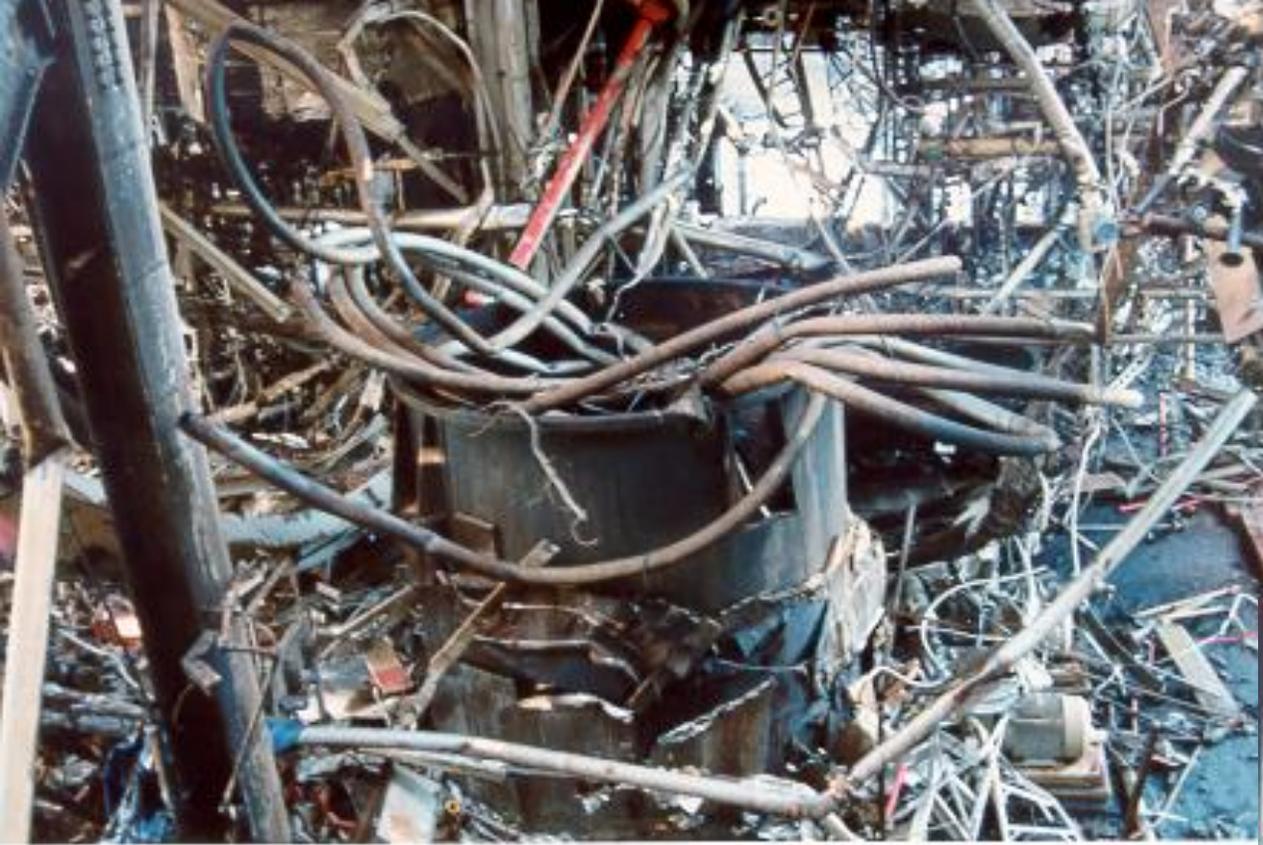
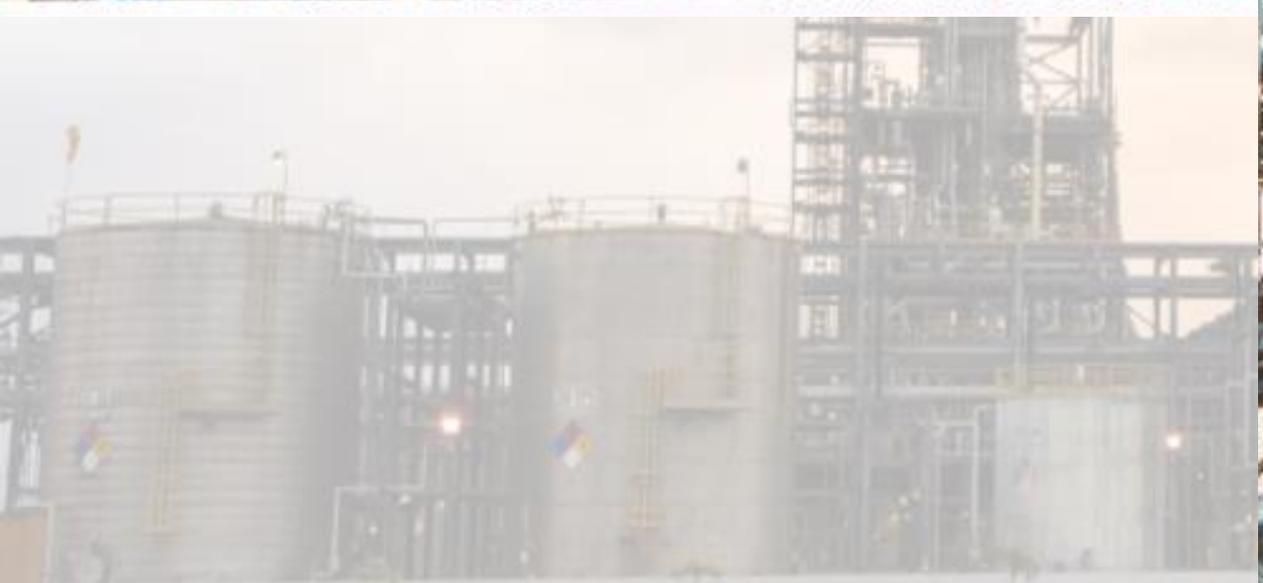
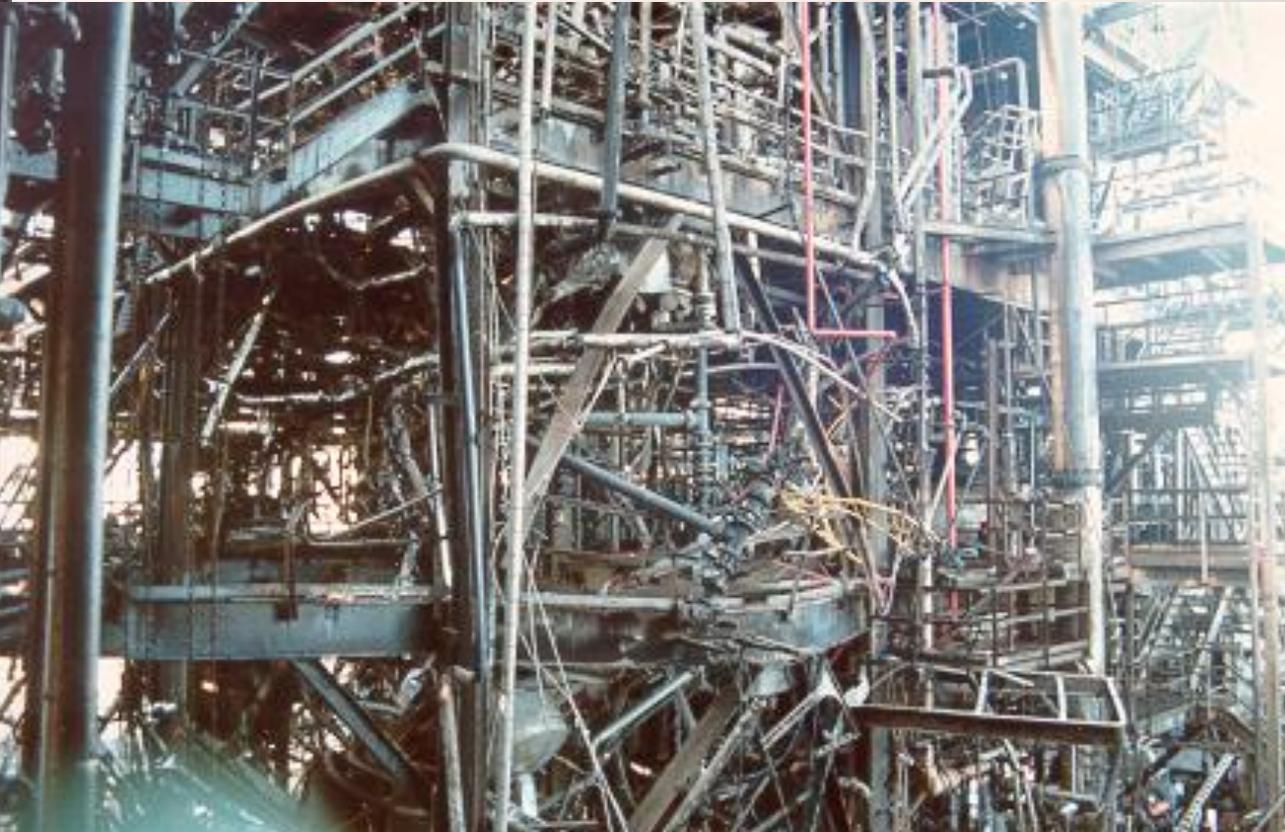
In 1992 – explosion of feed tank

Significant property loss  
No injuries

Organic material thermally unstable

Water wash temperature was increased by site (more efficient wash)

Thermal instability known by corporate technology

Not known by plant operations

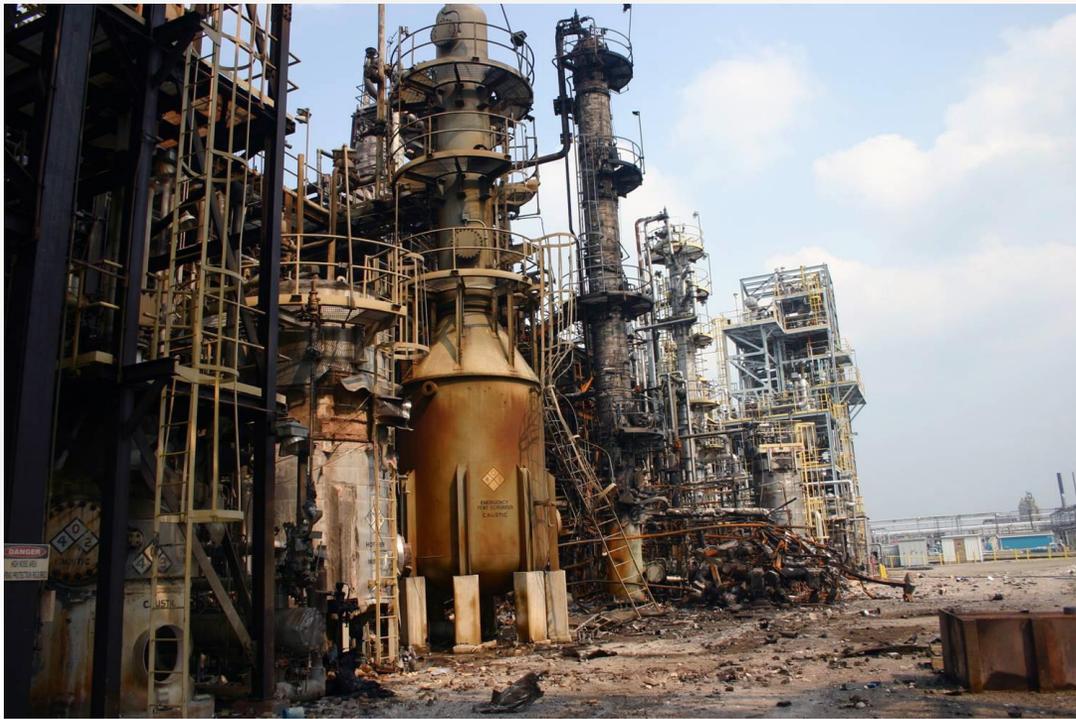
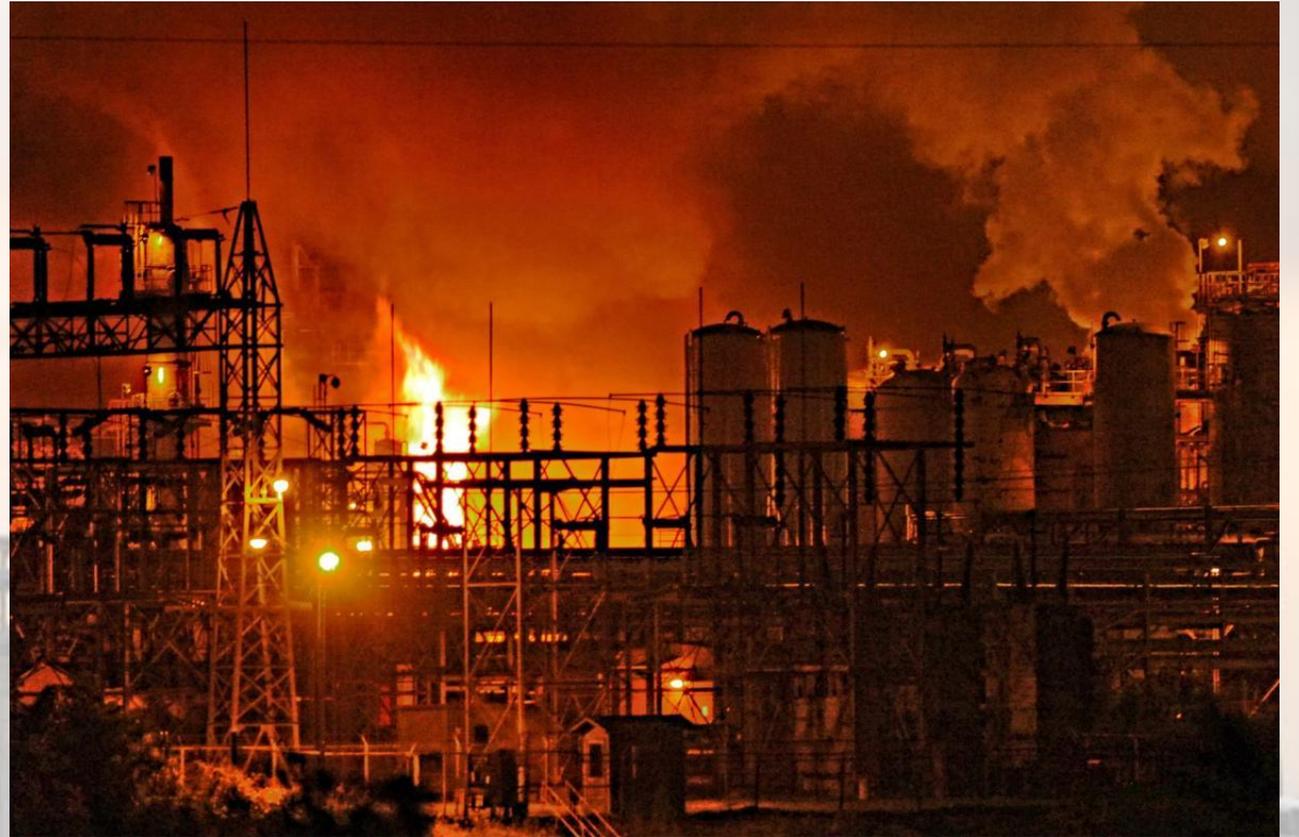
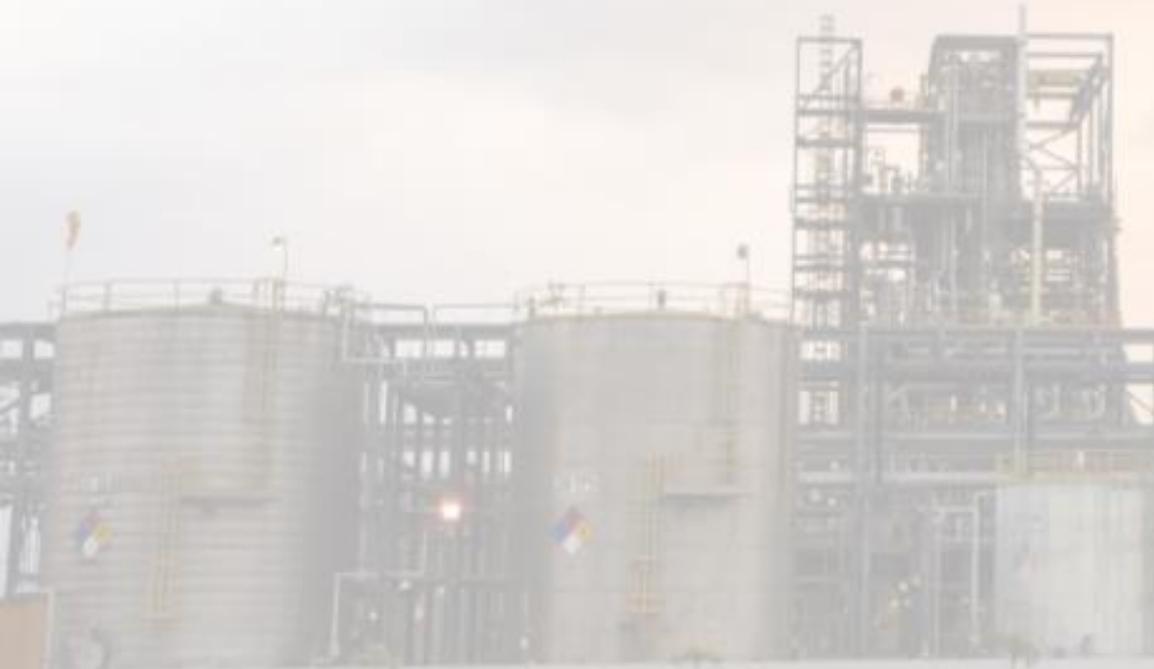
- // No solvent 'heel' charged to treatment vessel
- // Temperature interlock on feed valve bypassed
- // Higher concentrations in feed due to process upsets upstream

- // Runaway decomposition
- // Vessel rupture
- // Two fatalities
