# Hazards of Hydrogen Peroxide handling

Gilles ROMAN, Corp. HSE / Process Safety  
EPSC conference - Maastricht Dec 13<sup>th</sup> & 14<sup>th</sup>, 2023

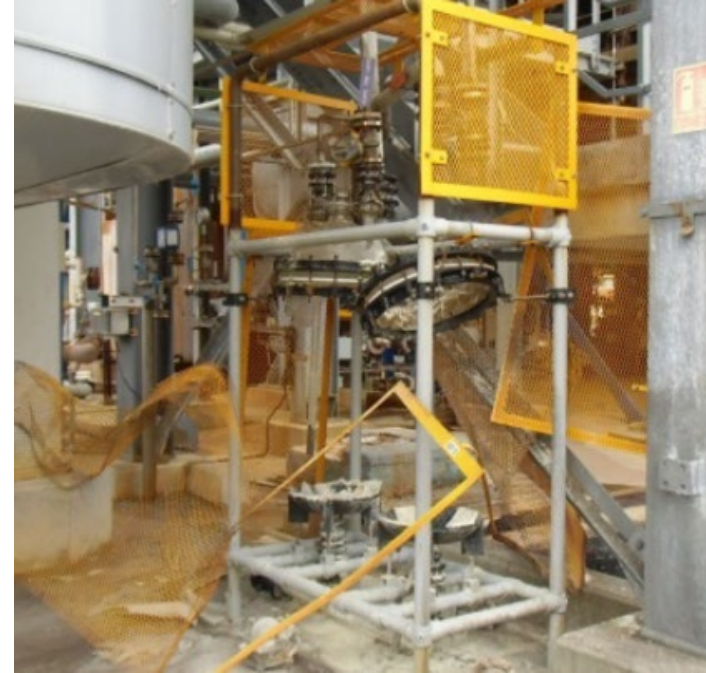
# Event #1 - Manufacturing facility, France, 2015

- Explosion in the vent pipe from the oxidizer to a glass seal pot
- Shrapnel was sent dozens of meters away
- One temporary hearing loss, no damages to the environment

- Dichloromethane condensed in the vent pipe low points
- Dichloromethane is not classified “flammable liquid”, but vapors are flammable!
- Oxygen from HP decomposition generated a flammable gas mixture in the vent header
- The mixture was ignited at the oxidizer

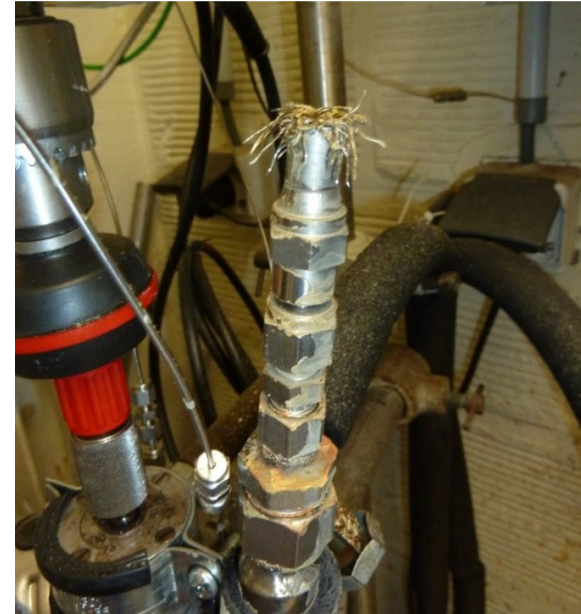
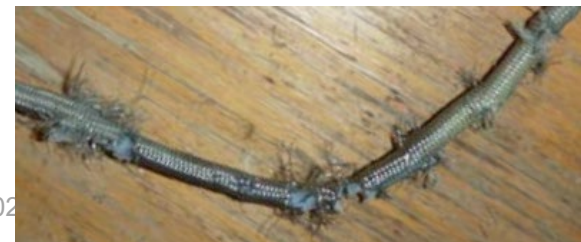
# Event #2 - Research facility, Belgium, 2017

- Poor yields observed when  $O_2/(O_2+N_2) < 7\%$
- $O_2$  quantities were increased gradually
- Explosion occurred during test where  $[O_2] = 52\%$
- Flexible pipe shattered (detonation)
- One hearing injury, no damage to the environment.

- Constraint to keep  $O_2$  concentration below the LOC was misunderstood
- Ignition source during trial at highest  $[O_2]$
- SOP not followed: operator in the bunker

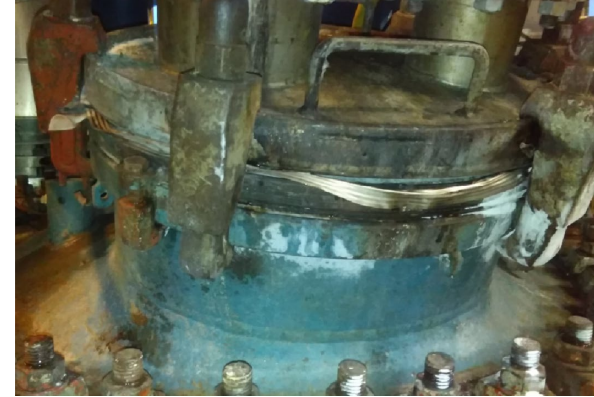
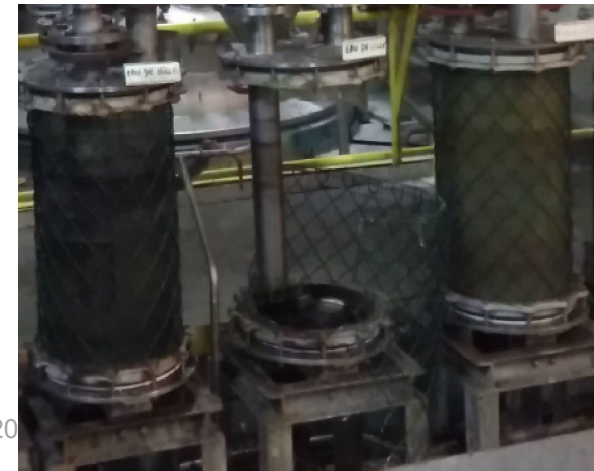
# Event #3 - Manufacturing facility, France, 2022

- Process carried out exactly as intended
- Explosion in the reactor and fire
- Rupture of glass seal pot on the vent line
- No injuries and no damages to the environment

- O<sub>2</sub> generation by side reaction known to experts
  - Not quantified
  - Not communicated to Plant & Hazop teams
- The new recipe implied 20 times more HP
- At lab and pilot scale, the O<sub>2</sub> was displaced by N<sub>2</sub> sweep
- There was no N<sub>2</sub> sweep at this Plant

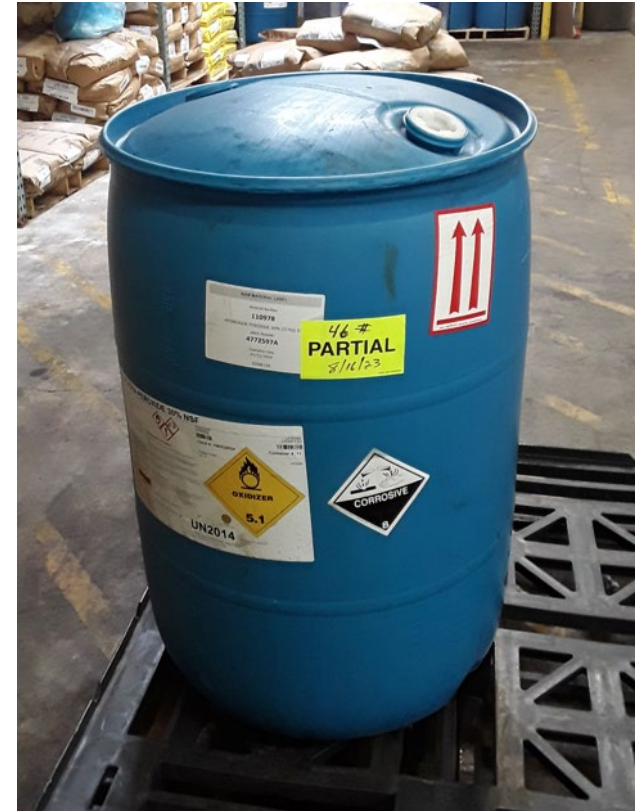
# Event #4 - Manufacturing facility, USA - 2023

- The partial HP drum heated-up and bulged
- The drum tilted over and burst
- Nobody was injured and the spill was contained

- Contamination of HP initiated its decomposition
- Either dirty suction cane, or liquid backflow

- Suction cane not rinsed thoroughly with water
- Drum's breathing vent replaced by standard cap

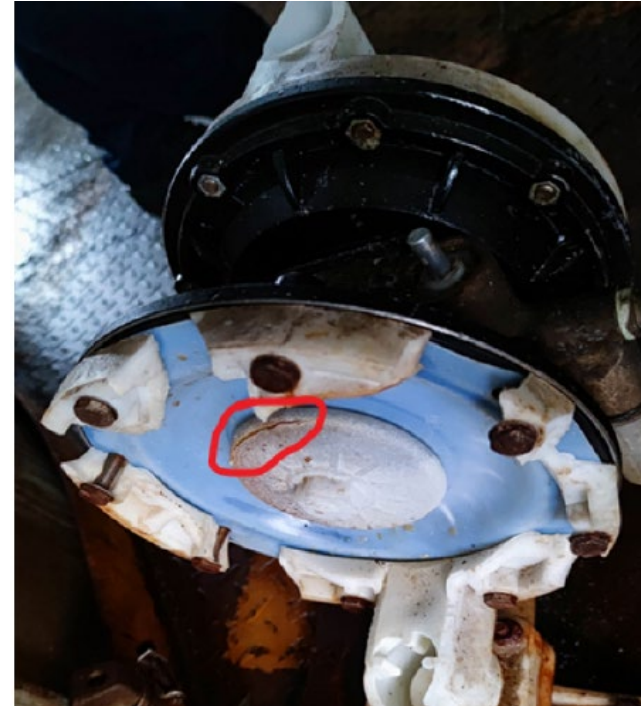
# Event #5 - Manufacturing facility, China - 2022

- Transfer of 20 kg HP to the reactor
- Pump & pipe are rinsed with solvent
- 10 minutes after flushing, the pump burst
- Fragments send few meters away
- Nobody was injured and the spill was contained

- Damaged PTFE membrane put HP in contact with rust: decomposition to  $O_2$  and  $H_2O$
- Lack of venting provision on piping & pump

- Pump & pipe not dedicated to HP / Not rinsed
- Coatings on incompatible materials to be avoided

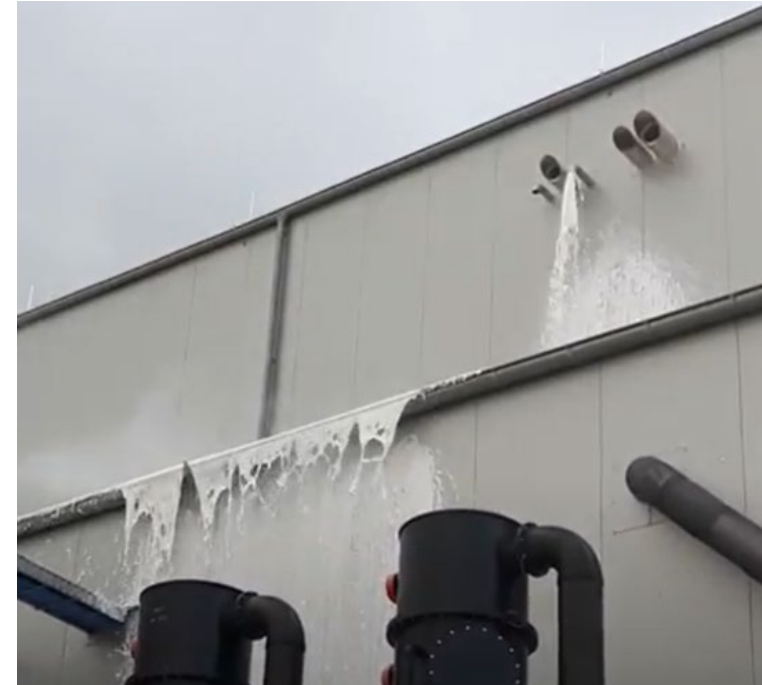
# Event #6 - Manufacturing facility, Germany - 2018

- When metering the HP35%, the normal initial exotherm was not observed
- Temperature was raised with heating coils
- ... Runaway
- 30% of the reactor mass vented via the Safety Valve and discharged to the roof

- Flowmeter units mismatch =>lack of catalyst
- Heating initiated the side reaction:  
$$\text{H}_2\text{O}_2 (\text{liq}) \rightarrow \text{H}_2\text{O} (\text{liq}) + \frac{1}{2} \text{O}_2 (\text{gas})$$
- The hazard of HP accumulation was known, but the SOP was not detailed enough

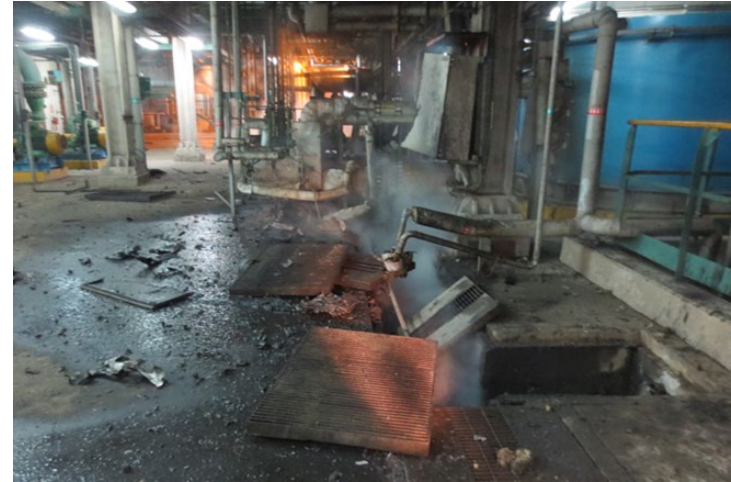
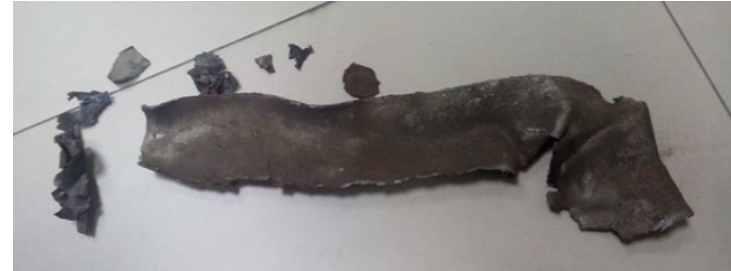
# Event #7 - Manufacturing facility, China, 2015

- Condensed-phase detonation in the drain pipe, fortunately located in a trench
- Shrapnel found dozens of meter away
- No injuries and no damages to the environment

- HP 70% displaced during flushing contacted organic product in the (heated) drain pipe
- Mixtures of organics with HP > 40% can become explosive
- Scenario identified in Hazop, however:
  - The SOP was not sufficiently detailed
  - Poor Bypass management
