# Boats, Bridges and Back-ups

Roger Stokes BSc CEng FIChemE MIE

EPSC European Conference on Plant & Process Safety  
December 2024

# MV Dali/ Francis Scott Key Bridge, Baltimore

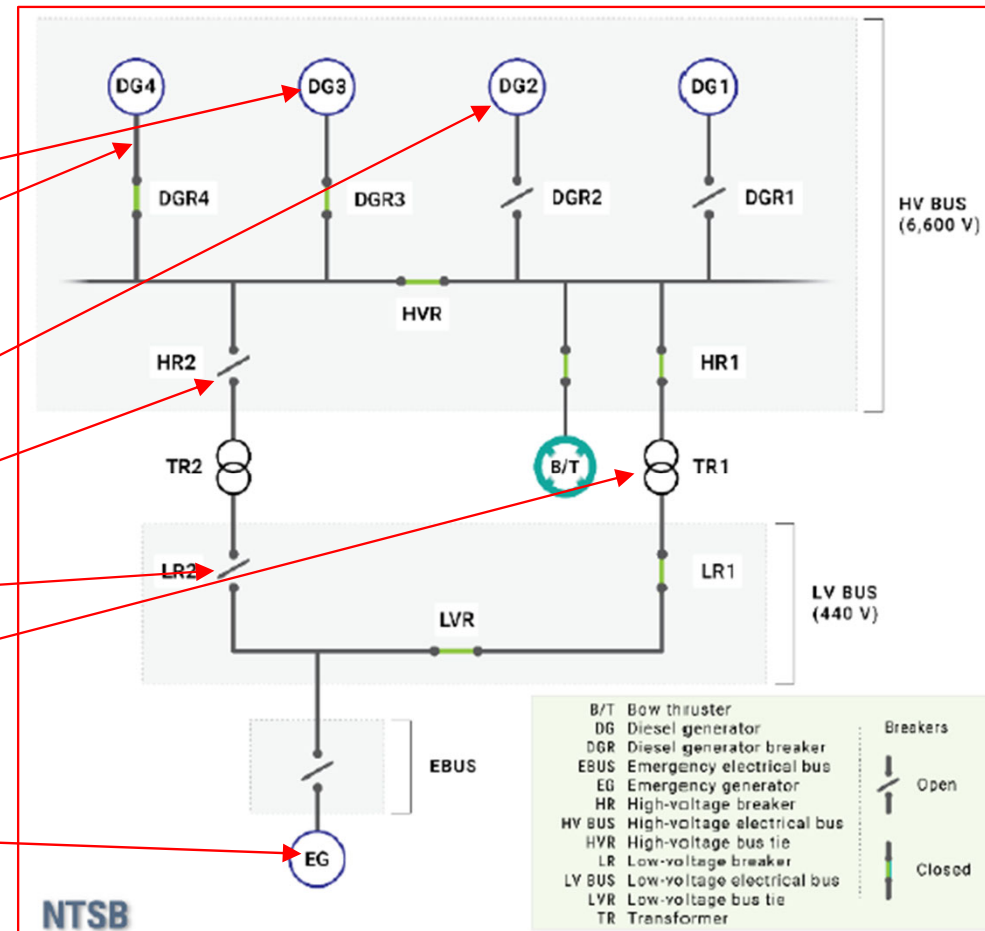
- HV power (6.6kV) to HV bus by up to four diesel generators
- Two operating (DG3 and DG4) at the time of the incident.
- DG2 “on automatic standby”
- Transformer TR2 isolated
- Transformer TR1 on line
- Emergency generator on LV bus

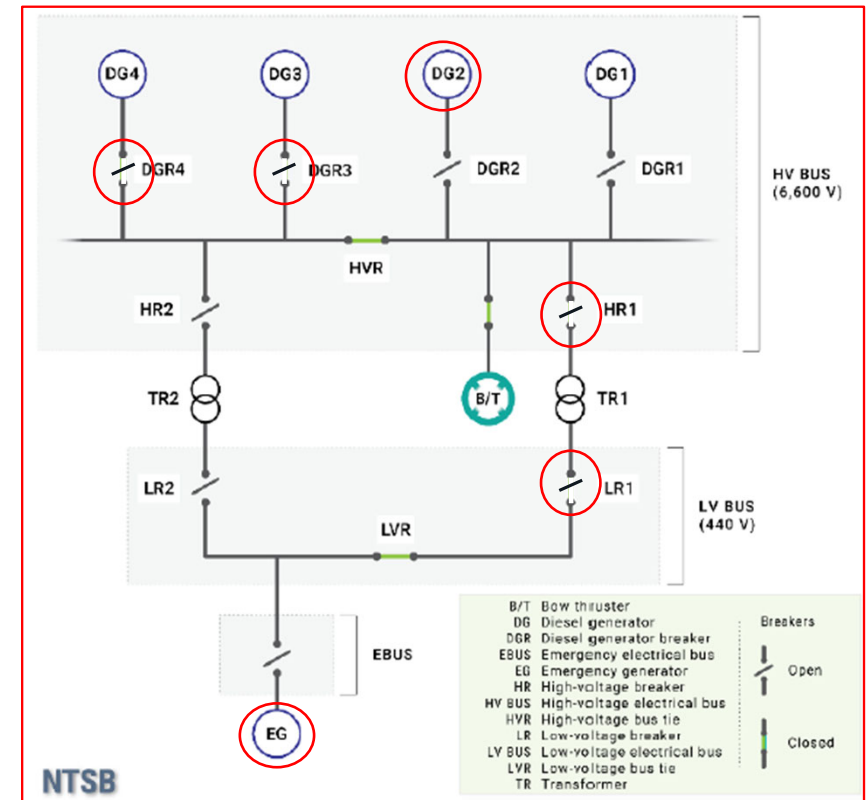
- 01:24:58 hrs SOG ~ 9 knots<sup>1</sup>
  - HR1 and LR1 tripped – LV systems lost power
  - Most bridge systems lost power
  - Engine shuts down (fuel/ lube/ cooling)
  - Steering pumps (x3) lost power
- 01:25:57 power restored (“Manual reset HR1, LR1”<sup>2</sup>)
- EG started – timing tbc (“over 1 minute”)
- DG2 started – timing tbc
- 01:26:13 pilot orders 20° port rudder
- 01:27:01 pilot ordered anchor drop
- 01:27:03 second power failure HV and LV bus
  - DGR3 and DGR4 opened due to fuel starvation to generator
- 01:27:23 pilot ordered 35° port rudder
- 01:27:36 power restored
- 01:29:10 Dali strikes pier 15 of Francis Scott Bridge

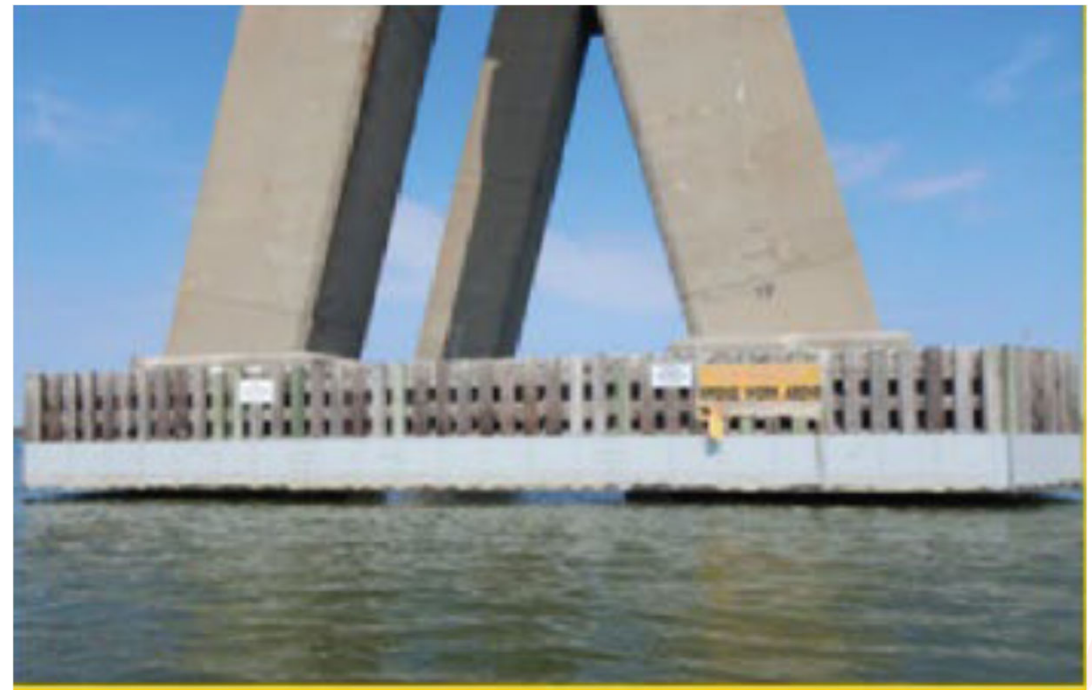
- 100 ft x 84 ft crushable concrete box and timber fender system
- Clearly not sufficiently large/robust

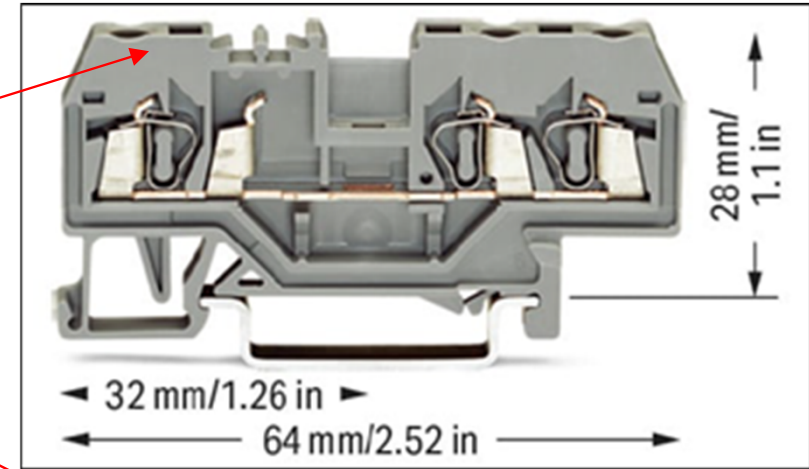
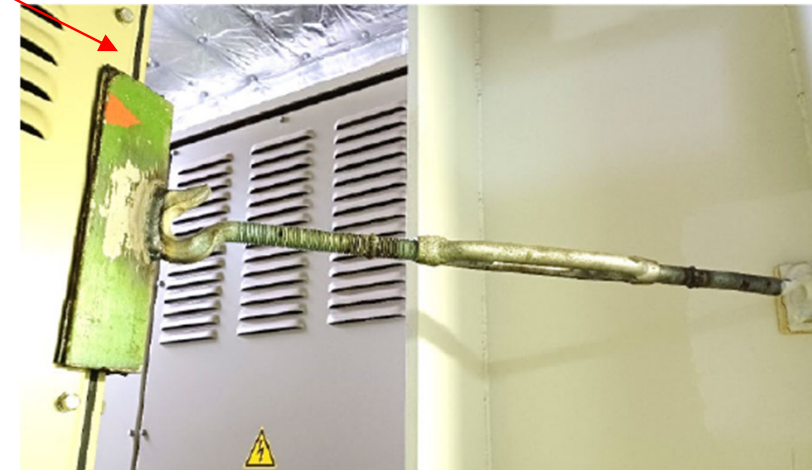
- First undervoltage release blackout: Loose connections on HR1's termination block
  - Possibly vibration
- Auto-switchover to No.2 transformer not operating “disabled”
- Second blackout : No 3 and 4 generators for US ECA areas – burn marine gas oil
  - Set up “temporary” fuel pump for 3 & 4, to use low sulphur fuel - that could not recover automatically after first black-out. (MOC)
  - Fueled only by a small emergency air-driven pump, the generators were starved of fuel and slowed down until switchgear tripped out.

Vibration reduction measures !

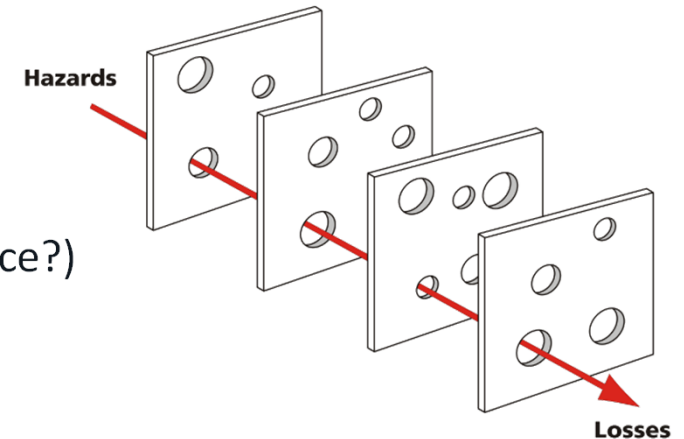
- Tugboat
  - Not available at critical point of departure (procedure?)
- Power loss due to electrical / vibration problems
  - No available back-up to allow main engine to run (design / maintenance?)
- Transformer not set to auto-changeover
  - Or set up on shared 50:50 load (procedure?)
- Fuel pump for generators
  - Not lined up for restart from power loss (MOC ?)
- Emergency Generator (LV) not started up quickly enough
  - Greater than 45 seconds (design/ testing / procedure ?)
- Pier Fendering system
  - Not effective for speed/ tonnage (creeping change?)
- Plus plus ...

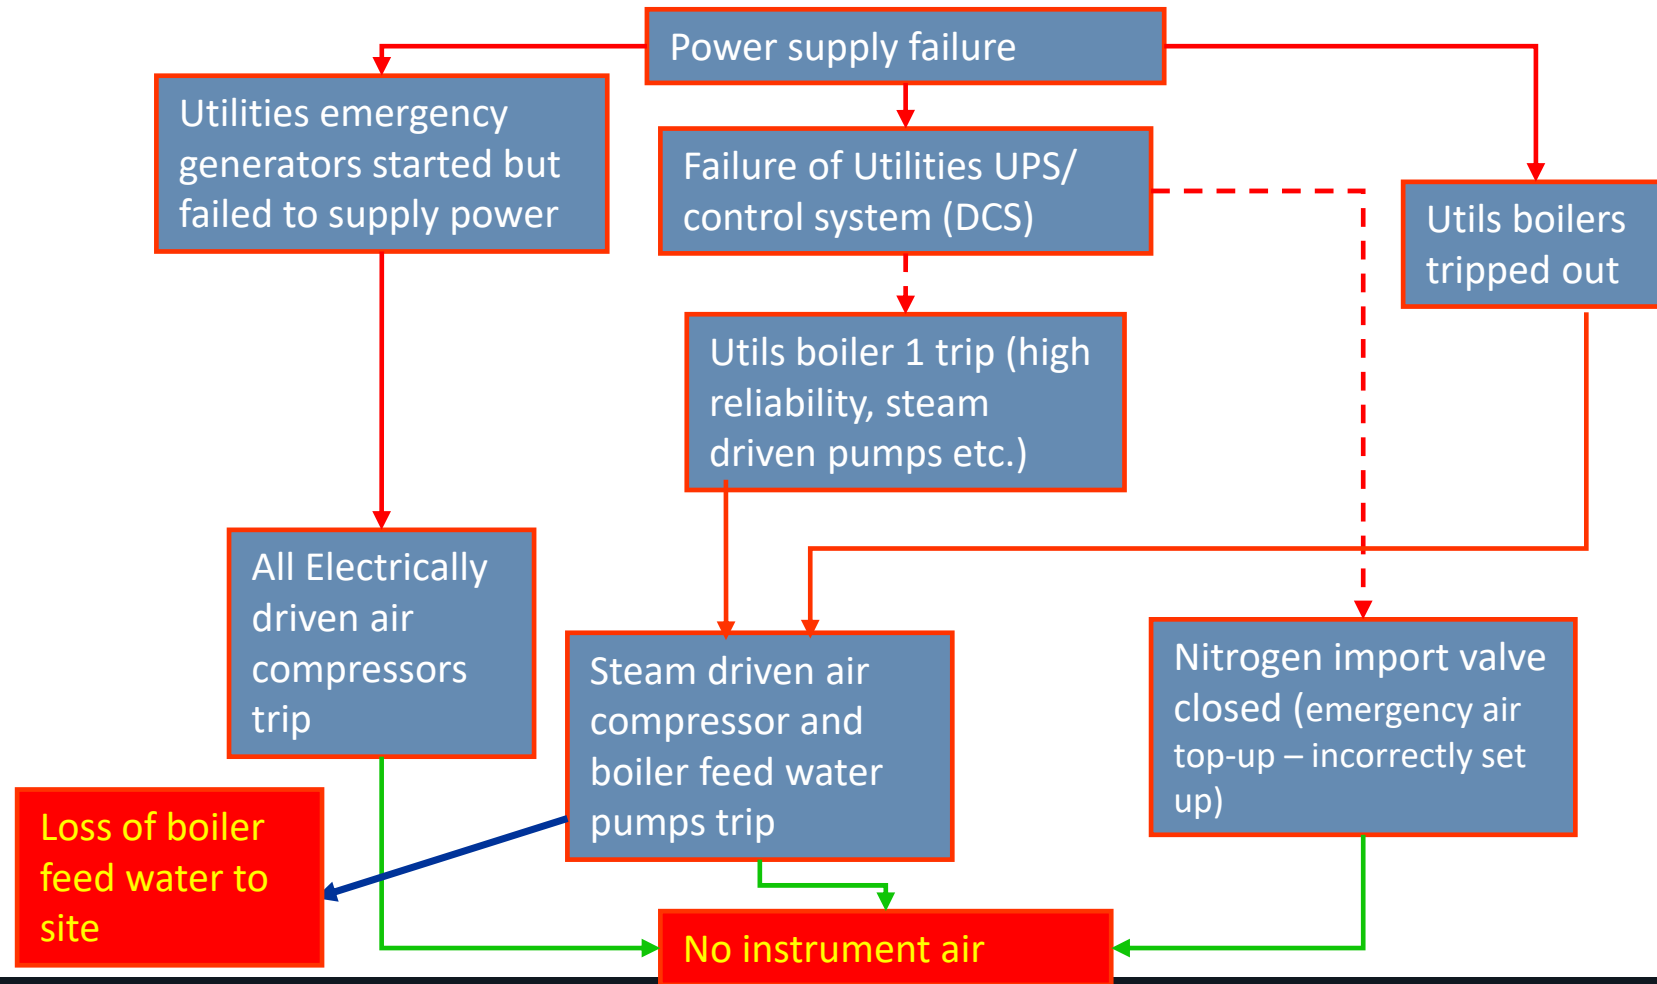
- Dual, independent power supplies on separate poles
- 14 diesel back-up generators at various locations
  - To allow safe shutdown of facilities
- 56 UPS (battery backups)
- Steam supply includes “high integrity boiler”
  - Steam turbine-driven feed pumps/ combustion air fans
- Steam turbine-driven air compressors
  - With back-up from nitrogen system for instrument air
- Both Power supplies failed
- Only 3 effectively supplied power
- 5 UPSs failed to work
- Boilers tripped
- Air compressors tripped

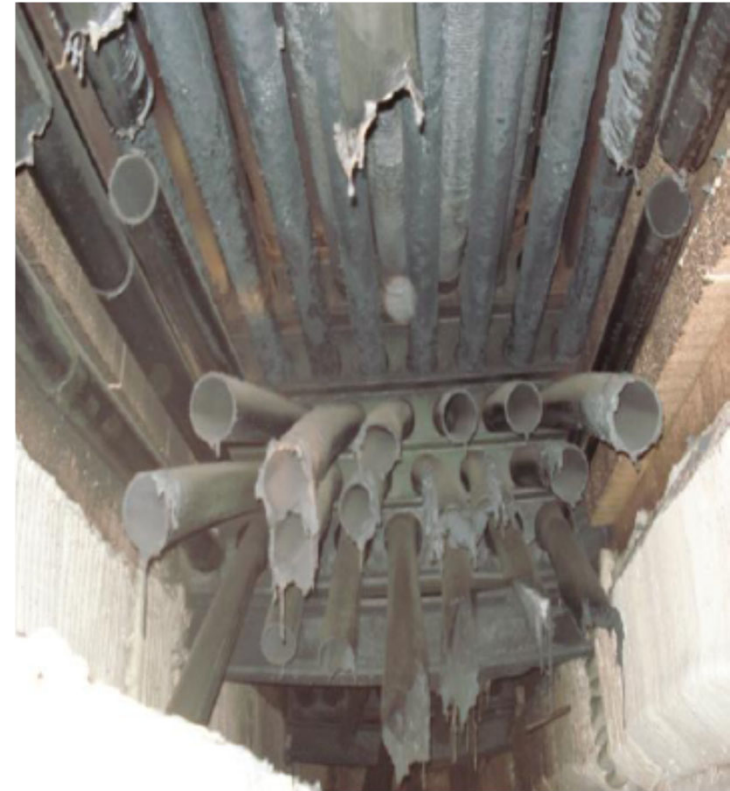
- Failure of furnace tubing
  - Thermal stress and overtemperature
- Backflow of hydrocarbons due to downstream pressure control valve failing closed
  - Backpressure on furnaces
  - Operators could not close manual valves in time
- Uncontained fires in multiple furnaces
- £MM repair costs/ environmental damage

- External power supplies were not independent - subject to common cause failure.
- Inadequate design, maintenance and testing of emergency generators
  - Not synchronized – routine test was to mechanically start the generators and verify voltage is generated.
  - No simulated load testing of generators was conducted, and the tests did not include electrical synchronisation.
- Failure mode of the control valve on backup to instrument air supply was incorrect.
- Failure to consider total loss of services in the design/emergency planning/human factors, including inability to manually close outlet valves from each furnace in time.
