ASSOCIATED PROTECTIVE DEVICES

HOW DO YOU KNOW THAT ALL PARTS OF YOUR RELIEF SYSTEM ARE EFFECTIVE?

Richard Hodges
EPSC Process Safety Conference, Barcelona, December 2024

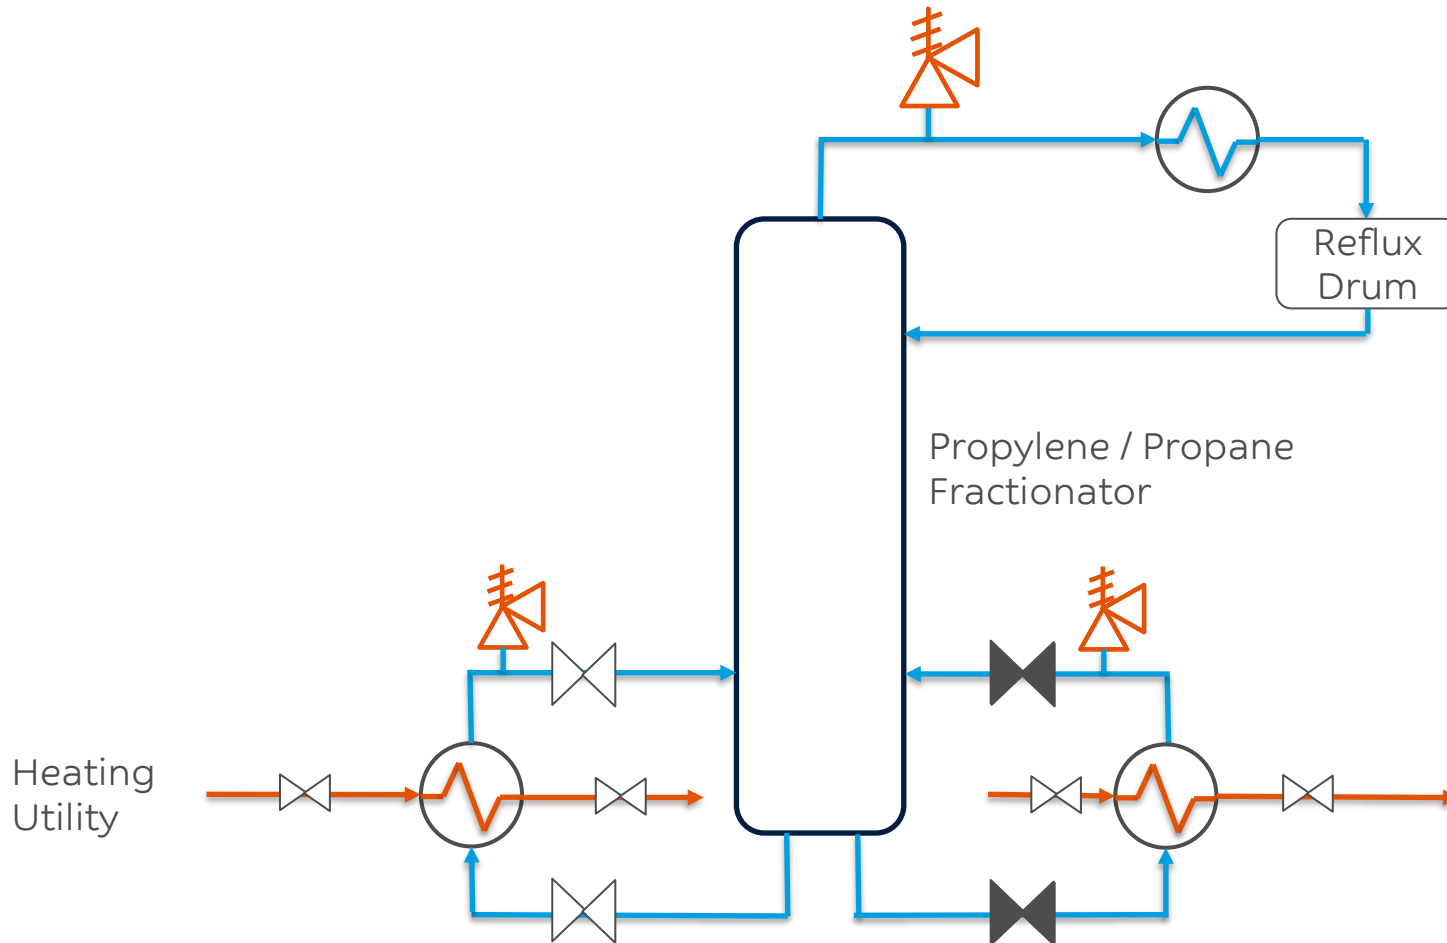
- Propylene Column as designed and installed
- Fouling of reboilers requires periodic column shutdown
- Isolation valves installed 2001
- The heat exchanger can be isolated from the column for maintenance
- But the process (shell) of the heat exchanger is isolated from its relief protection
- A safer installation

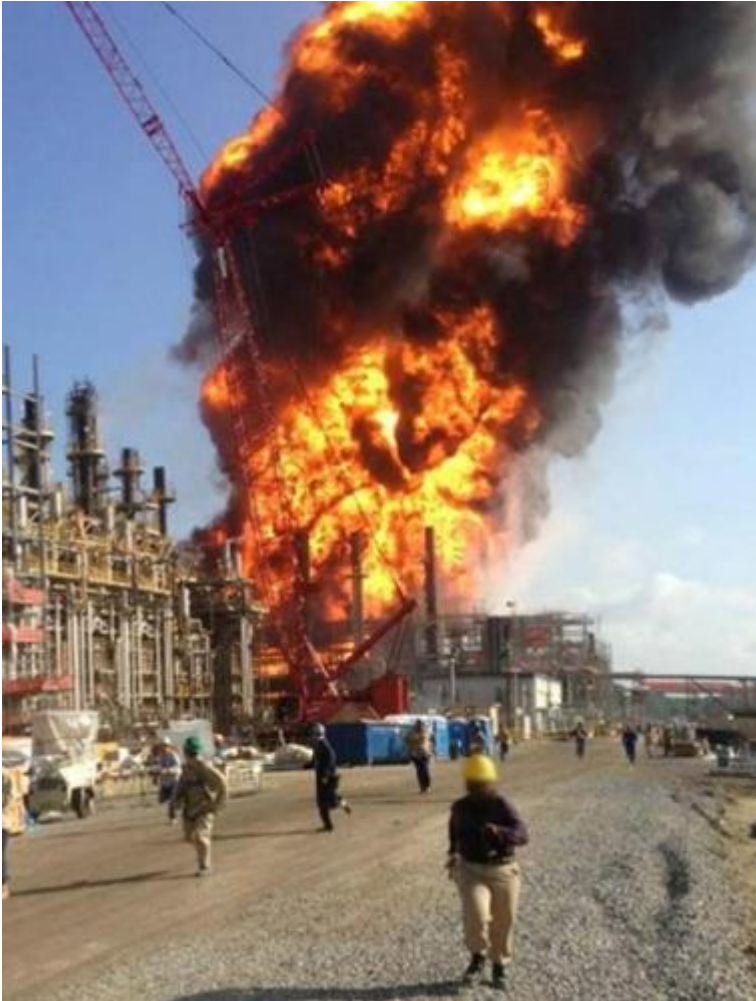
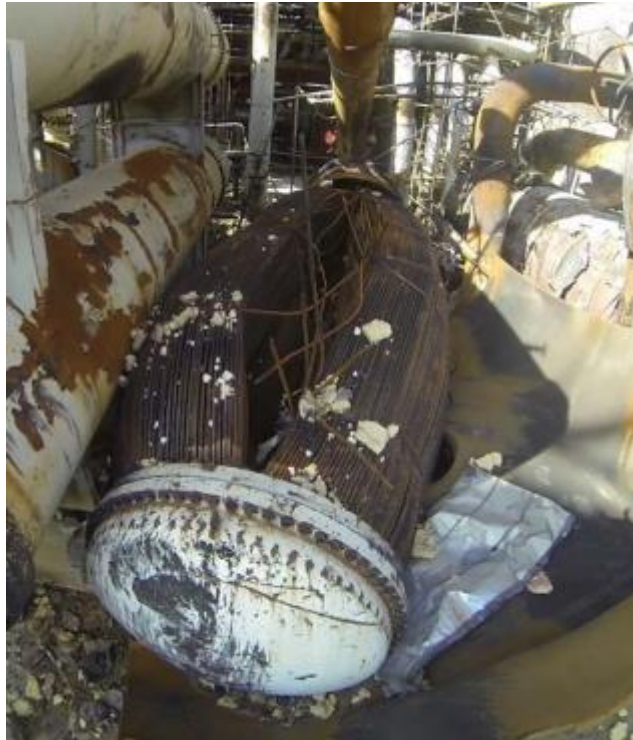
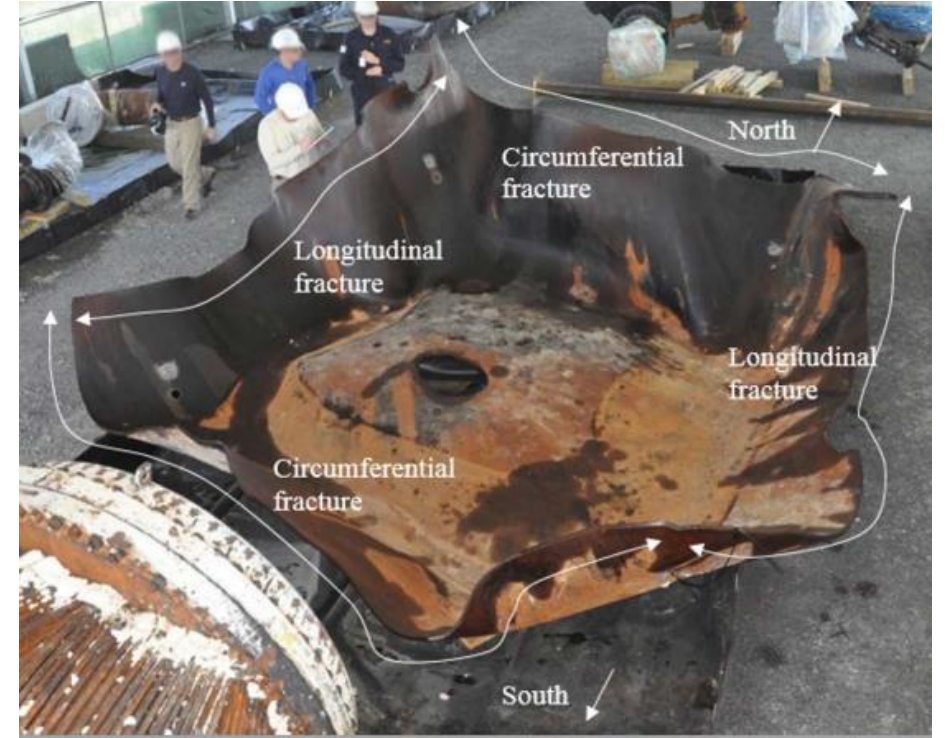
Williams Geismar – Explosion and Fire – 13/06/16

- This incident highlights the concept of an associated protective device.
- The original design for pressure relief was acceptable, but a subsequent modification installed an isolation valve between the heat exchanger shell and its relief valve.
- The relief provision was being provided through procedural controls, and reliant on the integrity of manual isolation valves.
- The deficiencies in design and operational control are very obvious in this example – but how can you be sure that your design intent for a well-designed relief stream is correctly implemented, inspected and maintained over the life of the plant?

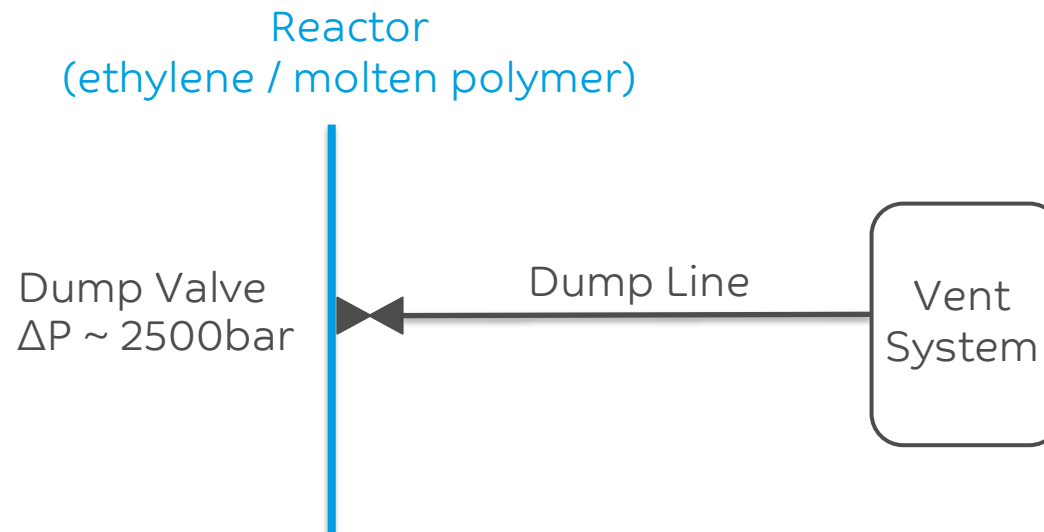
- Reactor overpressure protection is provided by a Safety Instrumented System, which dumps the reactor to an emergency vent system.
- Pre-startup checks identified evidence of polymer blockage in the emergency vent system.
- Investigation revealed a full blockage of the Dump Line which required several days to physically clean.

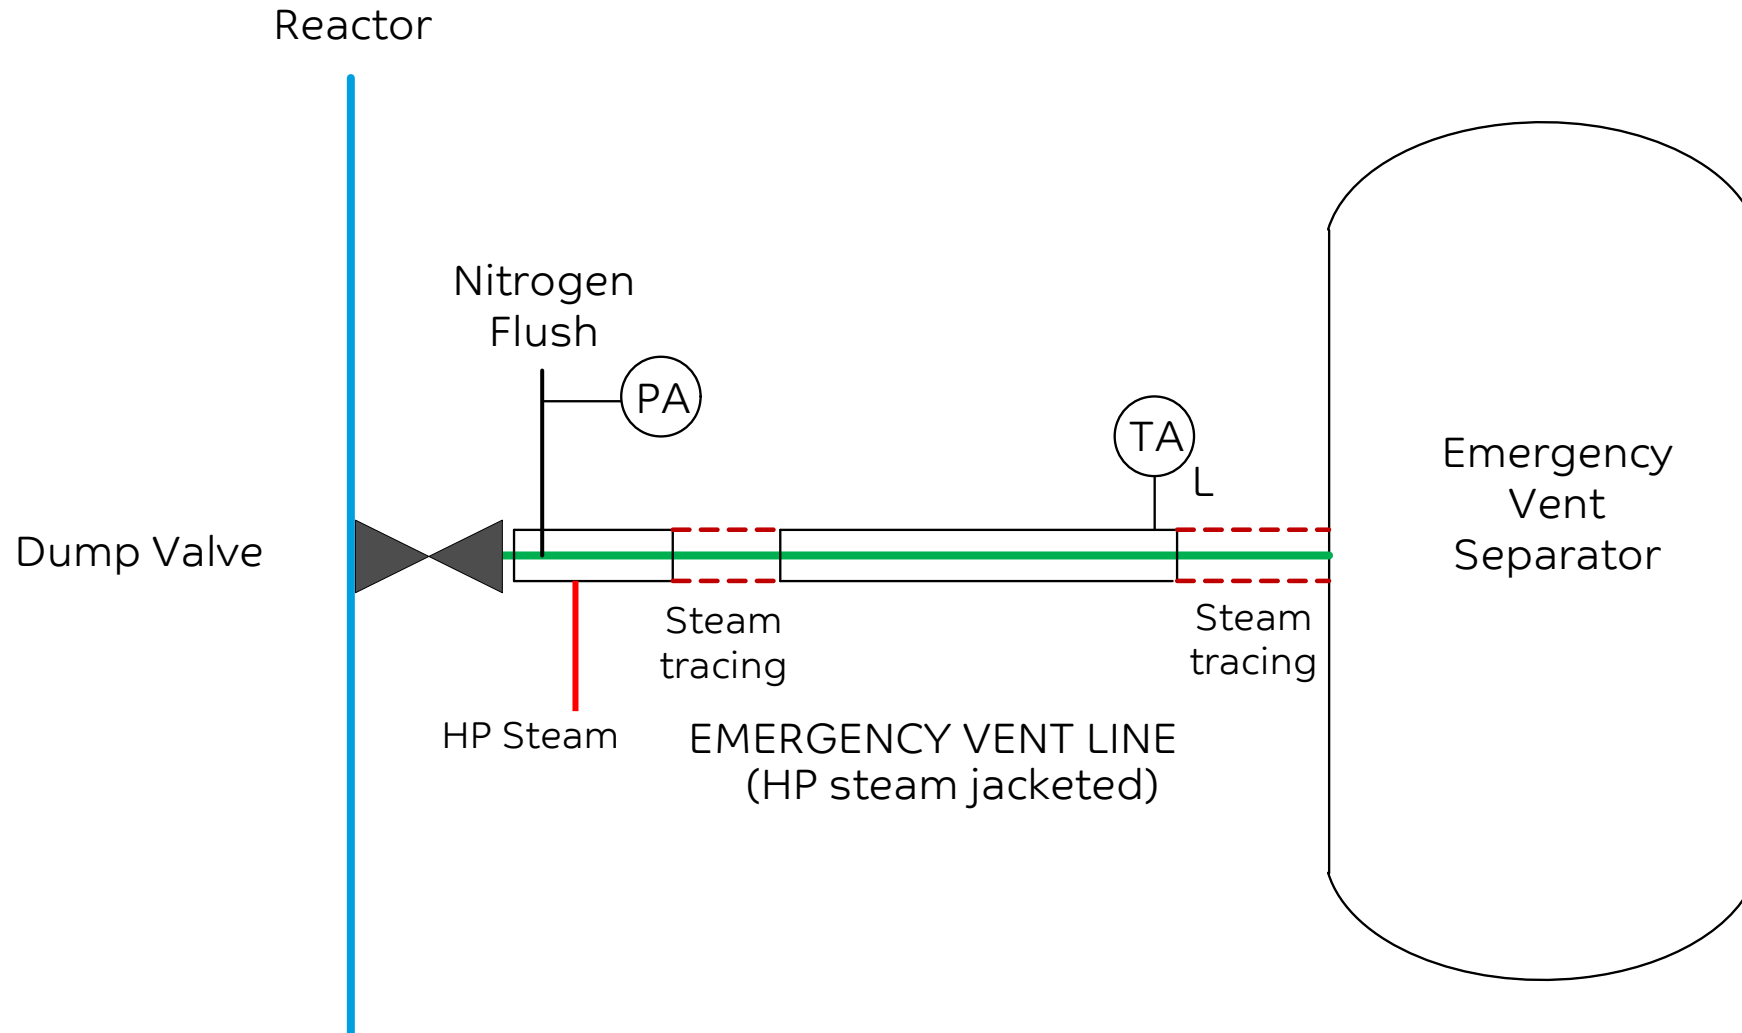
Commissioning MOC did not provide equivalent layers of protection to detect steam tracing failure as per the original design:

- No low temperature alarm on the traced sections
- Local isolation valve on the steam tracing supply – inaccessible with the plant in commission.

The investigation found this local isolation valve shut

- Steam-traced section of the Dump Line was at ambient temperature.
- Polymer blockage was found in this section.
