# MOL Exploration and production 2023 Incident review

## Tank overfill (T-67) at Pft-6 Gathering station (Pusztaföldvár)

*December 3<sup>rd</sup>, 2024, Barcelona  
EPSC Plant and Process safety conference 2024*

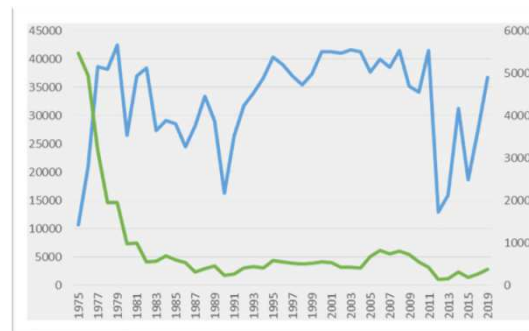
PF-191 (m<sup>3</sup>)

- ▶ Tank T-67 already contained 5m<sup>3</sup> of produced crude at the time of connection, but field operators decided to monitor the production and filling of the tank managing the risks
- ▶ Well PF-195 had occasional inconsistent production which was a known characteristic
- ▶ Located at a high point of the reservoir cap due to gas “pocket” migration, occasionally experienced here, the gas moved to the well site location and pushed the fluids.
- ▶ This increased the pressure in the area and the well started to produce as a self-flowing well, with much higher rates
- ▶ Tank T-67 had only a high level alarm and no executive (SIS) function

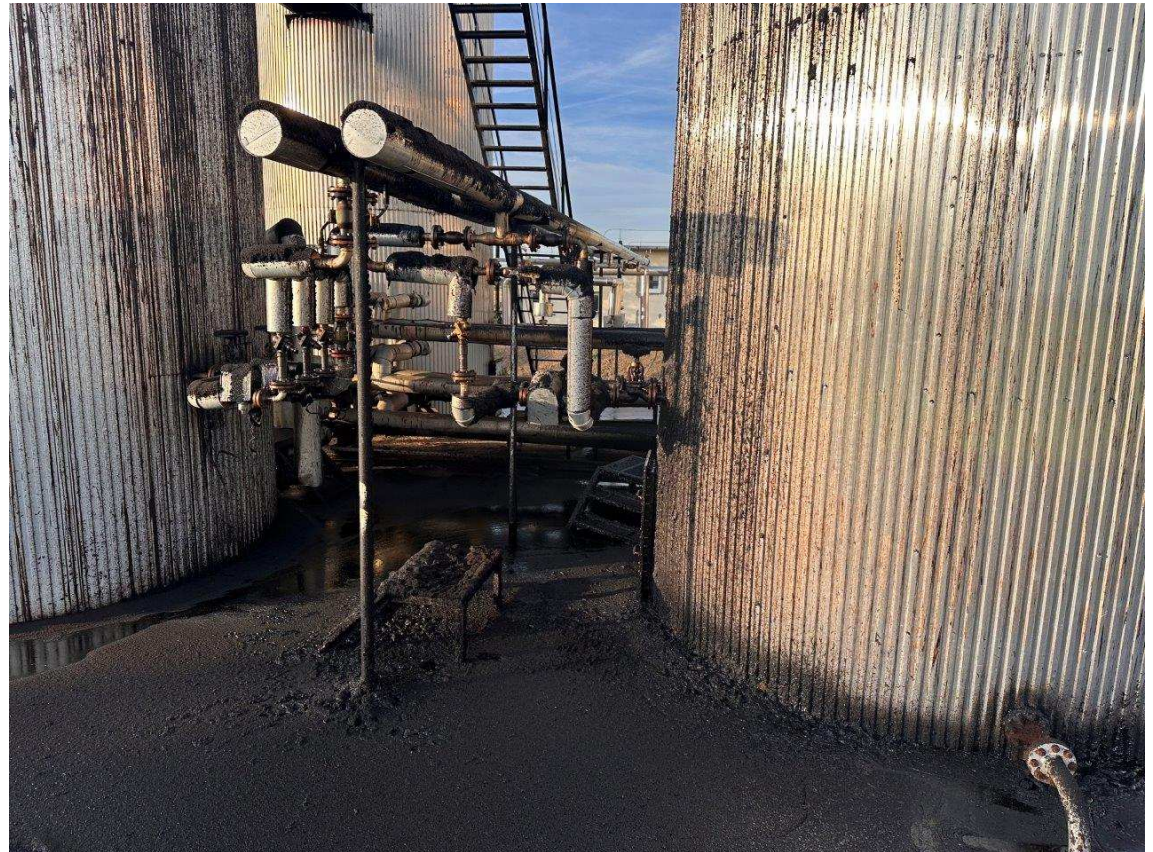
- ▶ By the time the high-level alarm was triggered, T-67 reached 46m<sup>3</sup> (approx. 78%) of tank capacity
- ▶ The dispatcher received the alarm signal in the operating room of the remote Dispatch station at 1.35h and immediately informs the on-call field operator
- ▶ Due to the production characteristics of the wells in the production field, the operator estimated that he has more than 4 hours until the fluid reaches a critical level. Production in normal conditions is estimated to 1.5 m<sup>3</sup>/h.
- ▶ The field operator arrives at the Pft-6 site within one and a half hour of the call and finds the overfilled T-67

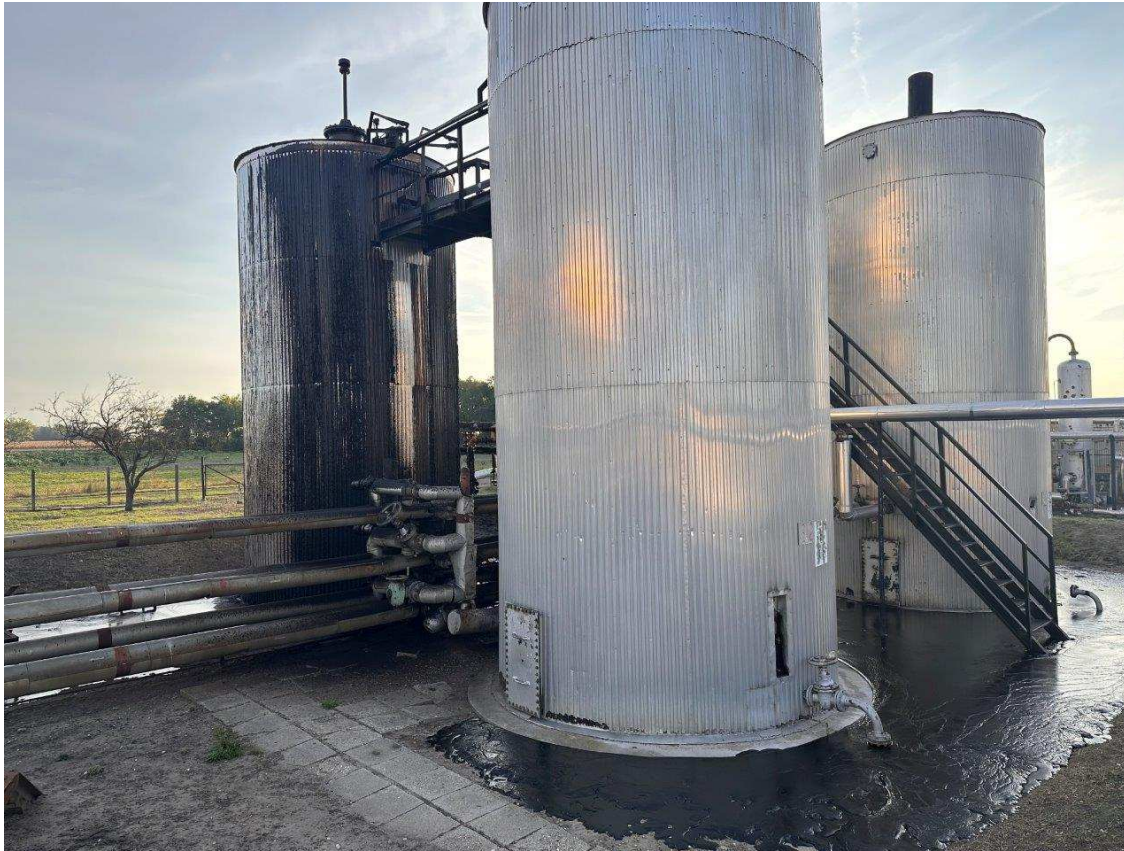
- ▶ 5m<sup>3</sup> of formation water and 5m<sup>3</sup> of crude oil spilled out of the tank's breather
- ▶ The spilled product contaminated the tank, piping, fittings and the ground inside the bund
- ▶ 116 tones contaminated soil to be remediated
- ▶ Asset damage and remediation damages up to \$100k,

- ▶ Only the calm and conscious decision by the Operator not to close the well but rather diverted the production avoided unforeseen consequences such as fluid kick and increase in the pressure of the flowline
- ▶ Fire/explosion of the leaked crude with high expansion condition and full Pft-6 destruction potential

- ▶ Perform Management of Change procedure to assess the operational risk increased during years of oil and gas exploitation (produced material composition change such as water-cut increase)
- ▶ Select critical process parameters at all gathering stations and implement proper monitoring system (with H/HH alarms and actions defined in case of H/HH levels exceeding)
- ▶ Establish frequent formal communication with the Reservoir Engineering about the status of the HC wells:
  - Flow rate (IPR/VLP)
  - Temperature
  - Pressure
- ▶ PF-195 Sucker Rod pump oil well can only be produced to storage tank under constant supervision of the operator
- ▶ Mass flow meter will be installed on the S-3 measuring separator, therefore the wells will be measurable directly via the main gathering pipeline during normal production
- ▶ Perform operational risk assessment during washing-out activity
