# GELEEN NAK2 EXPLOSION

**7 NOVEMBER 1975**

Jaco Nel

EPSC Aachen December 2025

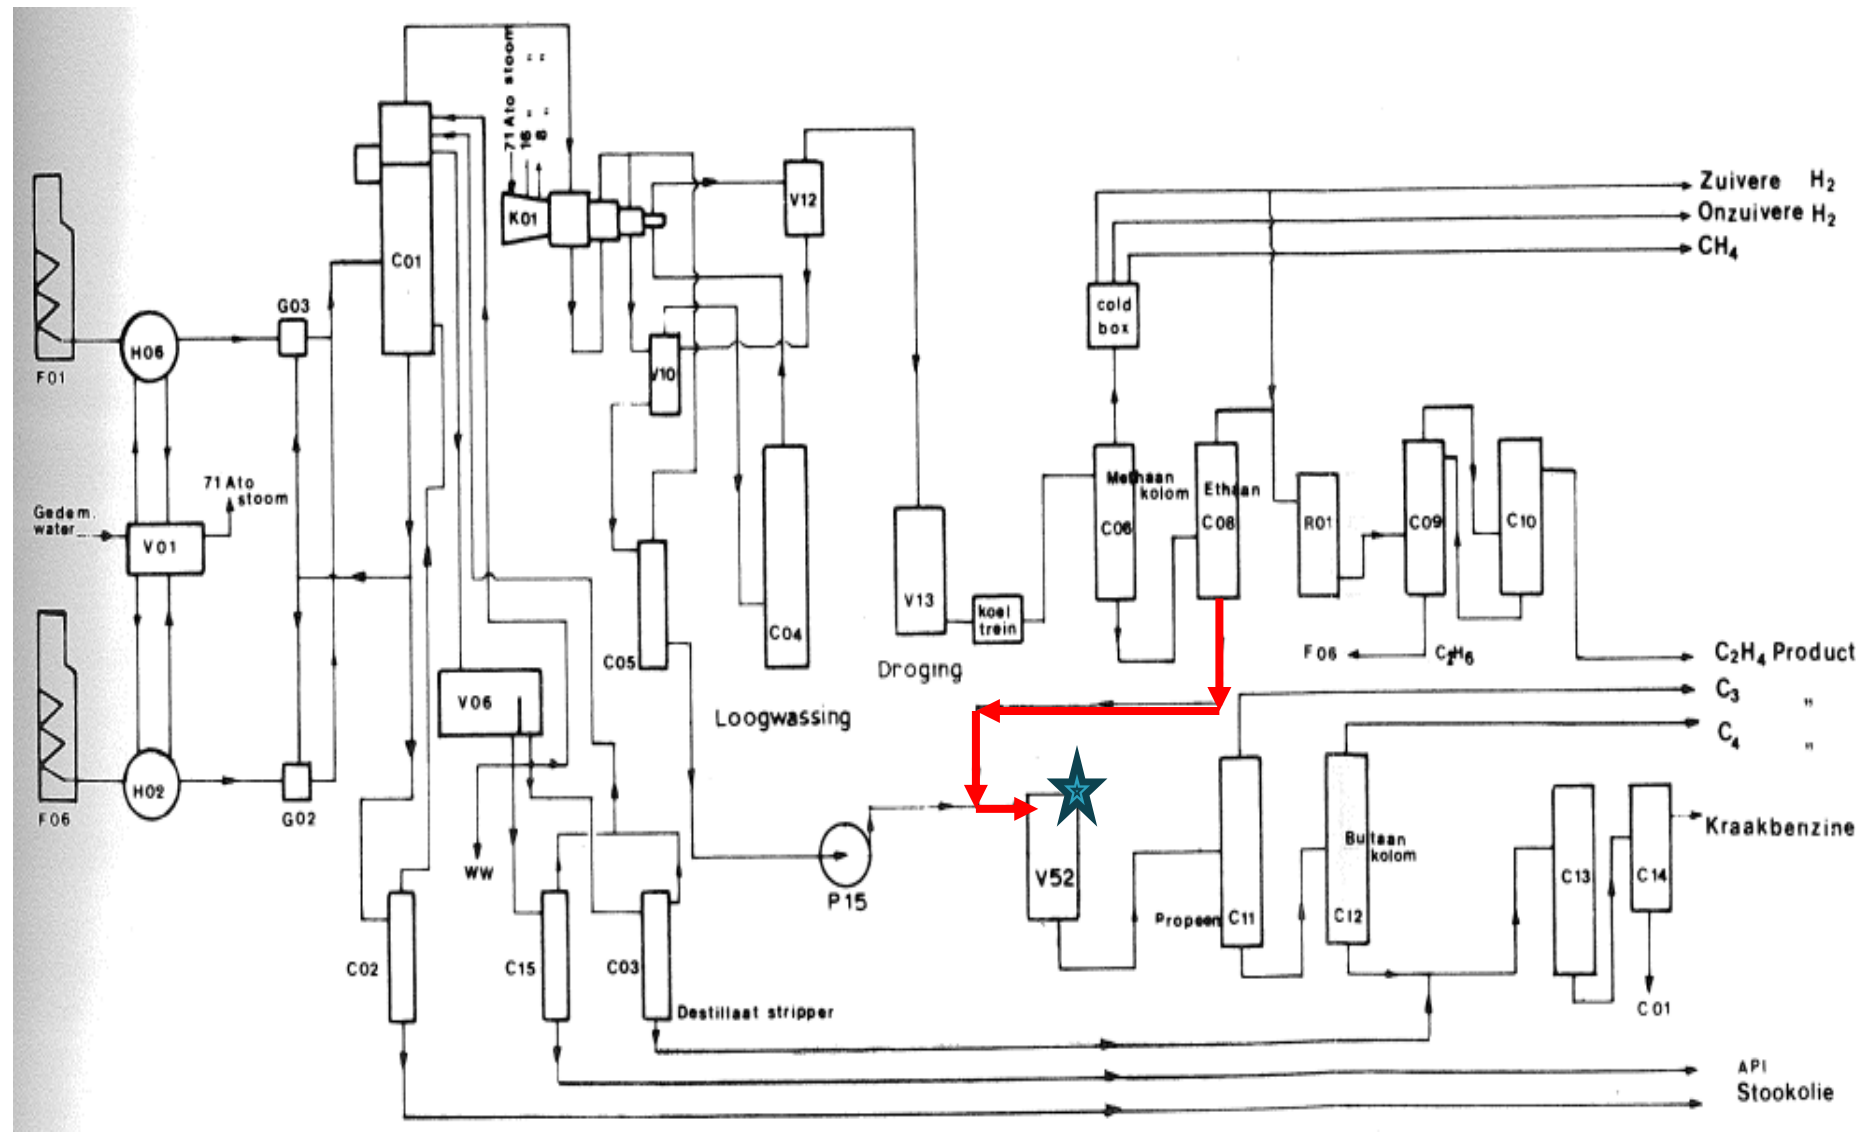
# WHAT LED UP TO THE EXPLOSION

- During commissioning a refrigeration compressor tripped that also supplied heating to the de-ethanizer column reboiler
- Due to loss of heating, the bottoms temperature of the de-ethanizer column could not be maintained and much colder C2 fractions slipped through to the de-propanizer.
- The metallurgy of the de-propanizer section was not suited for these much colder temperatures and piping fractured due to cold embrittlement at weak points (weld seams).
- Most notably a safety valve on the V52 de-propanizer feed drum broke off and created a full-bore opening through which the C3/C4 fraction jetted out.

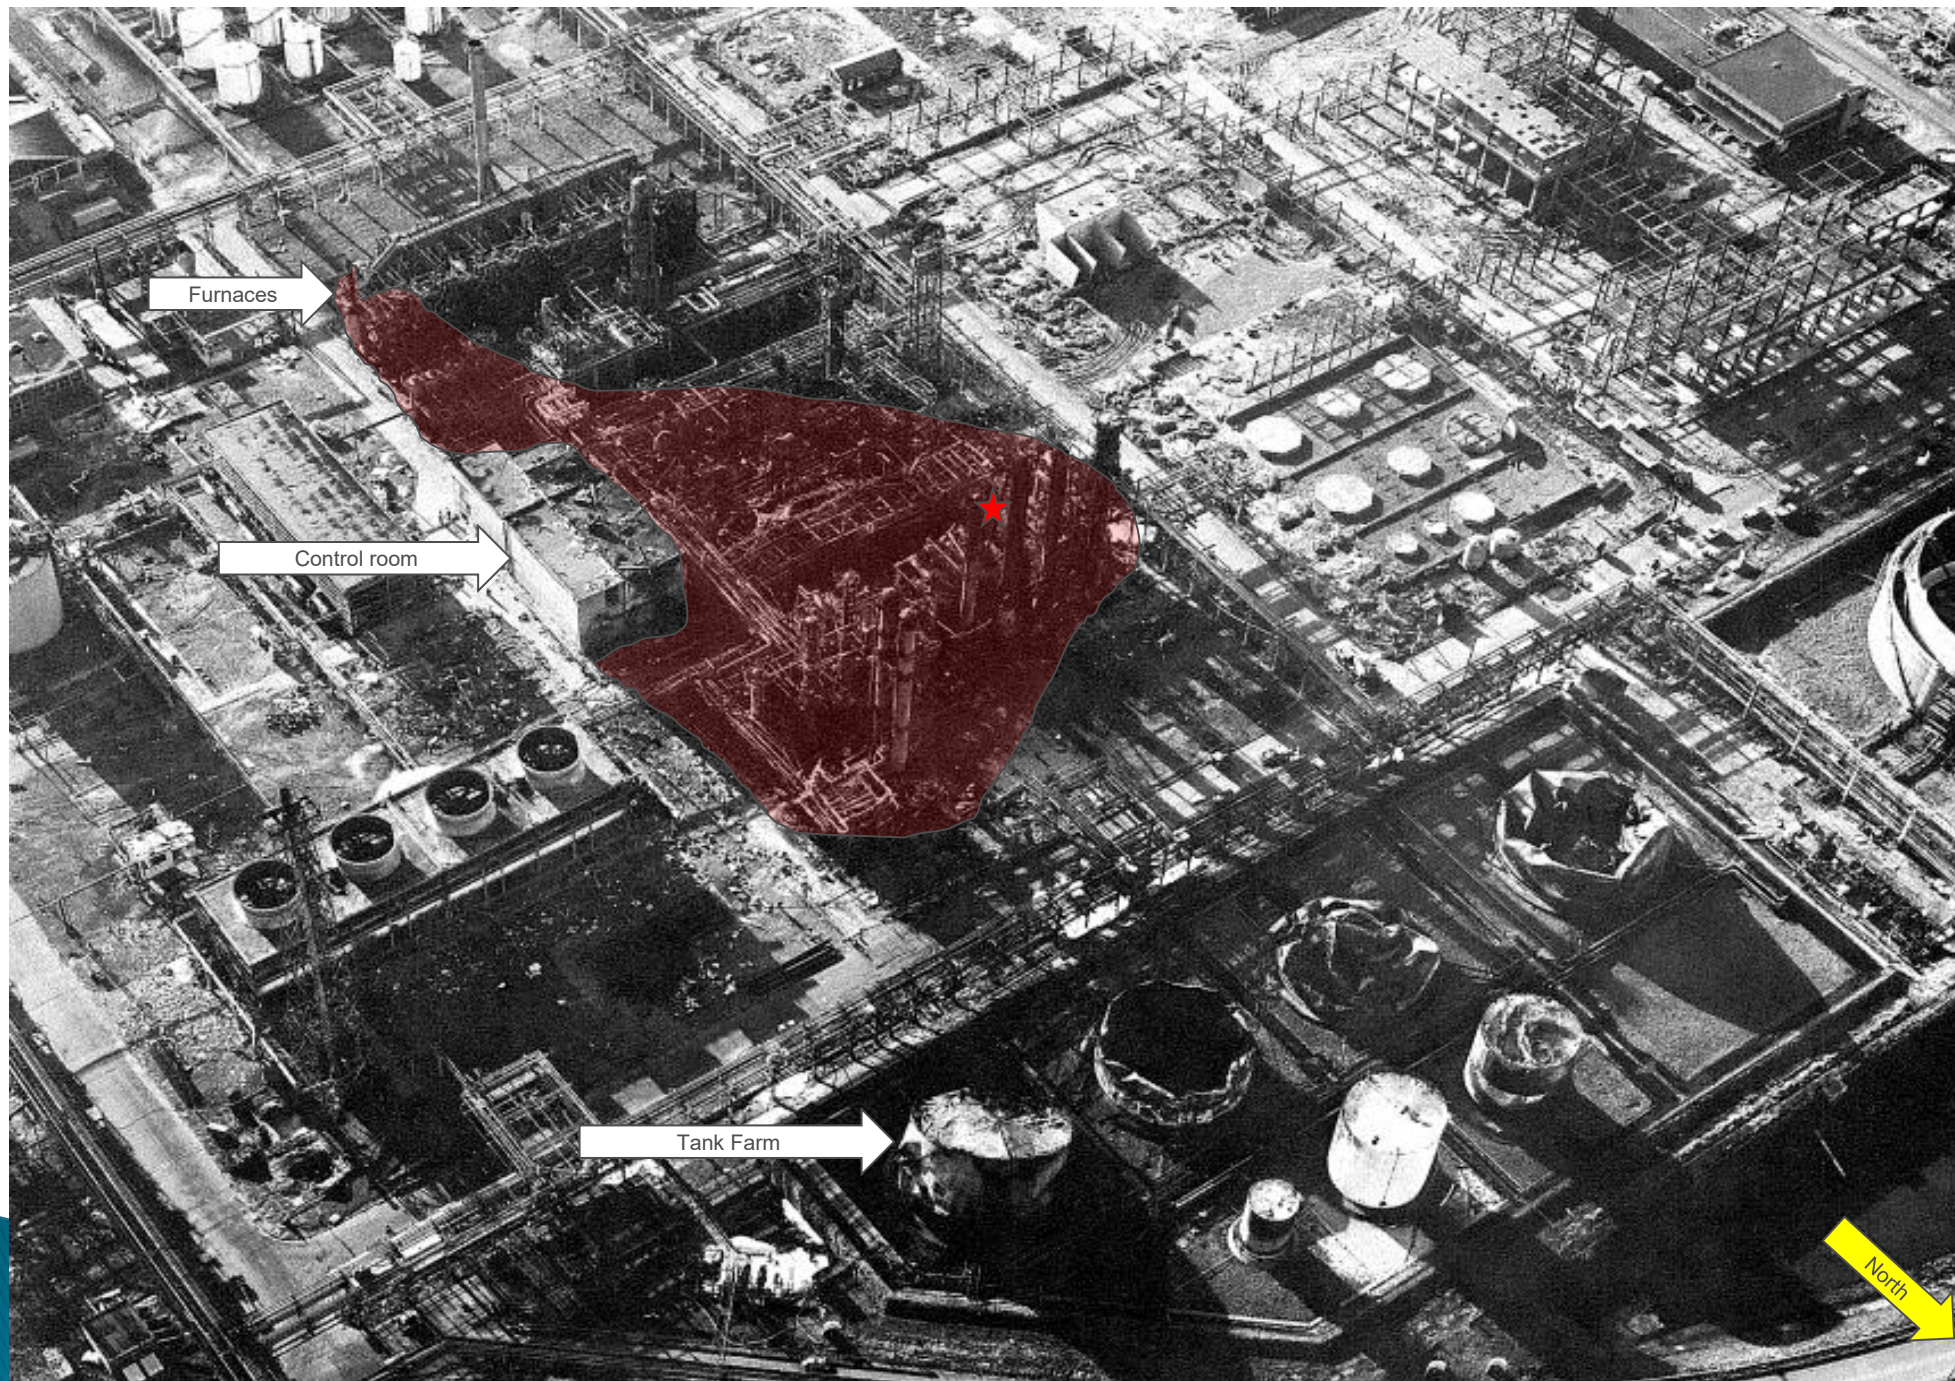
# LOC AND SUBSEQUENT GAS CLOUD DISPERSION

- Approximately 5.5 tons of gas leaked from the PSV on V52 for 6 minutes. The resultant gas cloud spread rapidly through the dense structure and was eventually ignited by a furnace on the other side of the plant
- It is evident from modelling that the initial deflagration transitioned to a violent explosion soon after ignition.
- The outside operator cabin– situated in the pipe rack close to the compressor house – was completely demolished and 8 operators lost their lives.
- The control room suffered severe blast damage, and 6 operators were fatally wounded inside.
- No evacuation alarm given prior to explosion – probably too much panic
- Blast ignited fires in the adjacent Tank Farm – firefighters battled several days to prevent a BLEVE occurring at the C3 sphere.

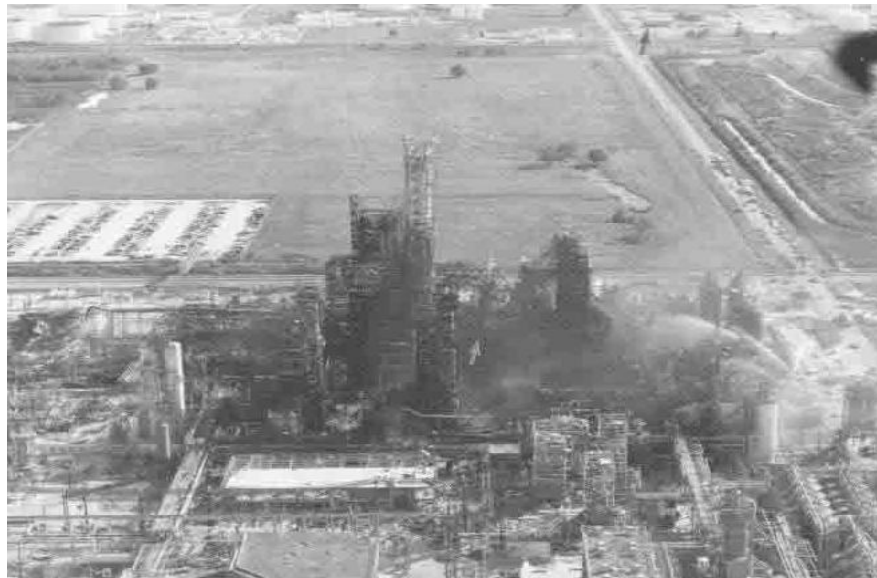
## 1989 Phillips 66 explosion – Facility Siting

- Proximity of Control room to installation.
- 23 fatalities, ~US\$2 Billion property loss.
- Lack of PHA, insufficient emergency measures contributed to disaster.

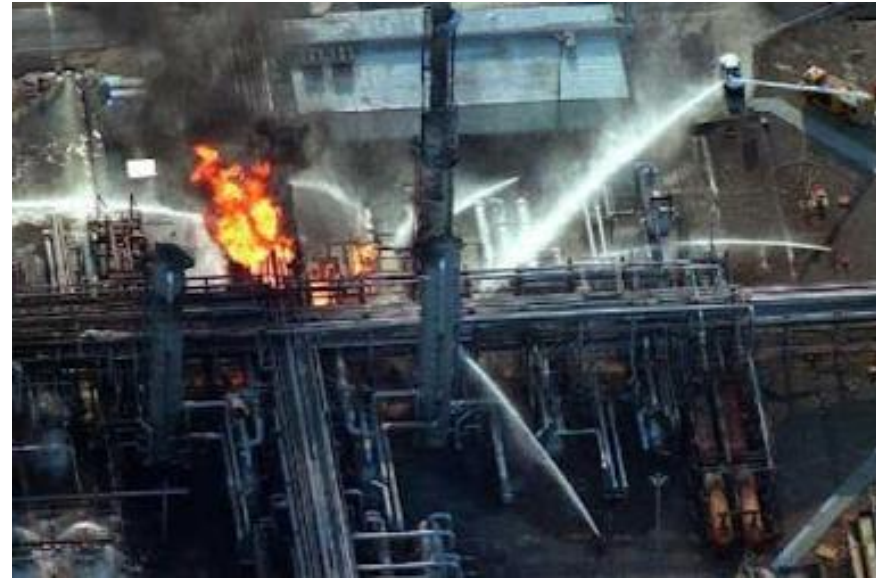
## 1998 ESSO Longford explosion – Cold Embrittlement

- No HAZOP, no proper MOC management, lacking leadership and safety culture.
- 2 fatalities, US\$987 million property loss.

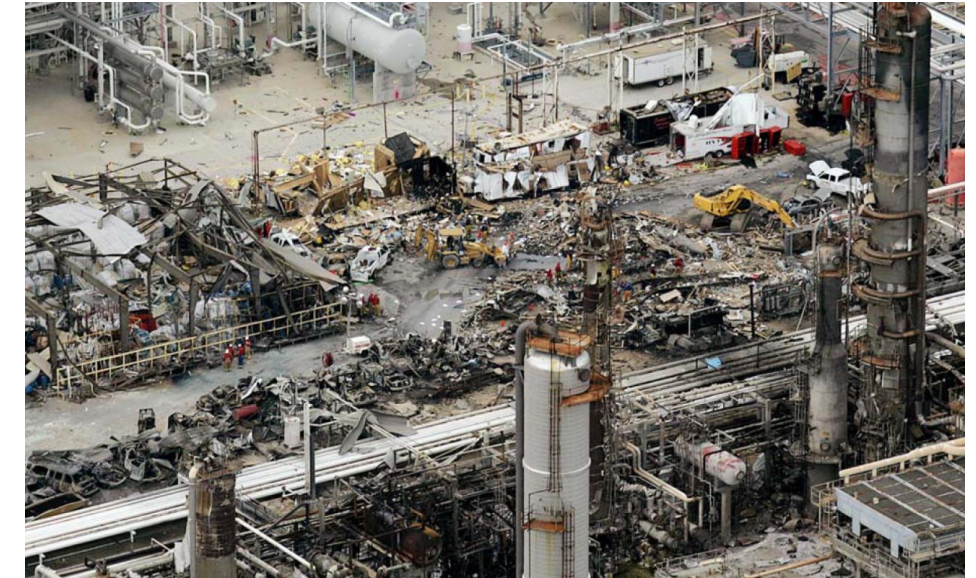
## 2005 BP Texas City– Emergency Preparedness

- Not only facility siting, but also emergency response found lacking.
- 15 fatalities, US\$322 million property loss.
