SDA Solvent DeAsphaltene Unit

SDA Dust Explosion

Porvoo Refinery PL4 | 2.12.2019

Dust Explosion and Personal Injury

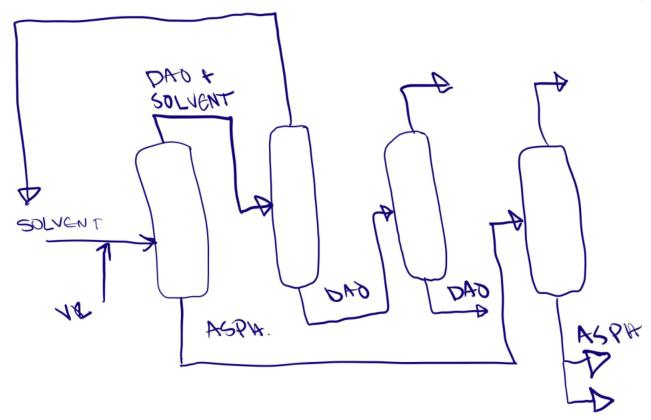
Asphaltene was loaded into a bulk truck trailer. At the final stage of the loading, during the emptying of the loading arm bellow, a flash fire occurred, which was followed by a secondary dust explosion. Truck driver was having full PPE and suffered only minor injury.

During the loading of asphaltene, the loading bellow was charged electrically due to asphaltene flow. The charged bellow created an electrostatic discharge that ignited the fine asphaltene dust inside the bellow. Actions related to prevent and mitigate dust explosion risks were inadequate.

- Asphaltene loading system safety modifications (SDA Retrofit project)
- Update of <u>HSE Design Guidelines</u> to include dust hazards
- Update of SDA asphaltene loading system PHA (Process Hazard Analysis) and DHA (Dust Hazard Analysis)
- Arrangement of proper training to ensure competence when handling dust material
