Hydrogen release during unloading

European Conference on
Plant & Process Safety

13th September 22

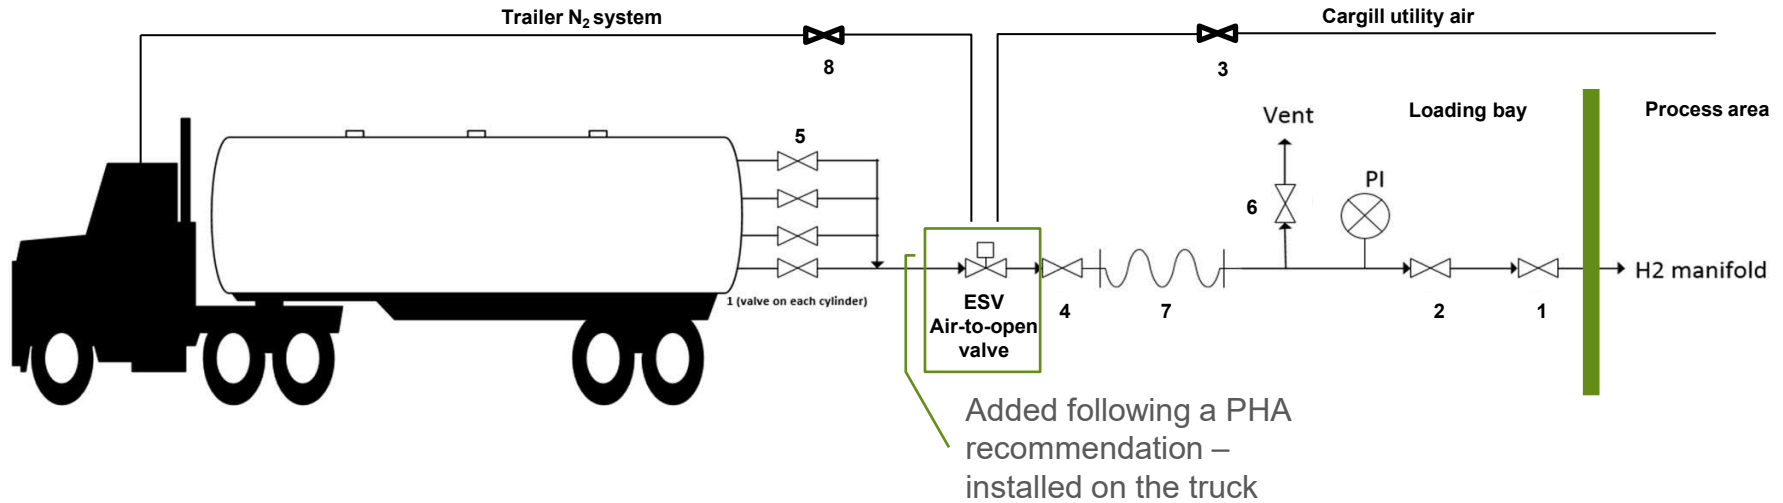
System configuration

The PHA team identified the risk of hydrogen being released from the transfer hose in between the truck and the process if that connection would fail

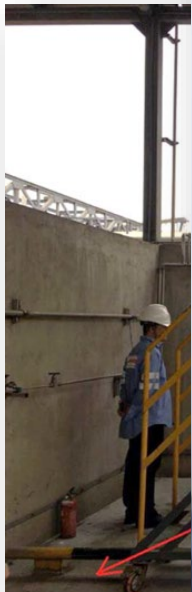
Picture 4: position

- The valves on each of the 11 gas cylinders were found in open position, contrary to the procedure
- Valve 4 found partially open – the driver did close it but not fully
- The procedure (outdated) at this location differs from the standard practice followed by the supplier at other locations – addition of the ESV
