— Refrigerant R-507 – MRU piping release

- Facility: Polyethylene (PE) Operations
- Incident Date: June 3rd, 2020
- Incident Type: Process Safety Incident - Tier-2 (API RP-754)
- Location: Mechanical Refrigeration Unit (MRU) - Indoors
- Impact: None (besides non-hazardous chemical release to atmosphere)

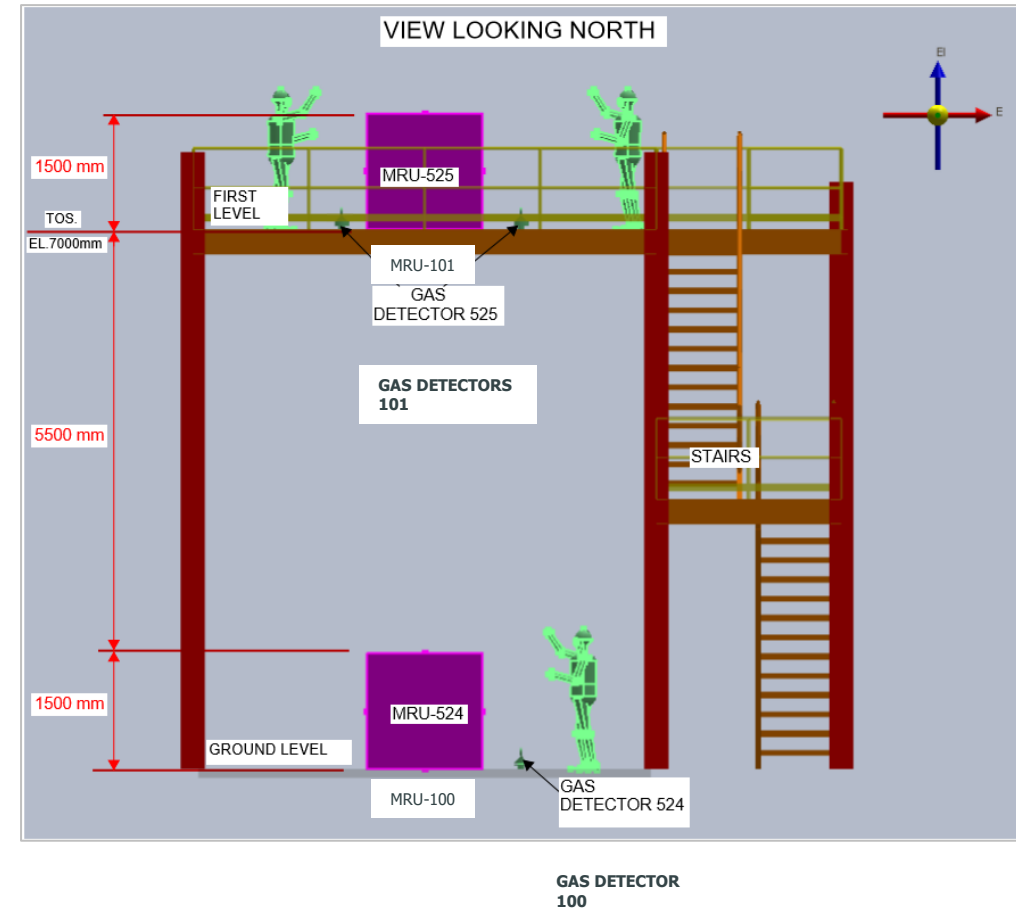
Overview of layout

- Location: Indoor finishing building of a PE manufacturing unit.
- MRU-100: piston compressor on ground level
- MRU-101: screw compressor ~7 m elevated above MRU-100
- Only one is in operation, MRU-100 on June 3rd
- Gas detection:
 - MRU-100; one freon detector at ground level
 - MRU-101; two freon detectors at elevated level
- Freon R507 is used, non-flammable, non-toxic, azeotropic mixture of two other refrigerants (gases heavier than air):
 - R-143a (1,1,1-Trifluoroethane) – flammable gas – 50%w
 - R-125 (Pentafluoroethane) – inert gas - 50%w
- Previous studies showed that no asphyxiation hazard existed for the R-507 worst case release
 - Natural draft by design - confirmed with physical measurement
 - Oxygen will not drop below 19,5% in any scenario
