Learning from Experience

# *Incident reporting and sharing*

**EPSC Conference**

Jan Weckx

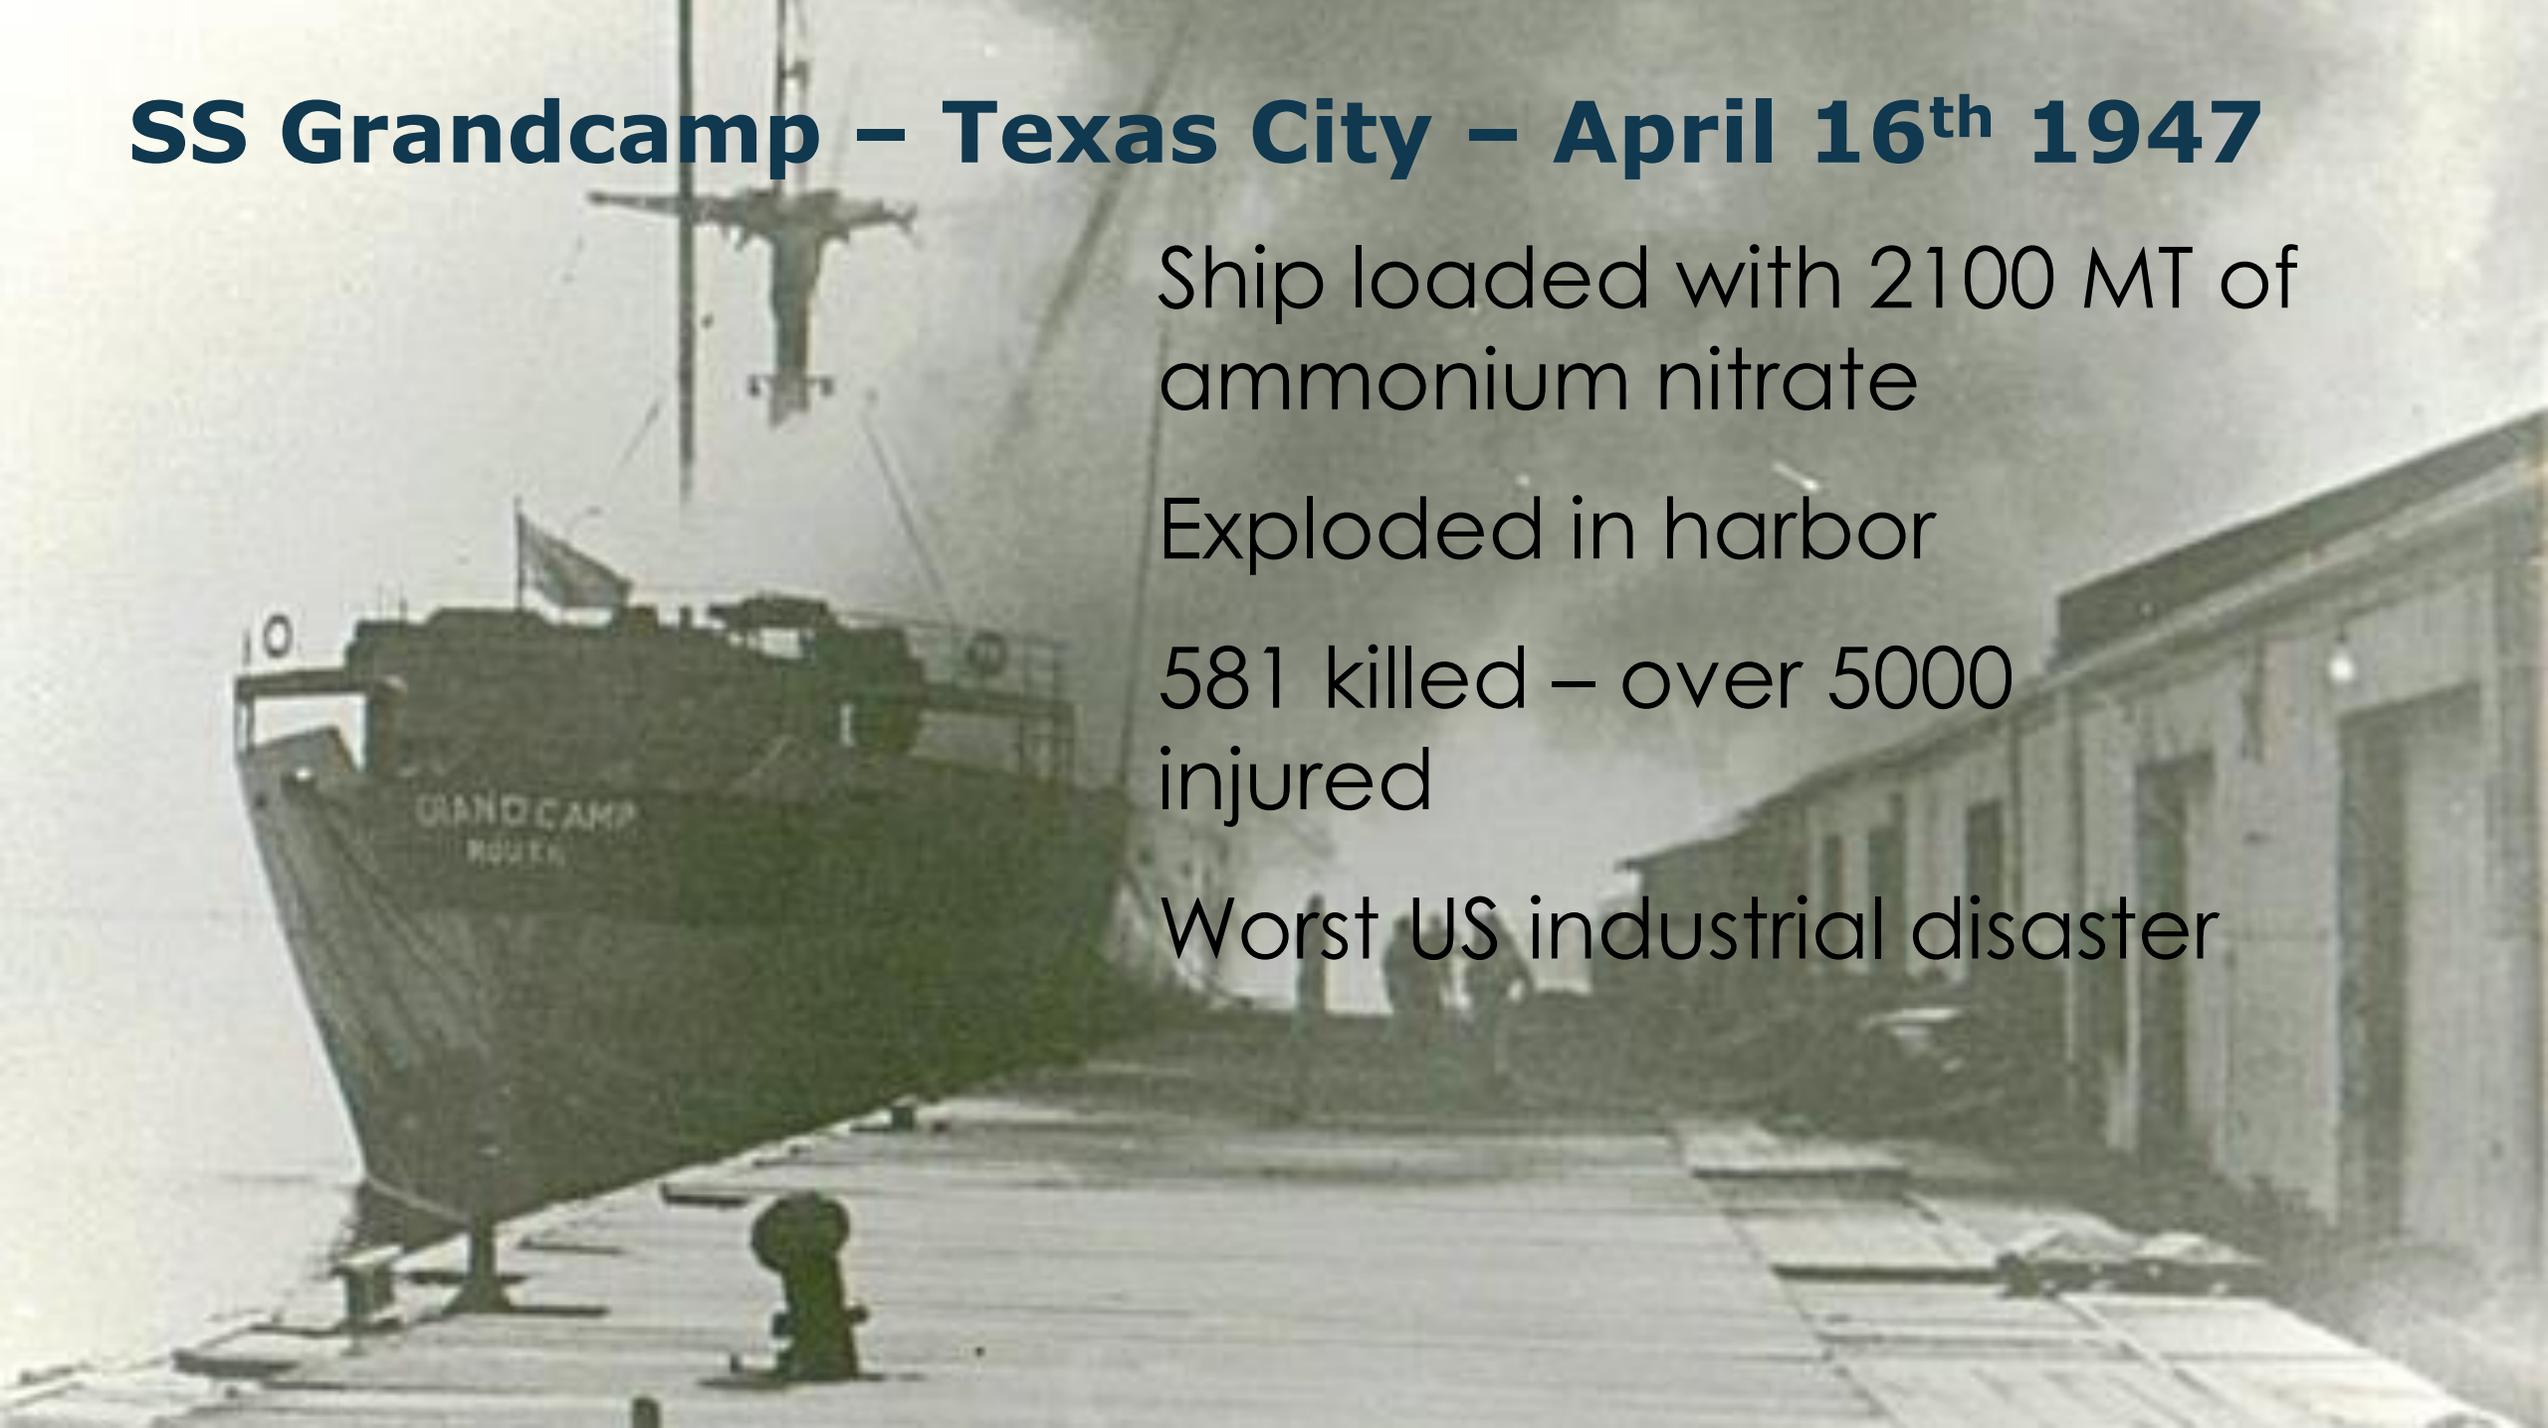
# SS Grandcamp – Texas City – April 16<sup>th</sup> 1947

Ship loaded with 2100 MT of ammonium nitrate

Exploded in harbor

581 killed – over 5000 injured

Explosions and fires in all refineries and chemical plants on waterfront

Nearby Monsanto site destroyed

268 victims on site

Fire protection

Layout & spacing

Importance of mitigation

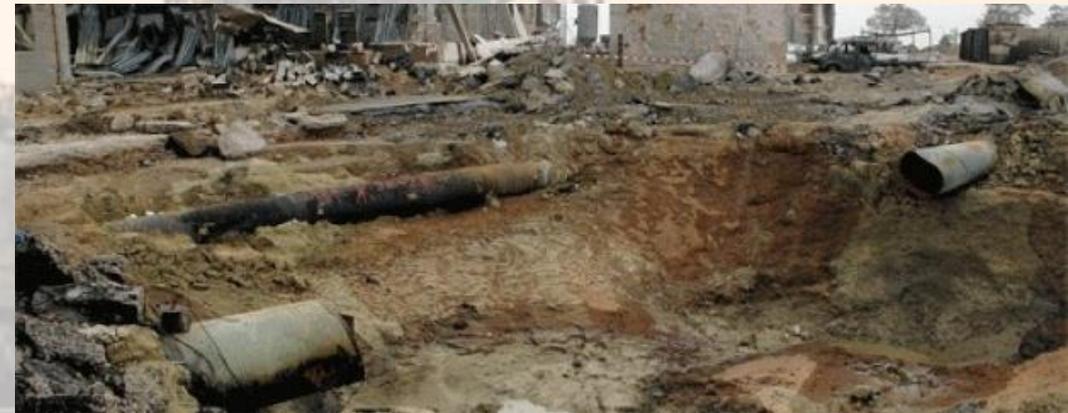
# Ghislenghien 2004

24 dead  
132 injured  
Underground gaspipe damaged during excavation works  
Leak ignited during repair

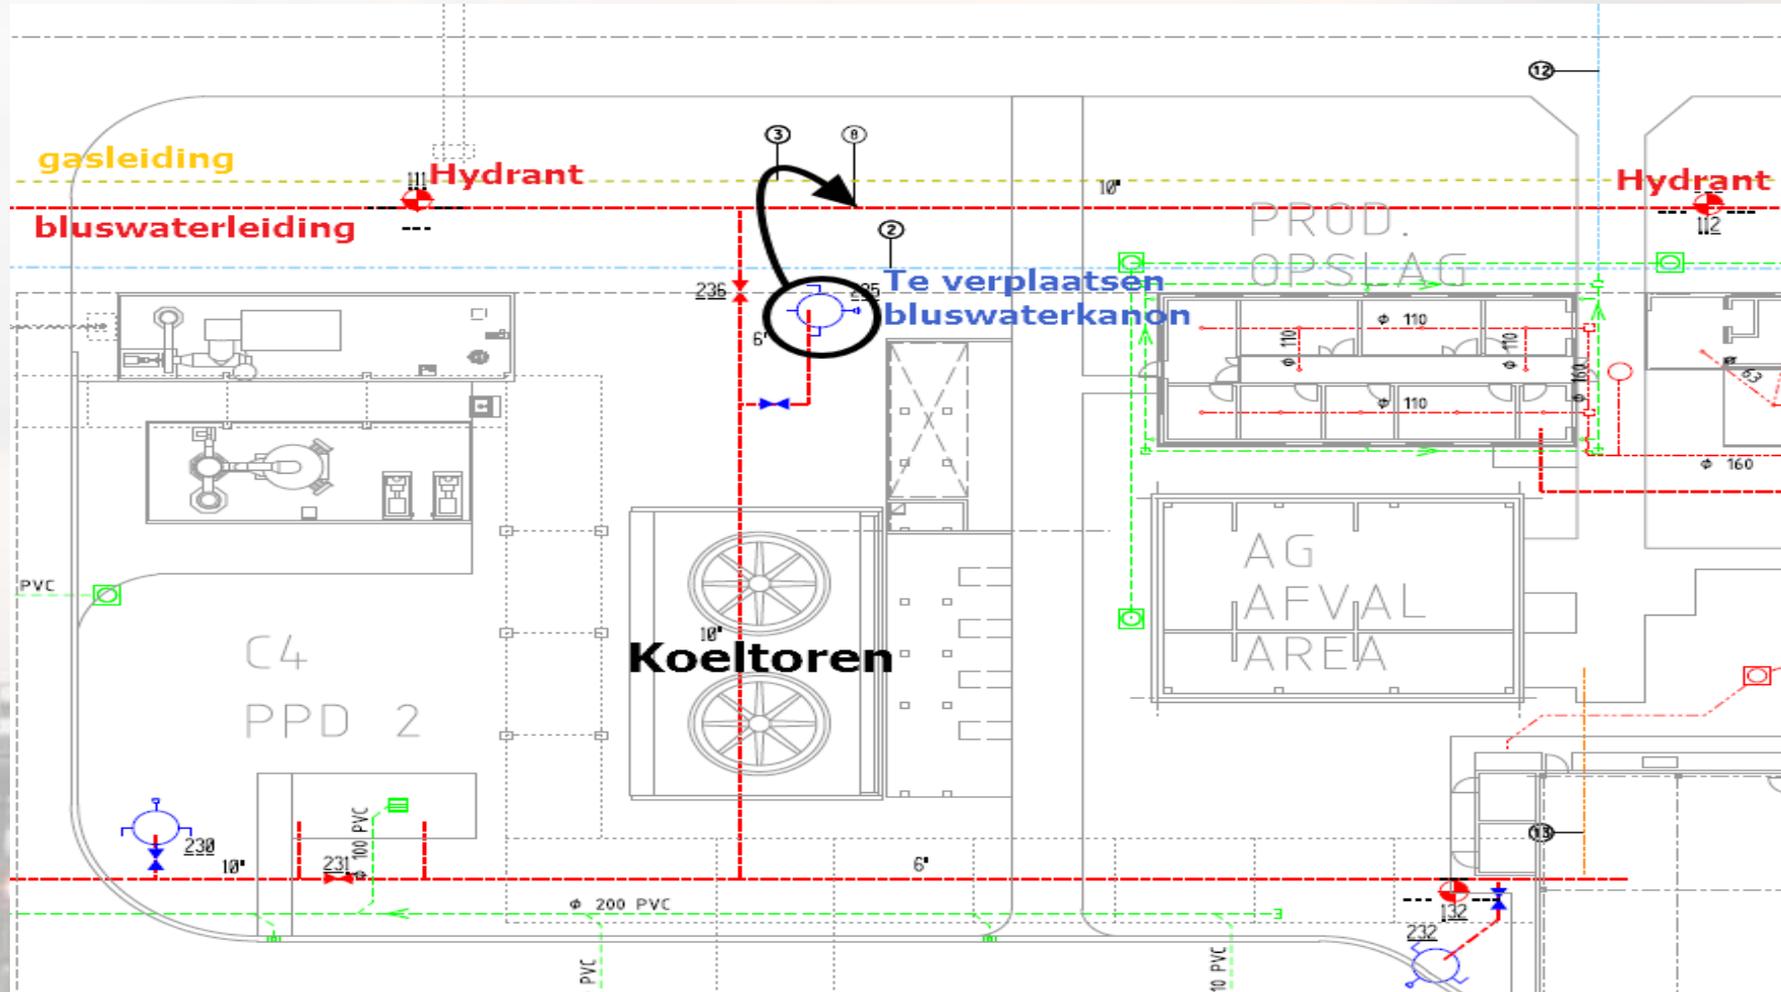
# Plot plan

- A trench was excavated to expose the line
- Preparations started for the tie-in on the line (removal of corrosion protection, cleanup ..)
- Monsanto shift supervisor and piping contractor responsible noticed this was not the right line:
  - Different type of corrosion protection
  - Pipe size did not match with prepared tie-in piece (8" instead of 10")
  - Pipe did not line up with visible fire hydrants

Excavation contractor not aware of gas header nearby

- // No face to face discussion between contractor and the job owner on drawing office advice
- // Natural gas line poorly visible on copy of print-out plan (yellow color)
- // During Last Minute Risk Analysis with contractor the unit responsible used the fire water plot plan – this showed location of fire water line but not the gas line and was not 100% as built

Root cause : communication deficiencies

Improve visibility of gas lines on plot plans (color)

Improve ESH procedure 011 (excavations)

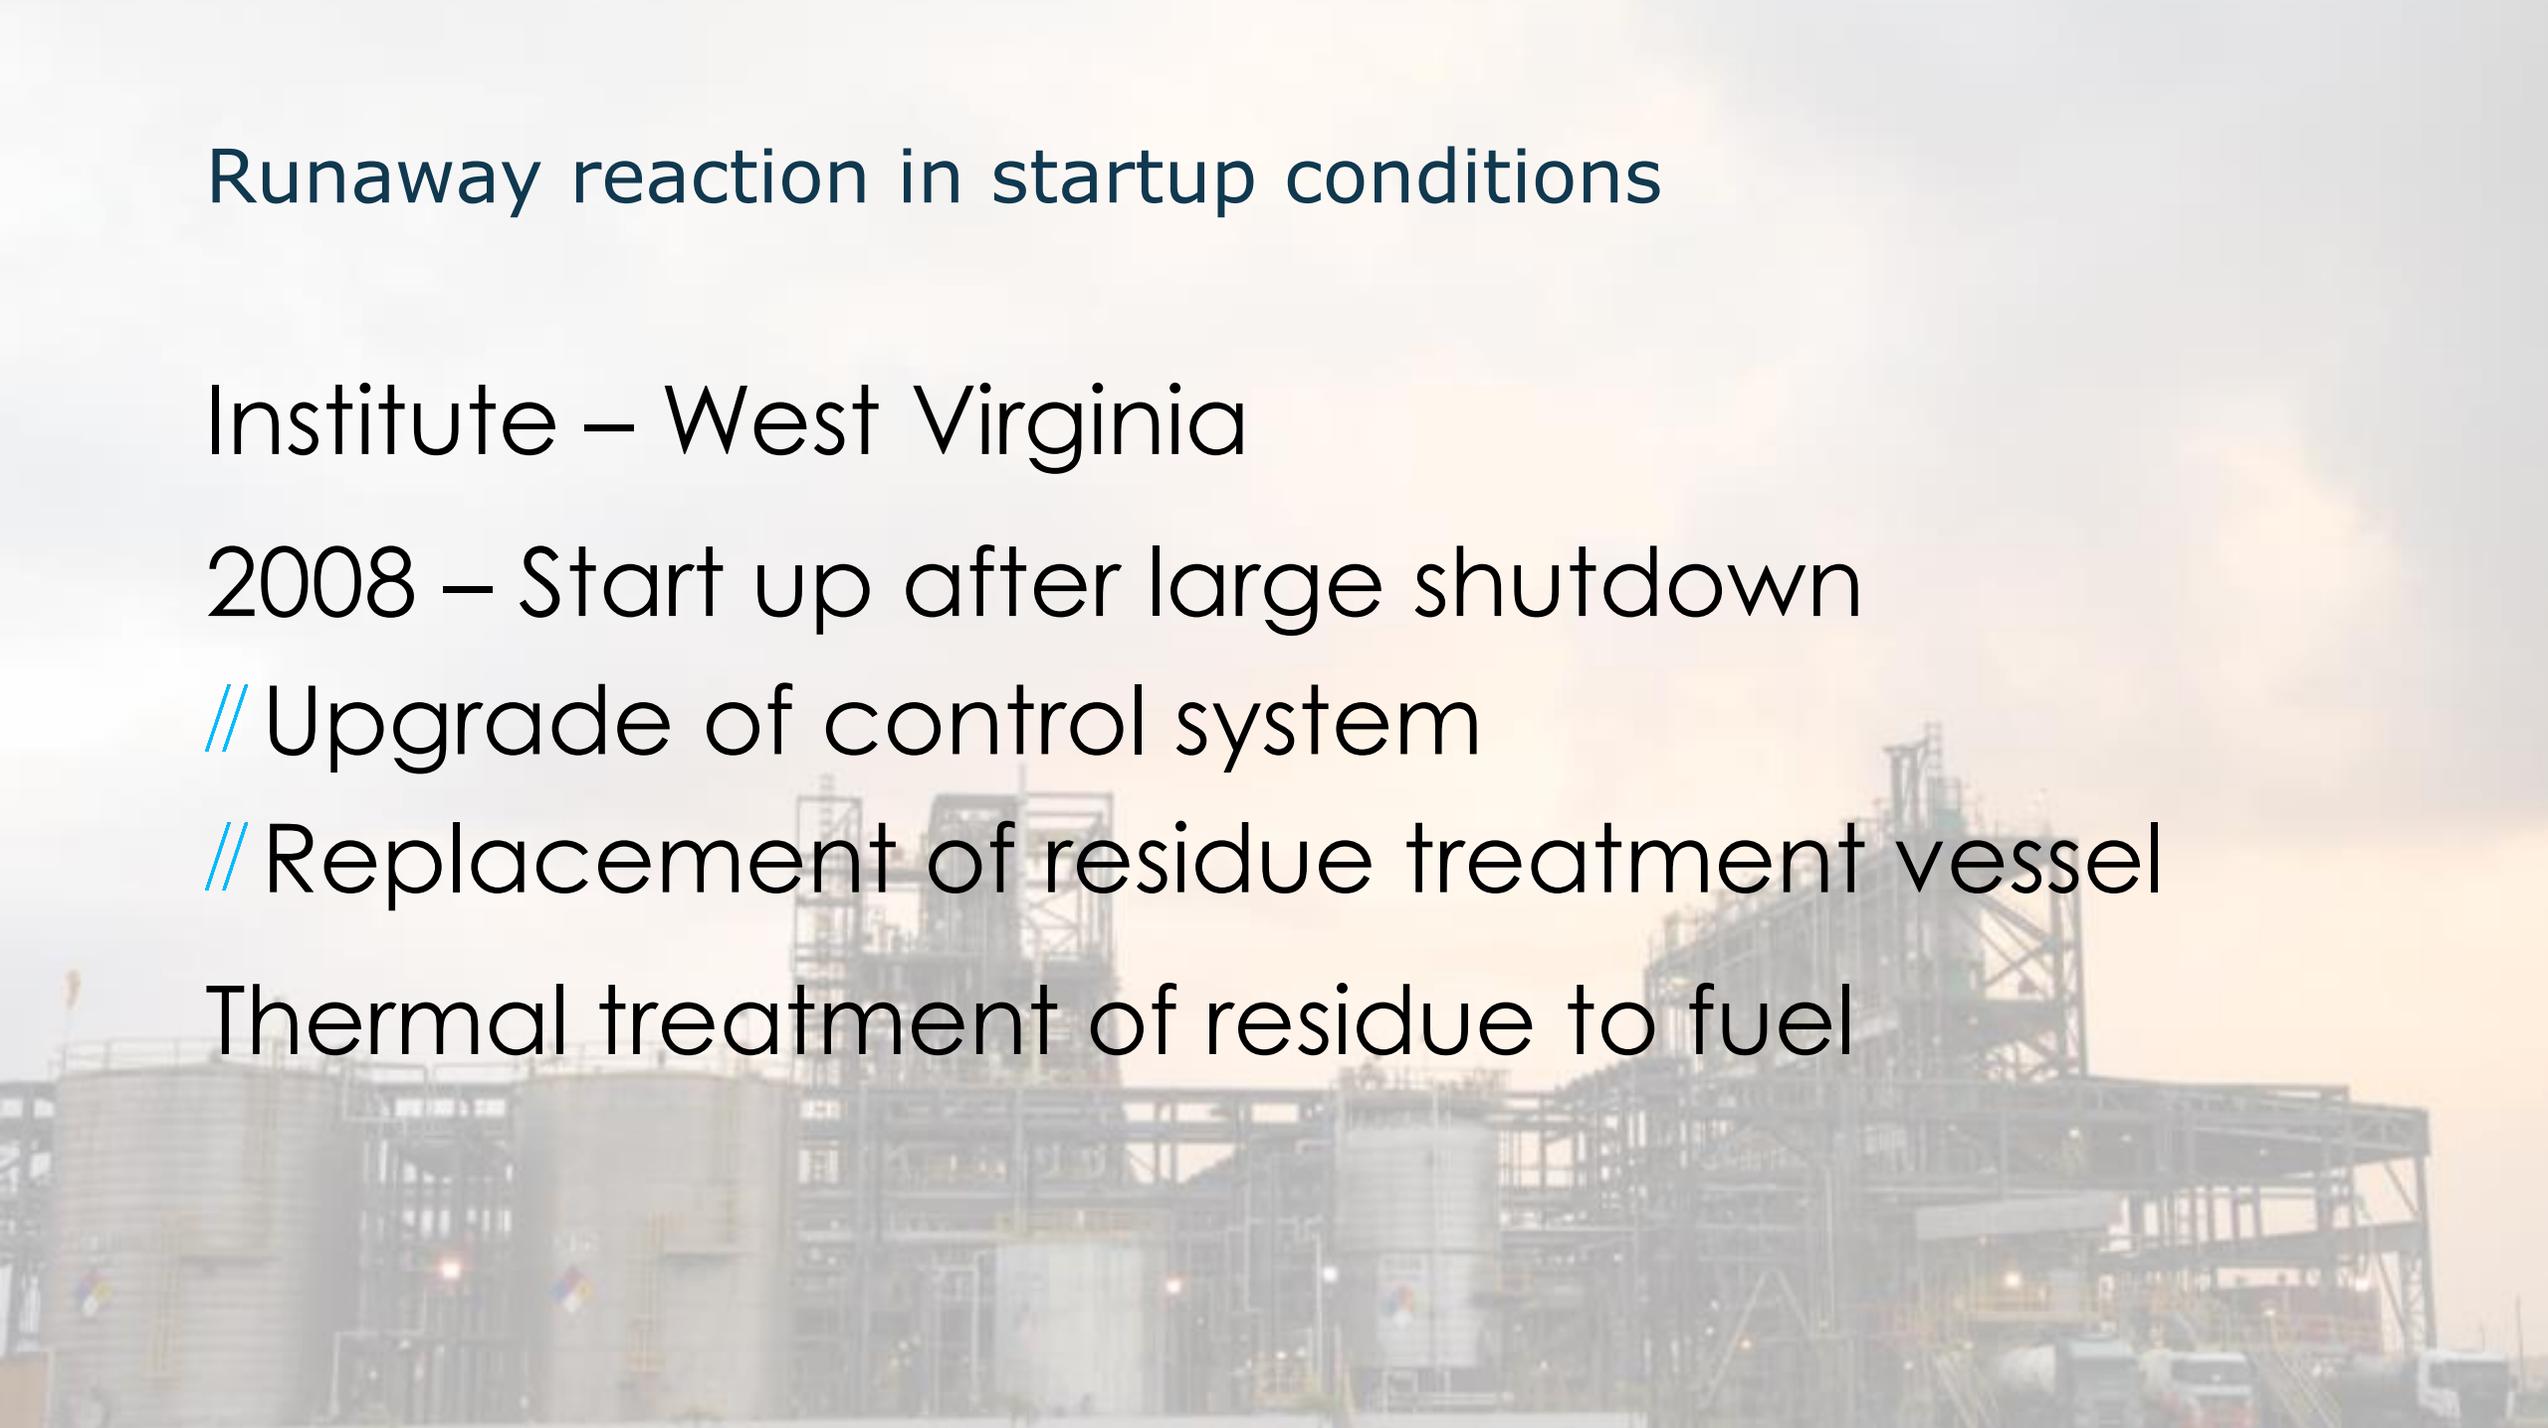
# Runaway reaction in startup conditions

2008 – Start up after large shutdown

// Upgrade of control system

// Replacement of residue treatment vessel

Thermal treatment of residue to fuel
