# Hazards of Hydrogen Peroxide handling

Gilles ROMAN, Corp. HSE / Process Safety  
EPSC conference - Maastricht Dec 13<sup>th</sup> & 14<sup>th</sup>, 2023

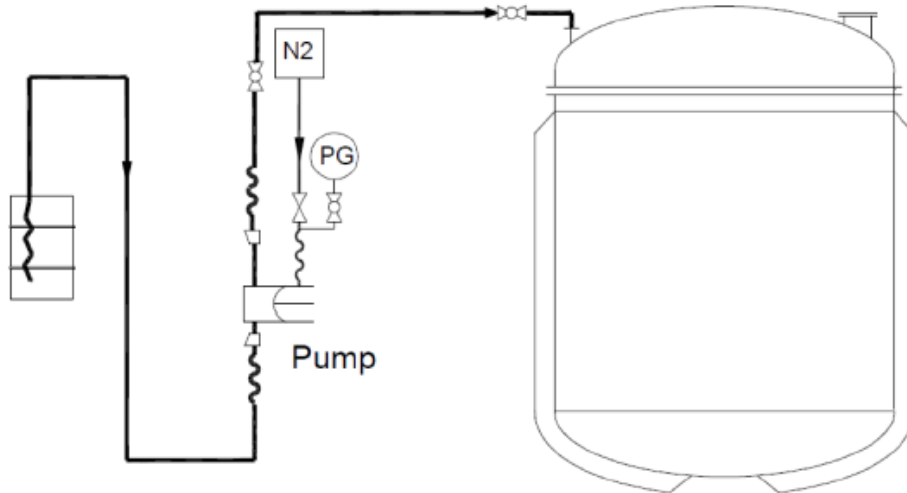
- HP 35% is fed to a reactor from drums
- Use of a PTFE-coated diaphragm pump
- After feeding HP, the pump & pipe are rinsed by pumping an organic solvent to the reactor

- Damaged PTFE membrane put HP in contact with rust: decomposition to  $O_2$  and  $H_2O$
- Lack of venting provision on piping & pump

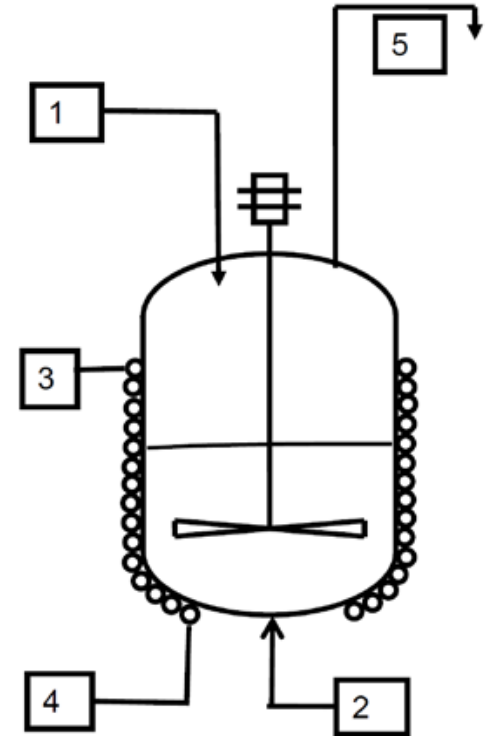
- Replacement of the CO<sub>2</sub> flowmeter

- When metering the HP35%, the normal initial exotherm was not observed
- Temperature was raised with heating coils
- ... Runaway
- 30% of the reactor mass vented via the Safety Valve and discharged to the roof

- Flowmeter units mismatch =>lack of catalyst
- Heating initiated the side reaction:  
$$\text{H}_2\text{O}_2 (\text{liq}) \rightarrow \text{H}_2\text{O} (\text{liq}) + \frac{1}{2} \text{O}_2 (\text{gas})$$
- The hazard of HP accumulation was known, but the SOP was not detailed enough
