# Boats, Bridges and Back-ups

Roger Stokes BSc CEng FIChemE MIE

EPSC European Conference on Plant & Process Safety  
December 2024

# MV Dali/ Francis Scott Key Bridge, Baltimore

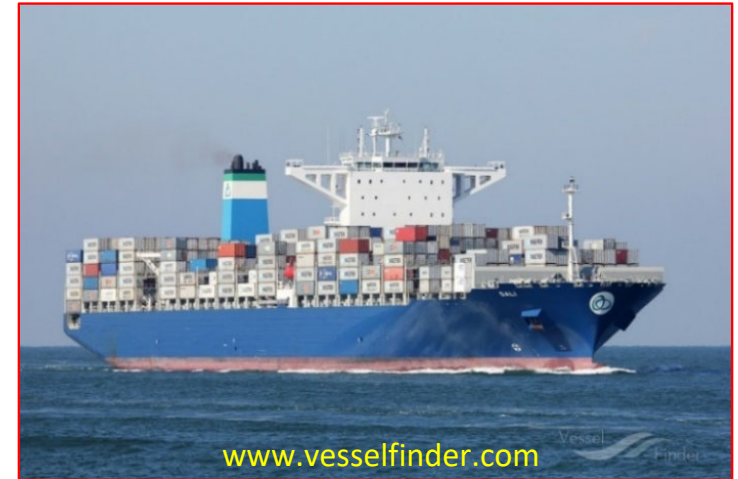
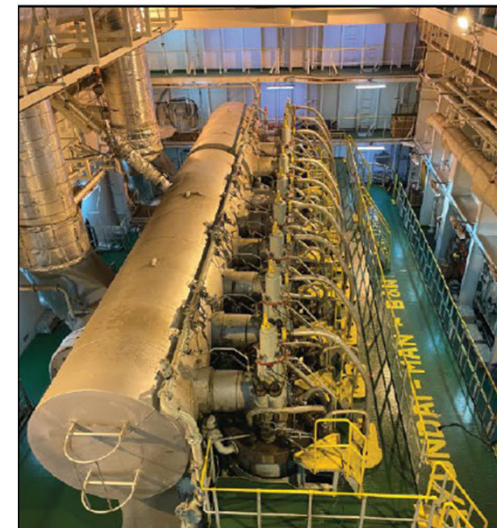
# MV Dali

- Registered: Singapore
- Length: 289 metres ~ 100,000 tonnes (gross)
- Engine: single 41,480 kW low-speed two-stroke diesel engine
- No gearbox/ clutch
- Compressed air to start/ reverse
- Propeller 27 rpm – 80 rpm
- Single rudder
- Fuel: Light oil (Low sulphur) and heavy fuel (outside emissions control areas)

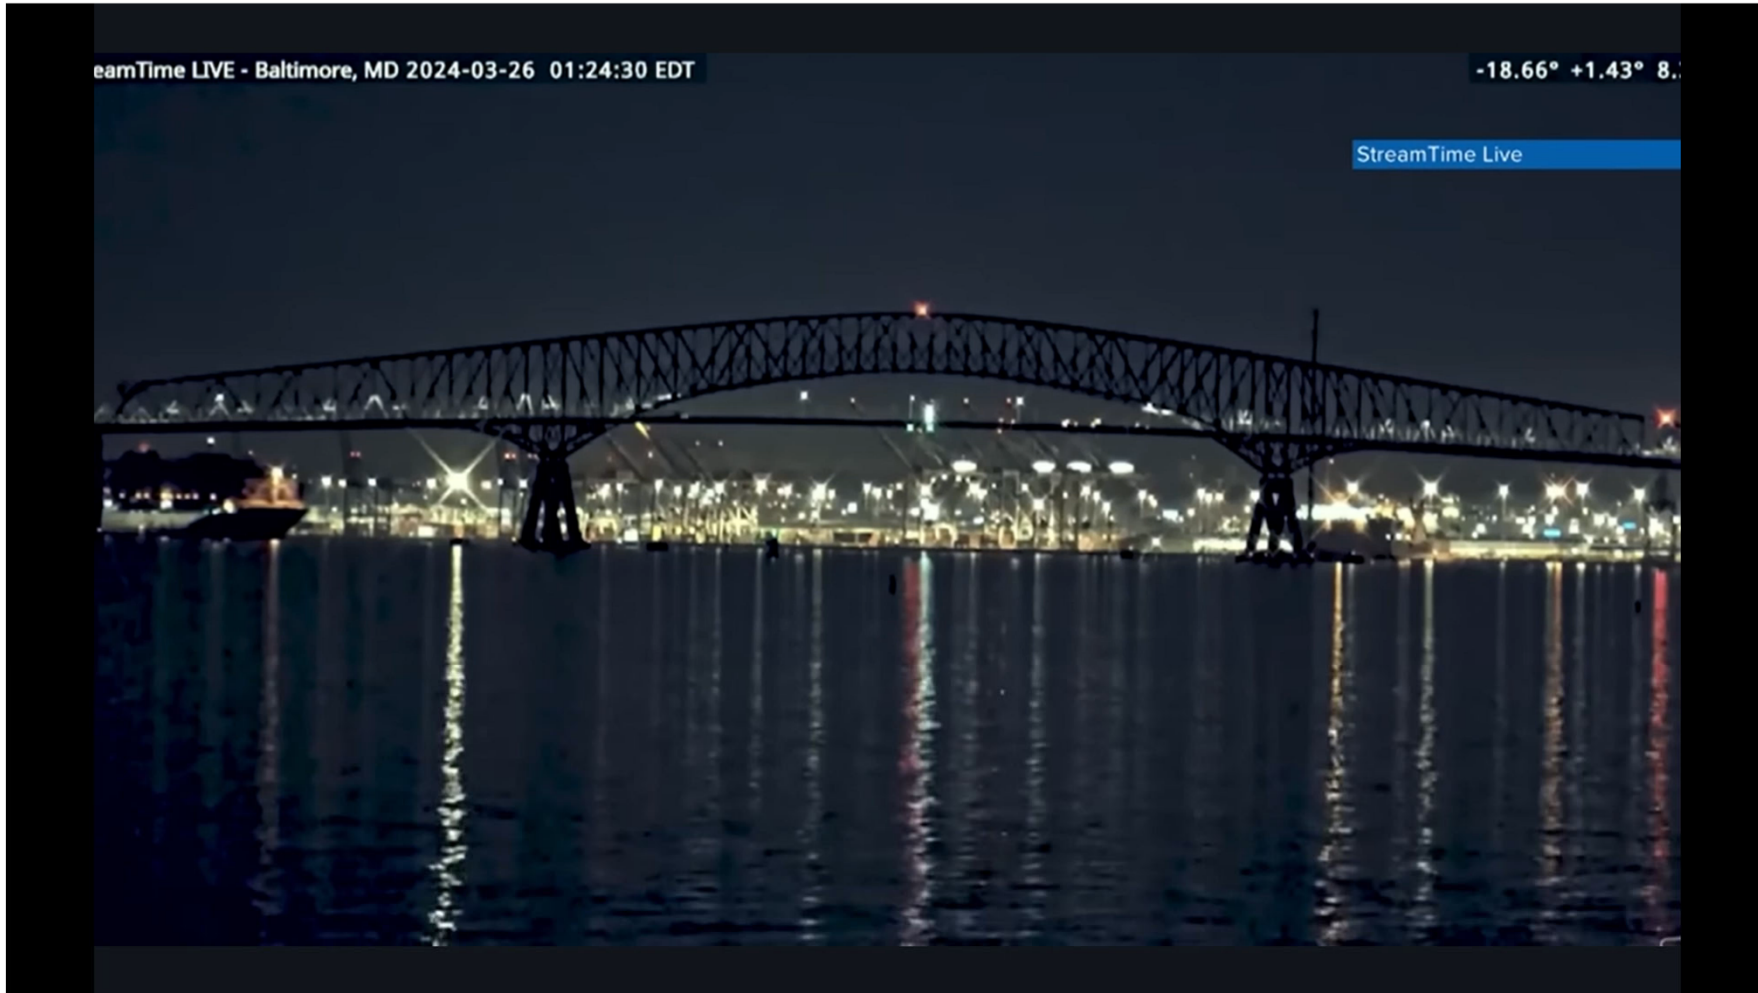
# MV Dali, Baltimore Bridge collapse, 26 Mar 2024

- 01:24:58 hrs SOG ~ 9 knots<sup>1</sup>
  - HR1 and LR1 tripped – LV systems lost power
  - Most bridge systems lost power
  - Engine shuts down (fuel/ lube/ cooling)
  - Steering pumps (x3) lost power
- 01:25:57 power restored (“Manual reset HR1, LR1”<sup>2</sup>)
- EG started – timing tbc (“over 1 minute”)
- DG2 started – timing tbc
- 01:26:13 pilot orders 20° port rudder
- 01:27:01 pilot ordered anchor drop
- 01:27:03 second power failure HV and LV bus
  - DGR3 and DGR4 opened due to fuel starvation to generator
- 01:27:23 pilot ordered 35° port rudder
- 01:27:36 power restored
- 01:29:10 Dali strikes pier 15 of Francis Scott Bridge
