ASSOCIATED PROTECTIVE DEVICES

HOW DO YOU KNOW THAT ALL PARTS OF YOUR RELIEF SYSTEM ARE EFFECTIVE?

Richard Hodges
EPSC Process Safety Conference, Barcelona, December 2024

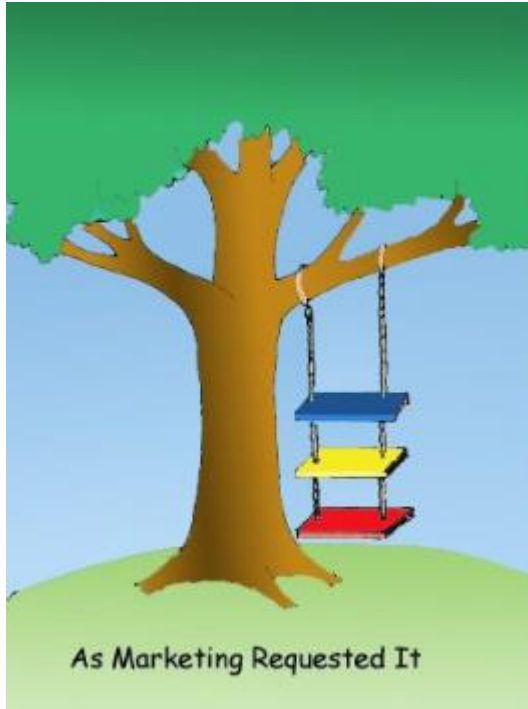
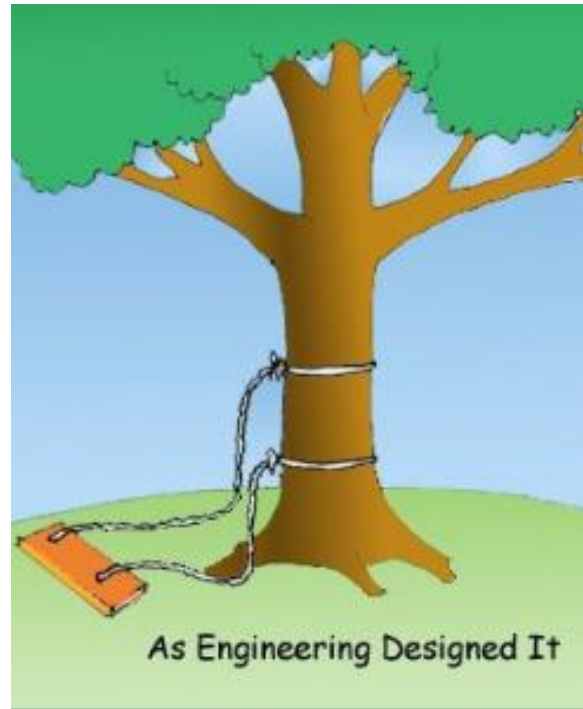
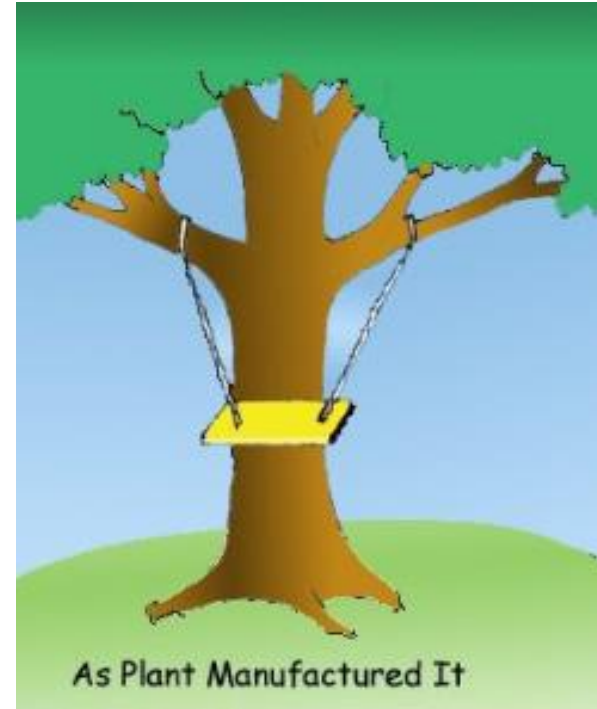
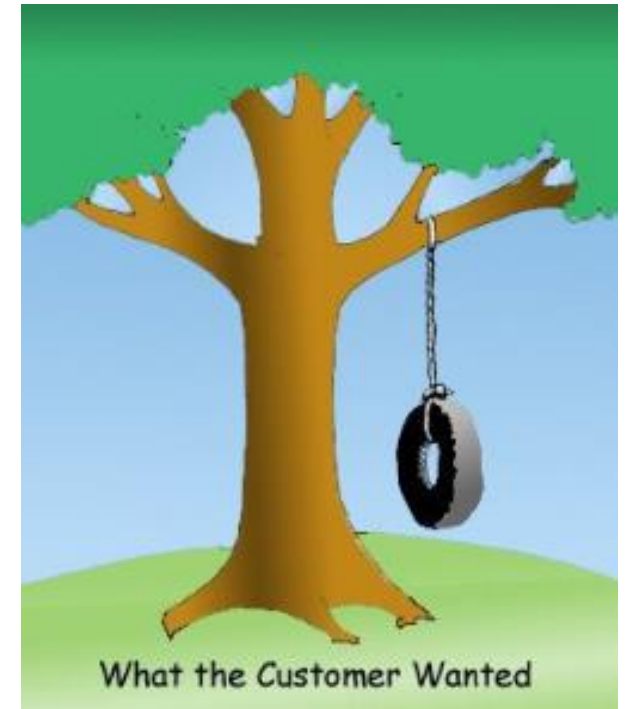
- This incident highlights the concept of an associated protective device.
- The original design for pressure relief was acceptable, but a subsequent modification installed an isolation valve between the heat exchanger shell and its relief valve.
- The relief provision was being provided through procedural controls, and reliant on the integrity of manual isolation valves.
- The deficiencies in design and operational control are very obvious in this example – but how can you be sure that your design intent for a well-designed relief stream is correctly implemented, inspected and maintained over the life of the plant?

BEWARE CHANGES IN DESIGN!

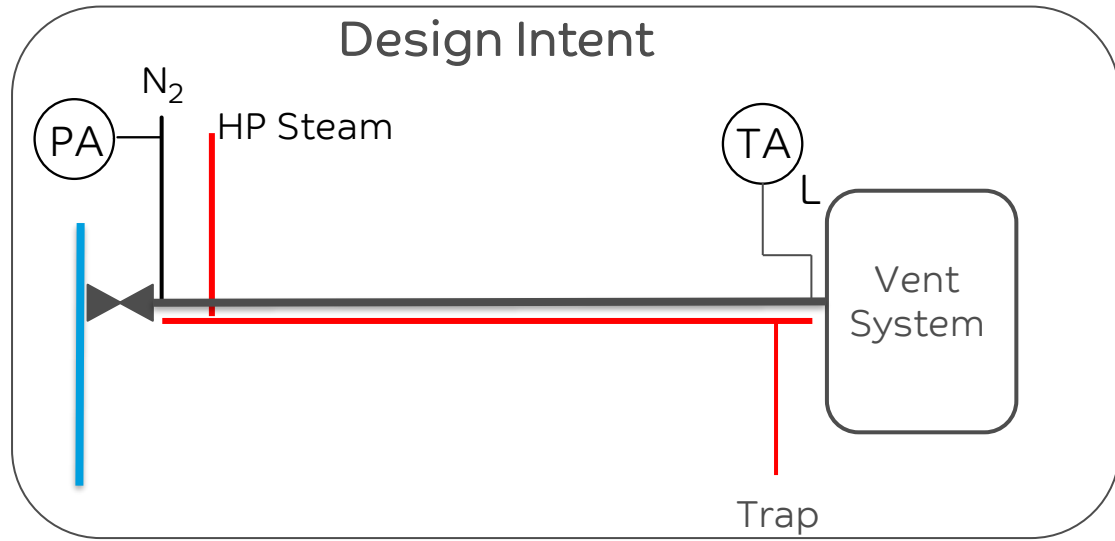
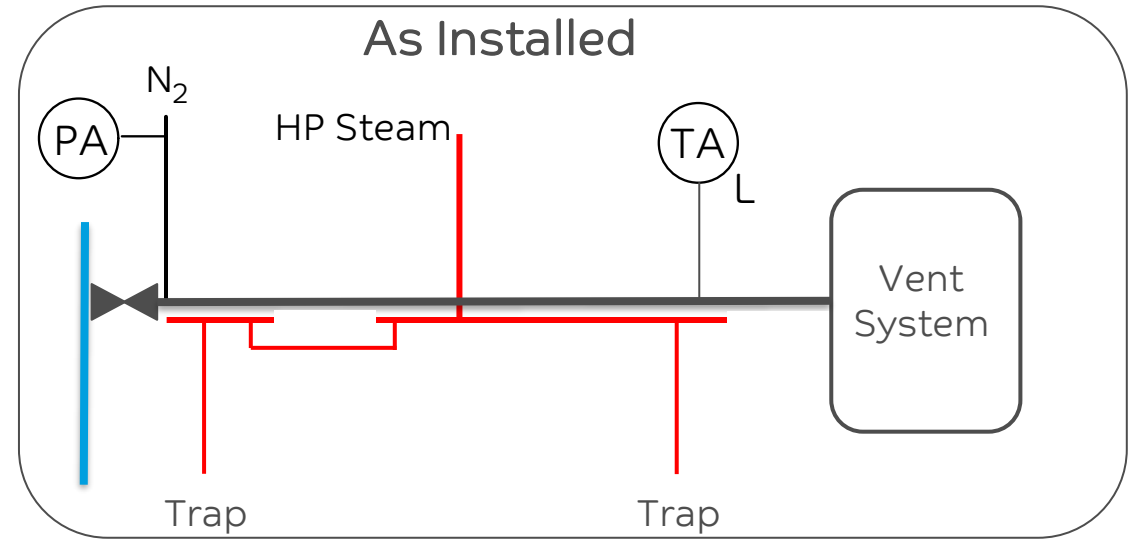
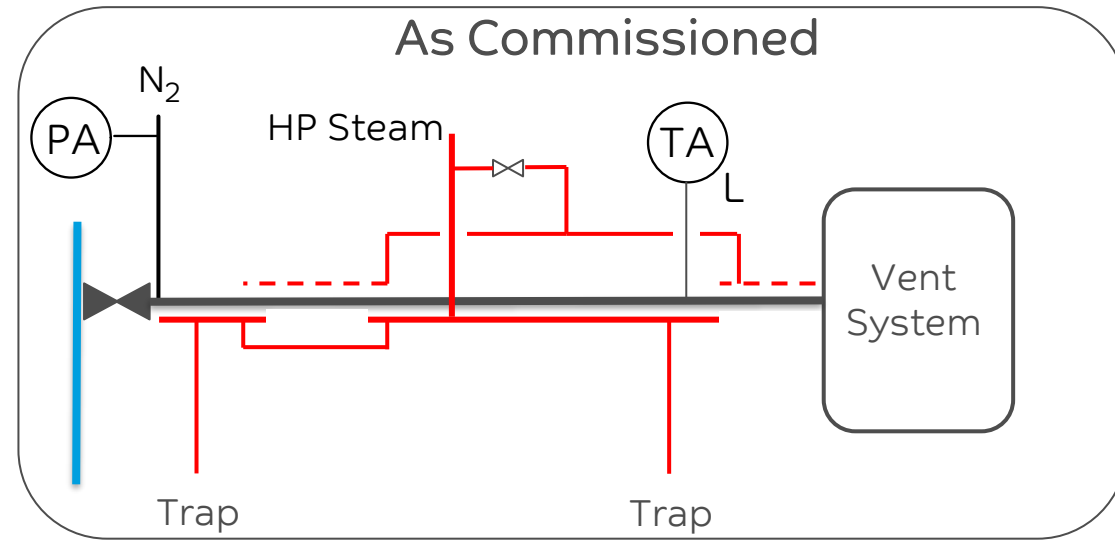
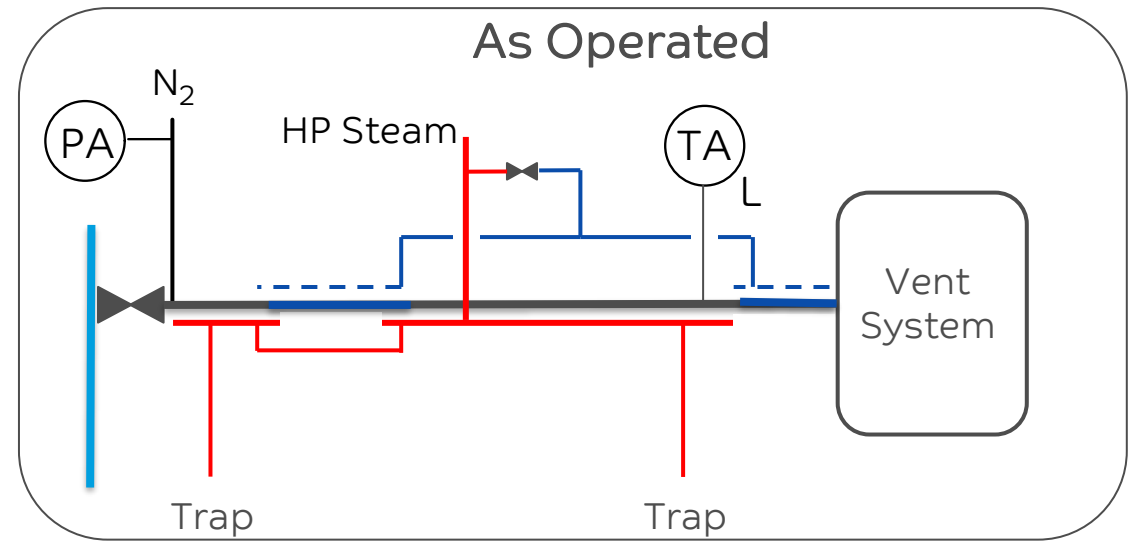
The investigation found this local isolation valve shut

- Steam-traced section of the Dump Line was at ambient temperature.
- Polymer blockage was found in this section.

The installed Dump Line did not meet the design intent with a continuous steam jacket.

The modification installed steam tracing to the non-jacketed sections, but this introduced another potential failure mechanism.

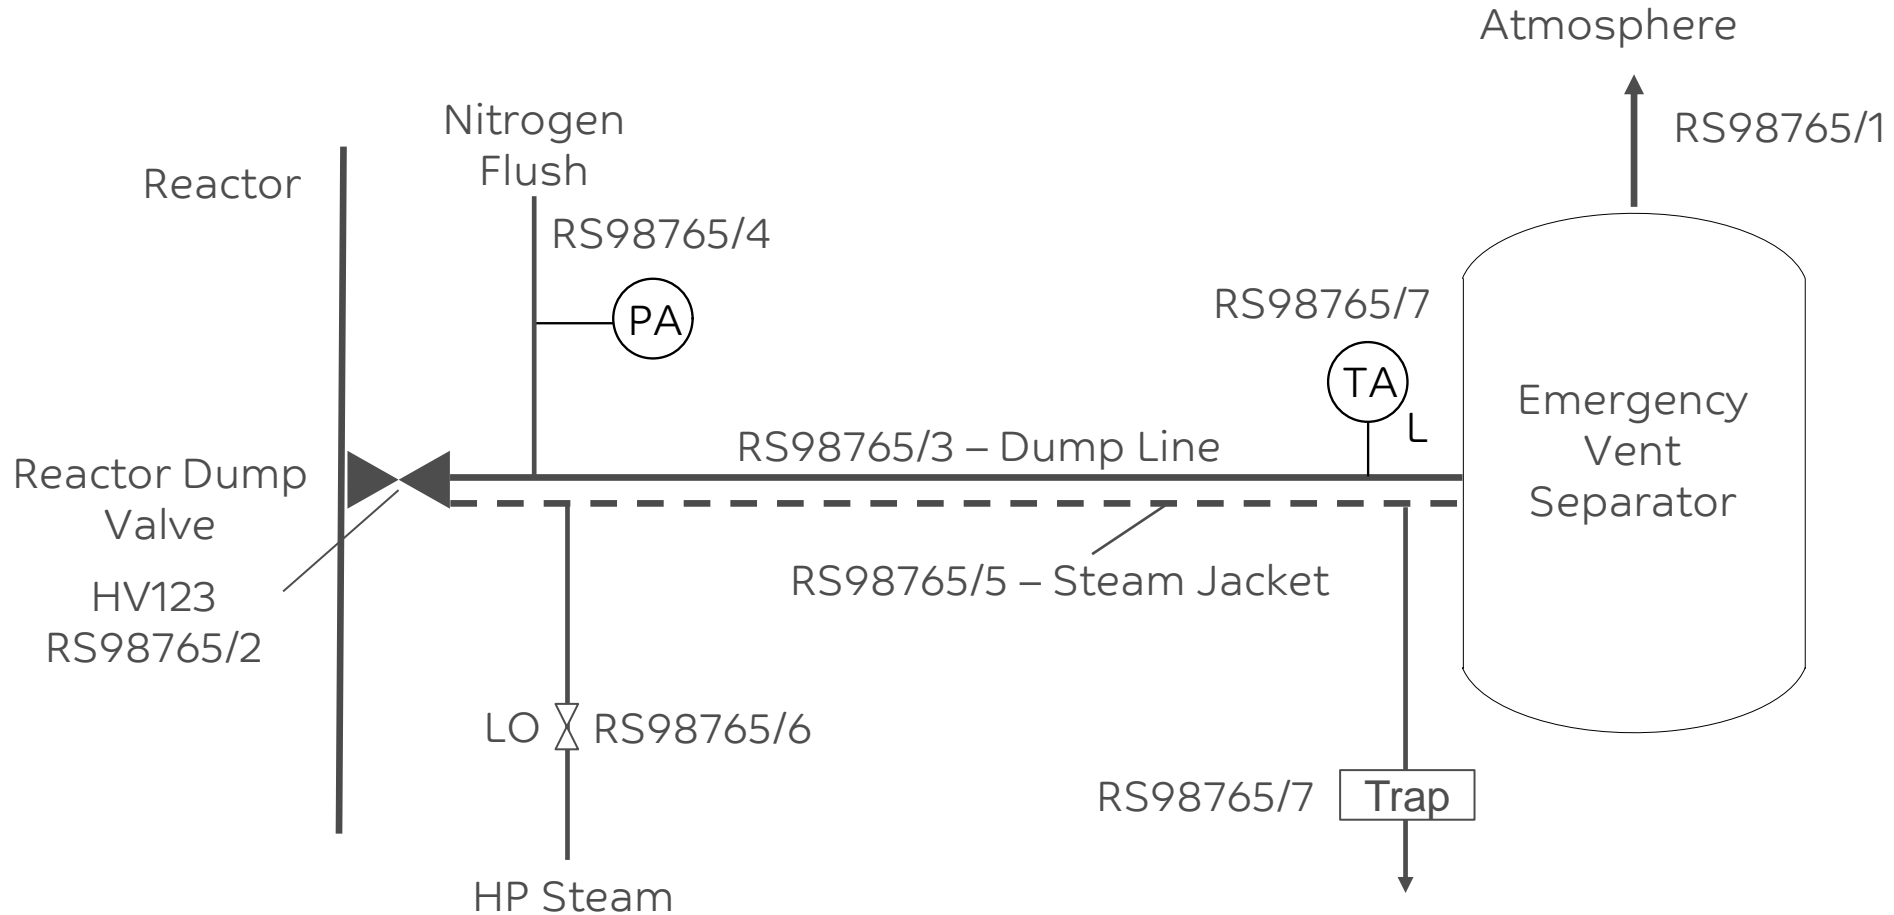
A picture tells a thousand words!
