# The Nature of Vapour Cloud Explosions

Mike Johnson

14 September 2022

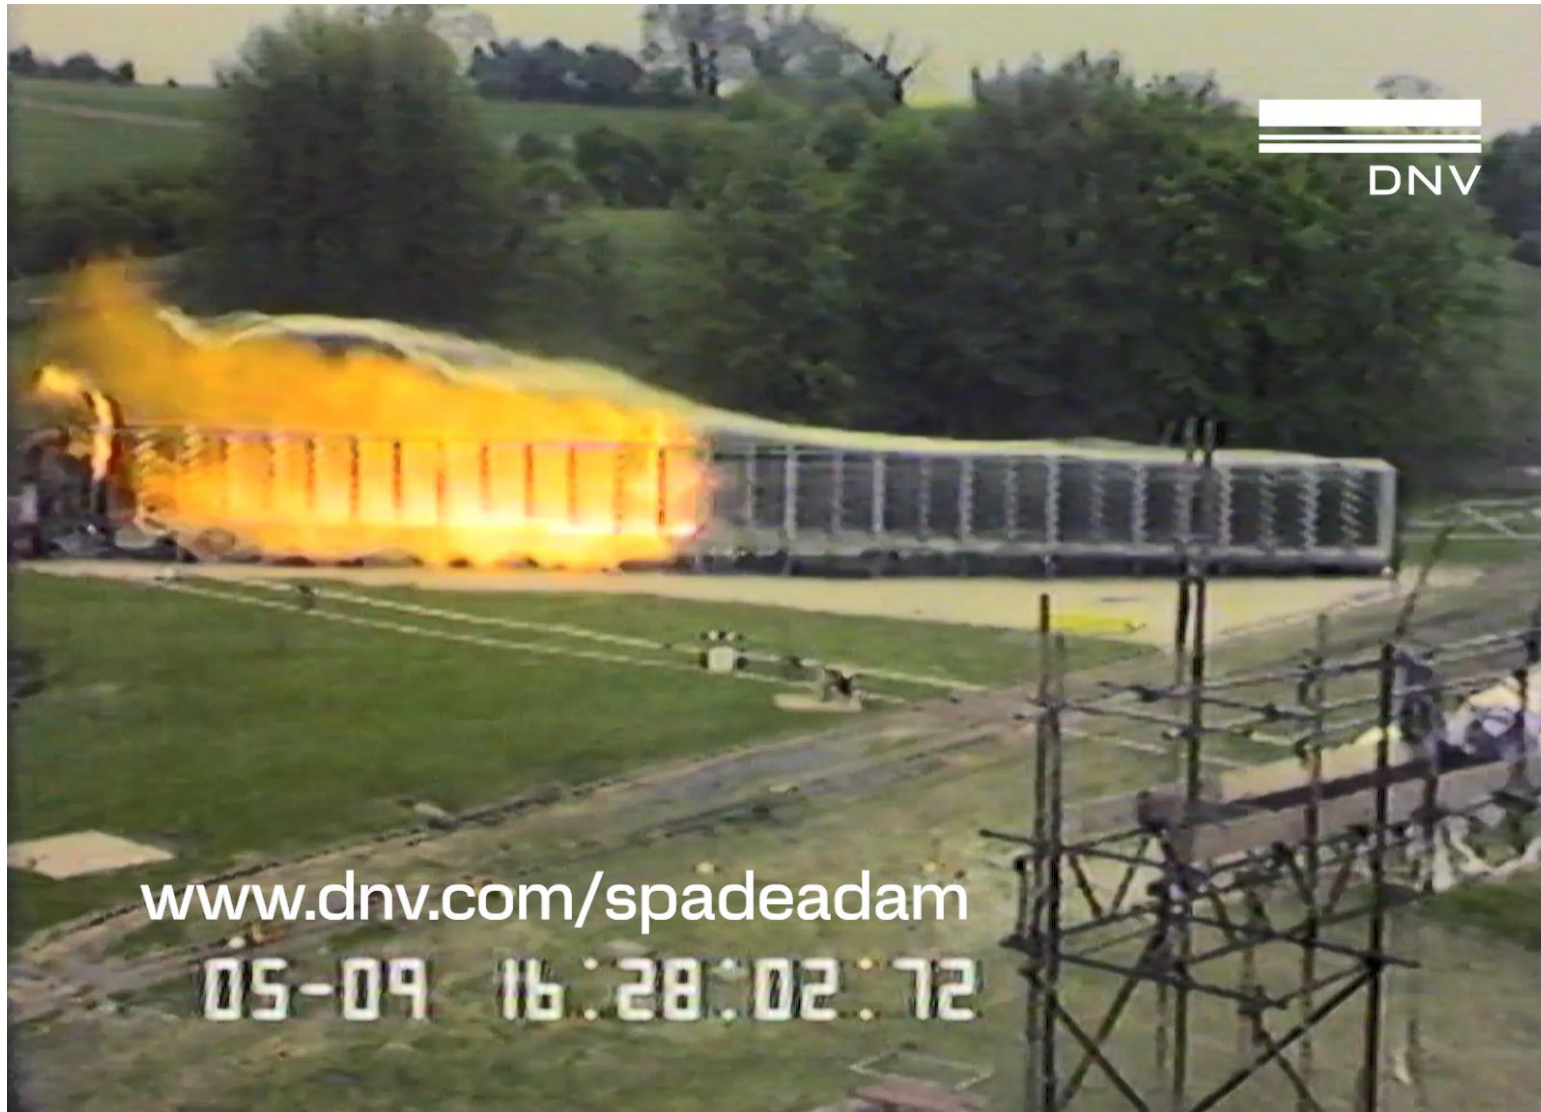
# Flame Acceleration – Natural Gas

Maximum flame speed ~100m/s

Expansion of combustion products produces flow

Turbulence in flow increases the burning velocity

Flame acceleration

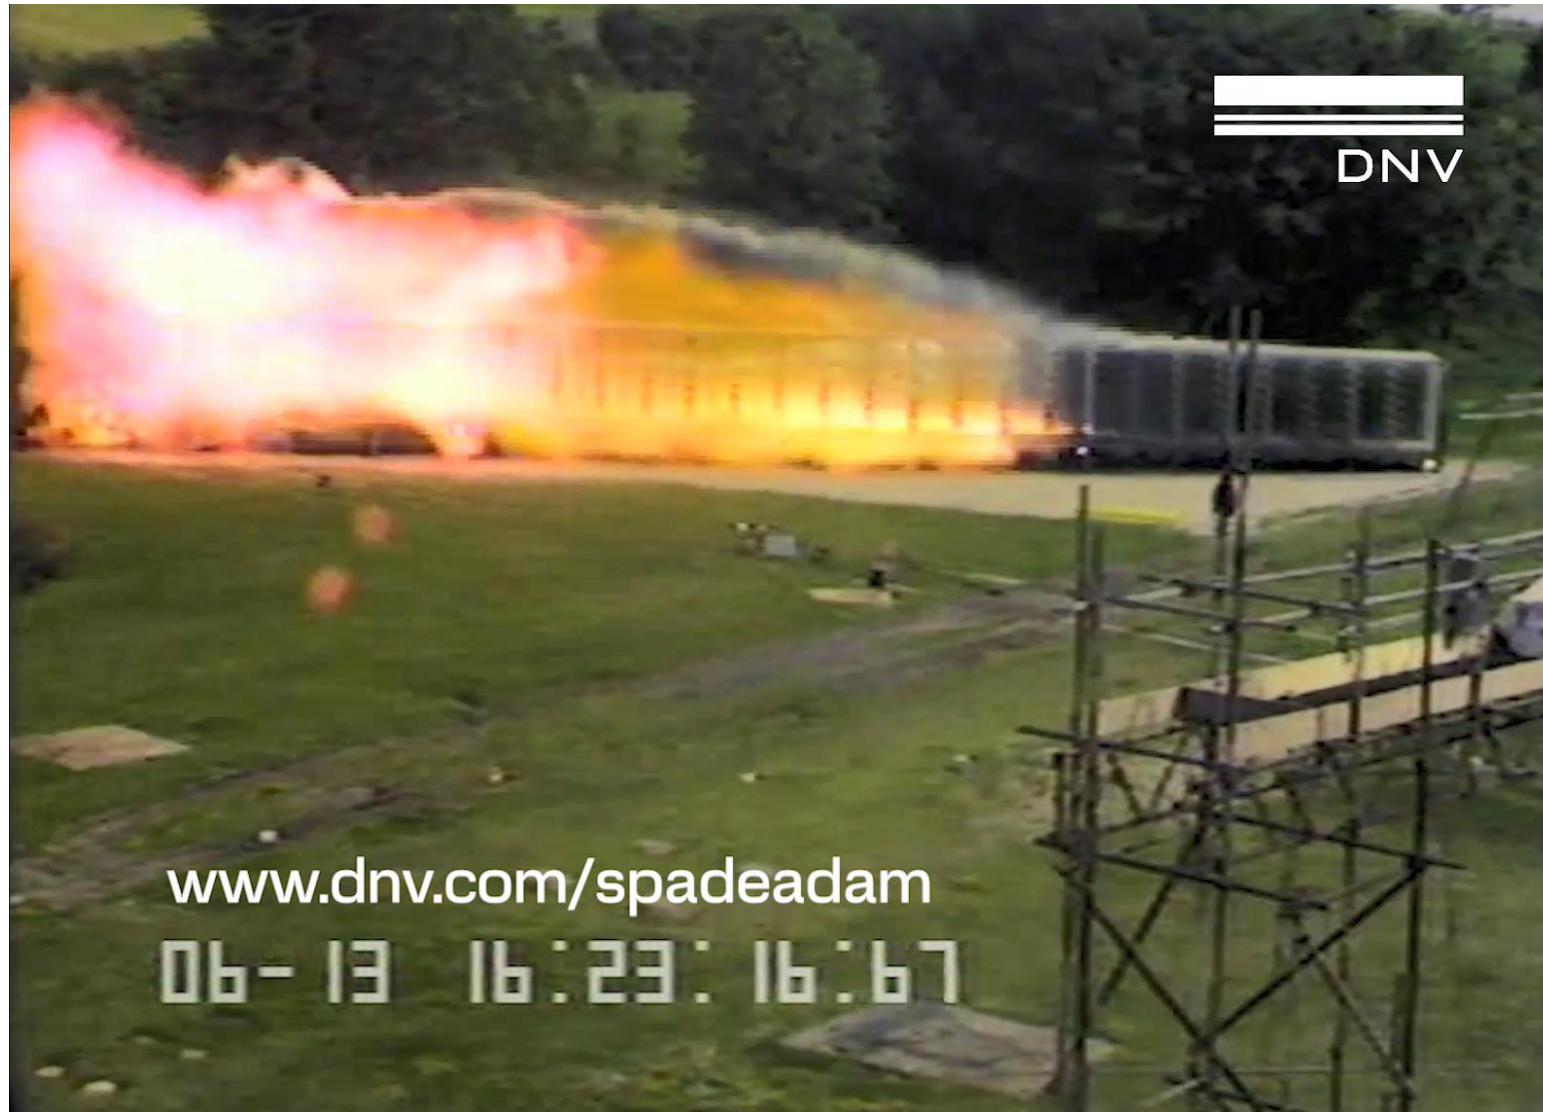
# Flame Acceleration – Cyclohexane

Maximum flame speed ~230m/s

Maximum pressure ~700 mbar

Clear difference between fuels

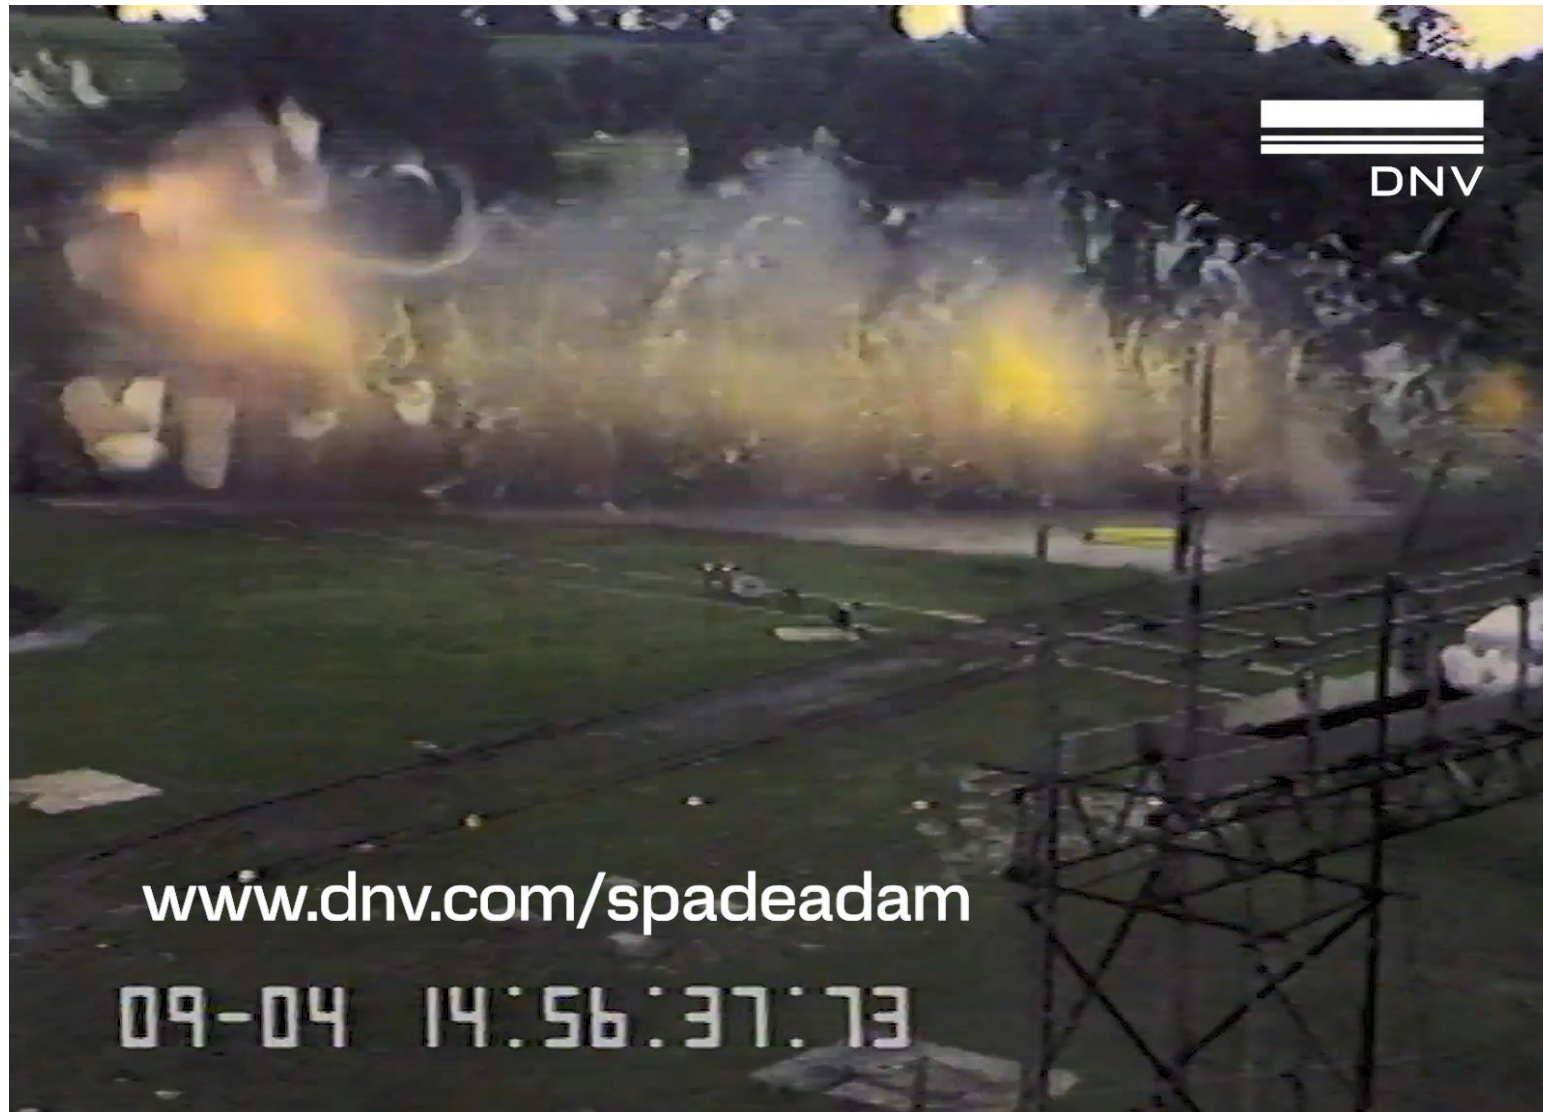
# Natural Gas

Flame speed  
~550m/s

Rapid initial flame  
acceleration

Supersonic  
deflagration

Still dependent on  
continued presence  
of process  
congestion

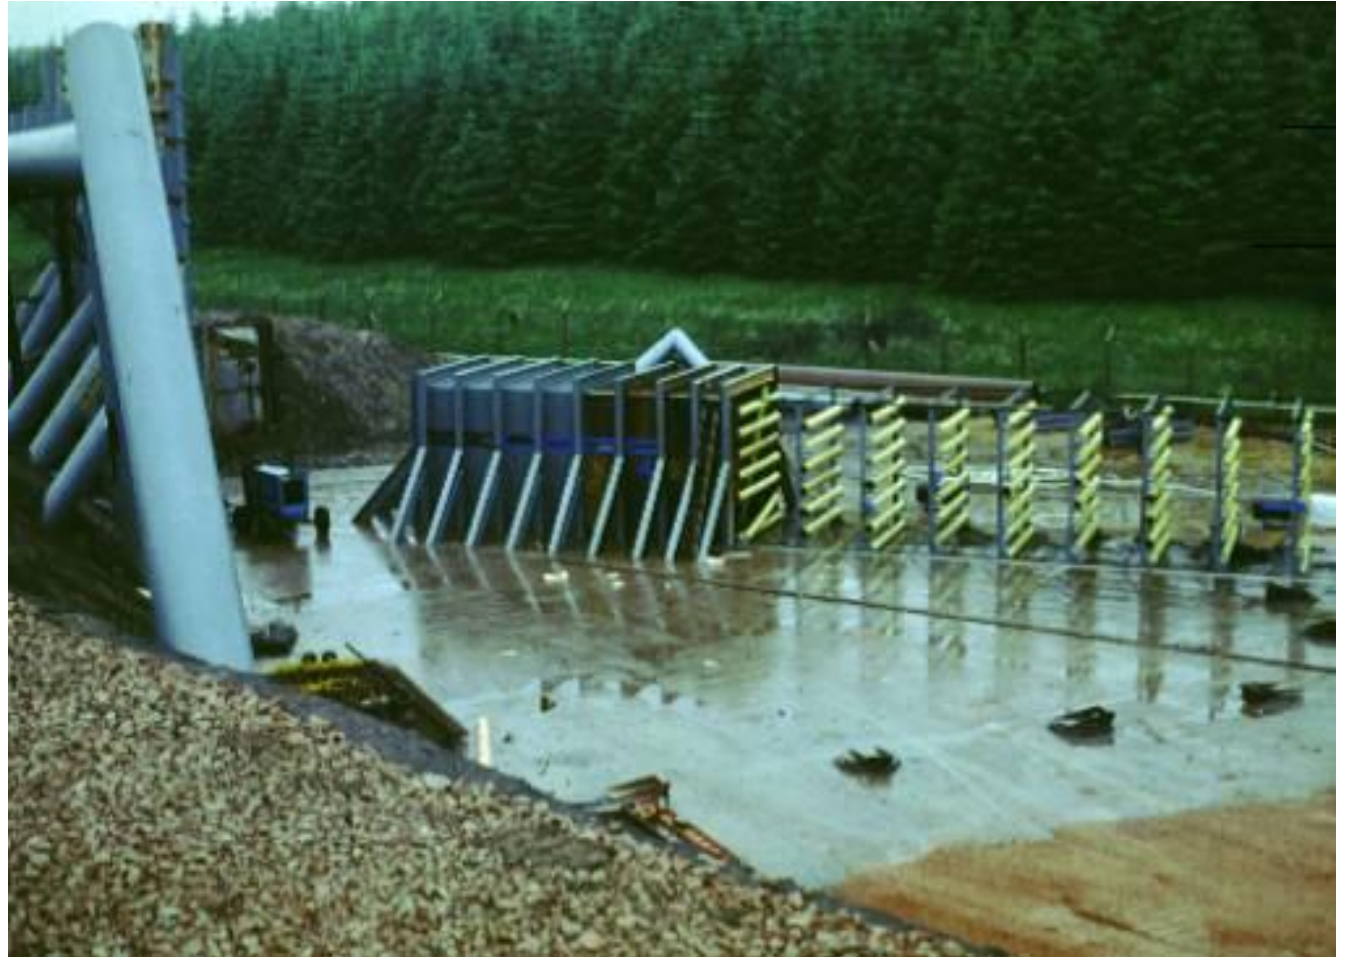
# Confinement and Congestion

- Now with a much stronger initial confinement
- Allows repeated experiments

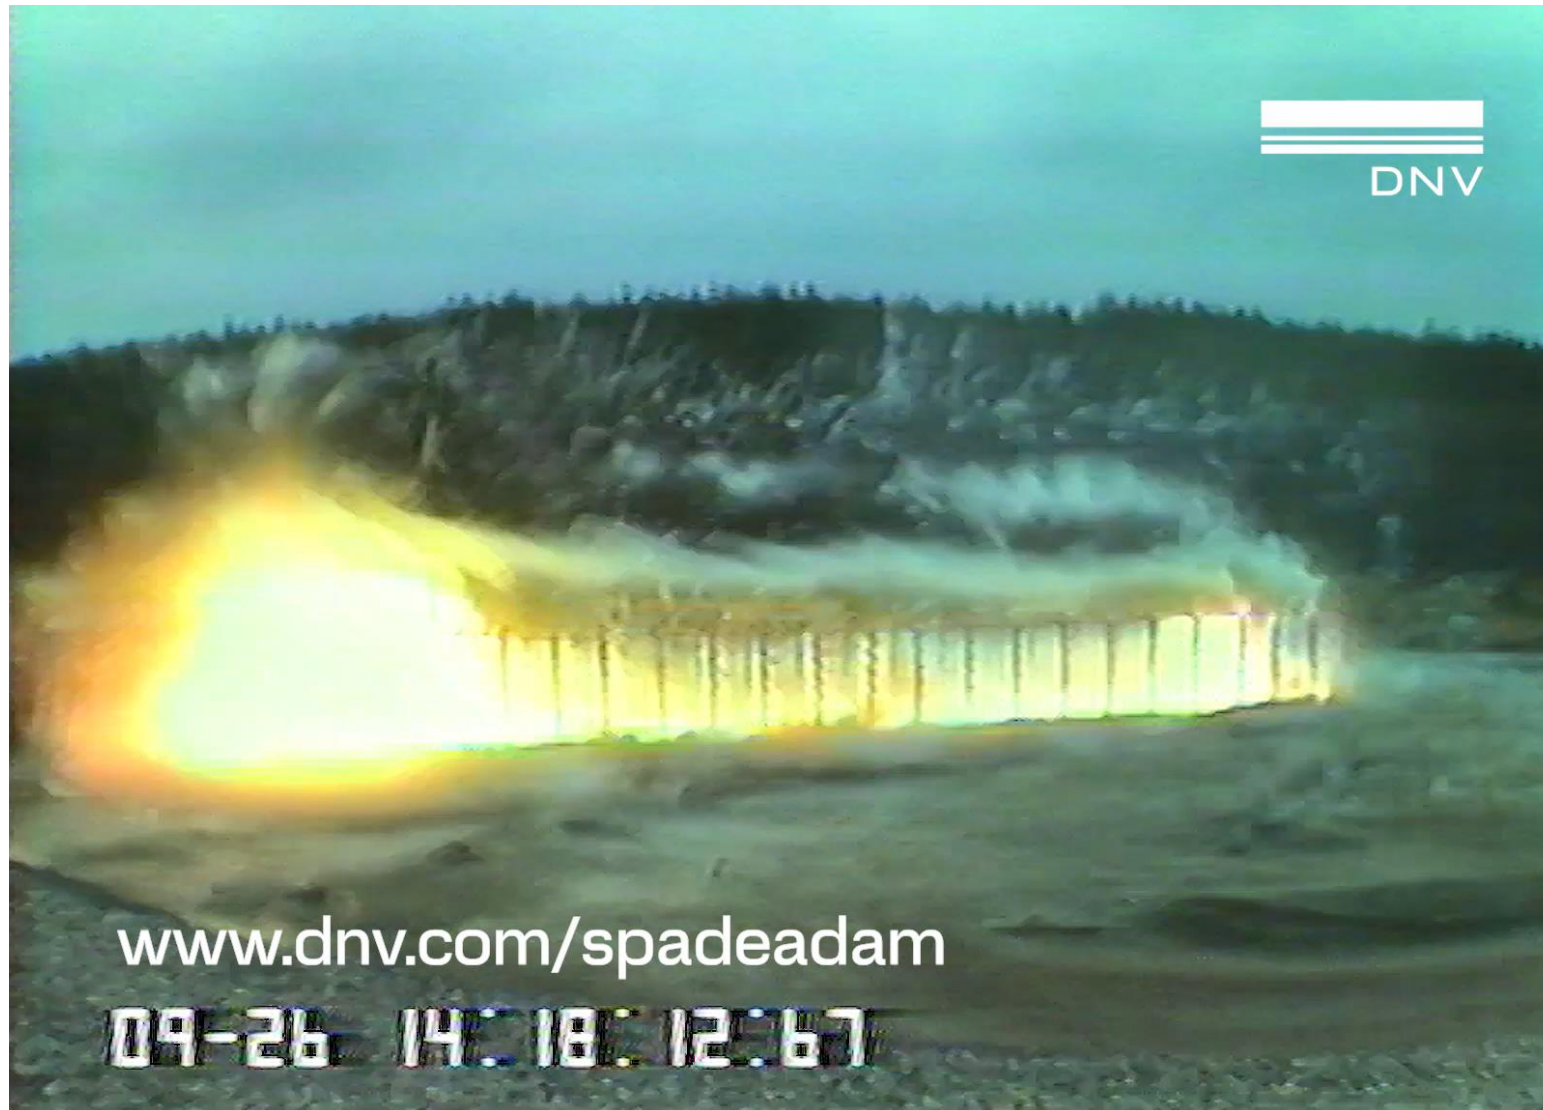
# Cyclohexane

Transition from  
deflagration to  
detonation (DDT)

Detonation  
propagates at  
1.8km/s with  
pressures of 20 bar

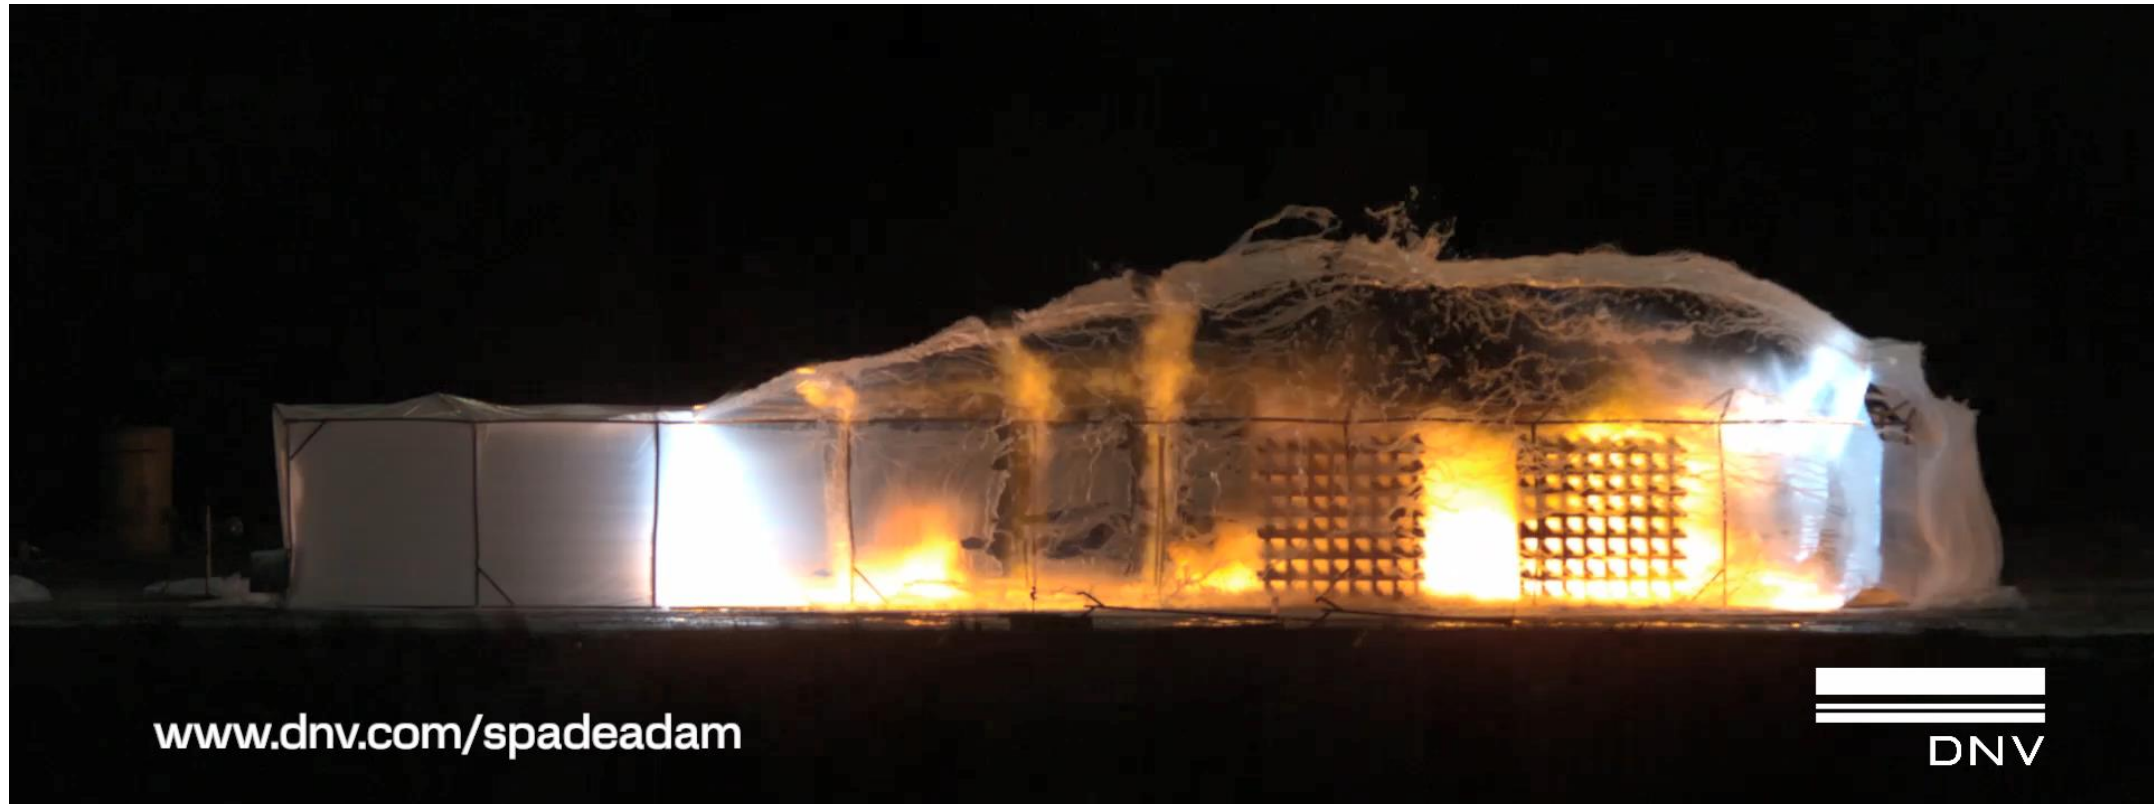
# Deflagration to Detonation Transition (DDT)

20 bar shock wave compresses mixture to autoignition temperature

Combustion maintains shock wave – self sustaining and not dependent on congestion

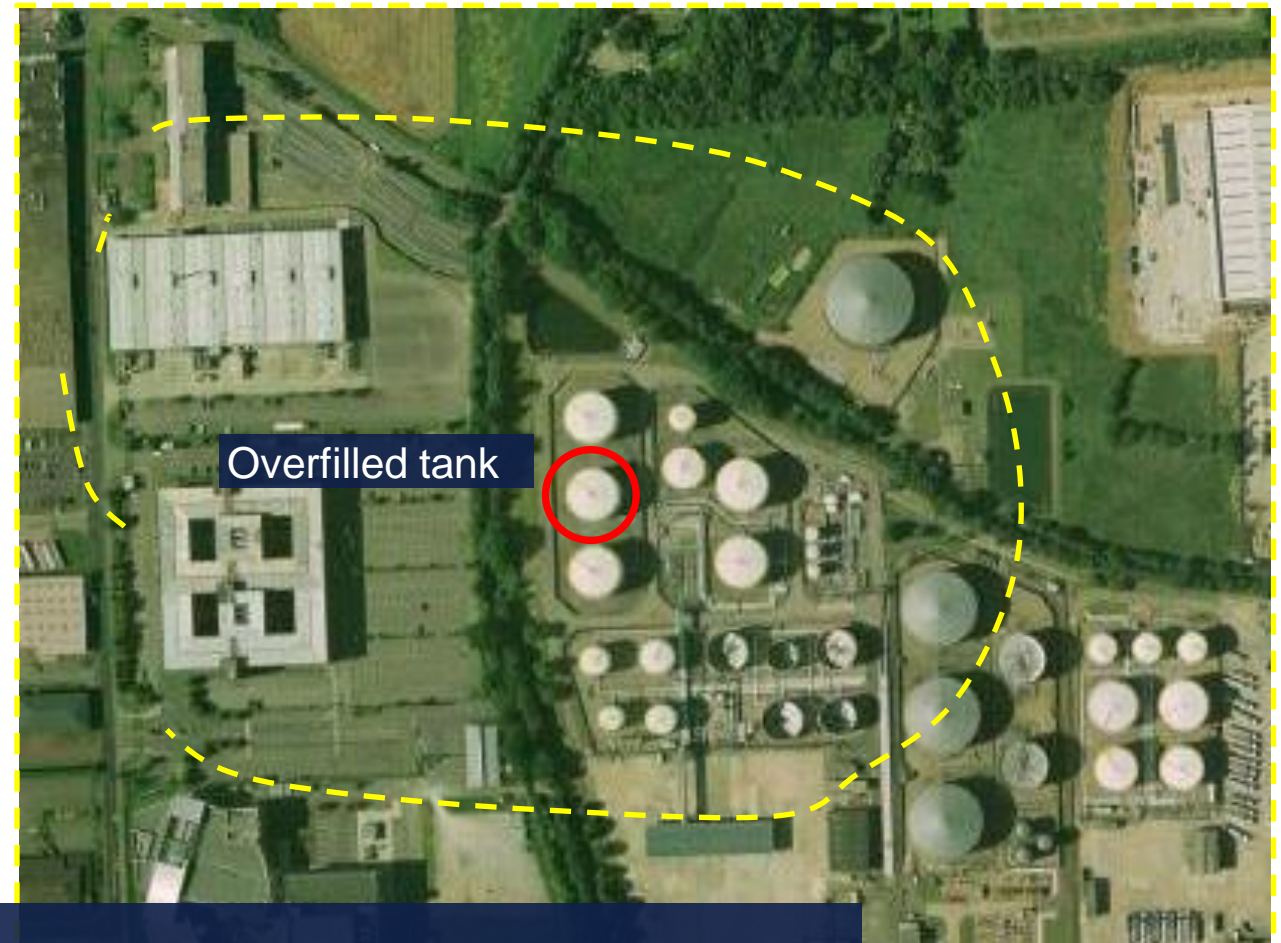
# Vapour Cloud

Dispersion enhanced by break up of fuel into droplets as it fell from tank roof, generating large surface area for vapour evaporation  
Vapour cloud extended offsite

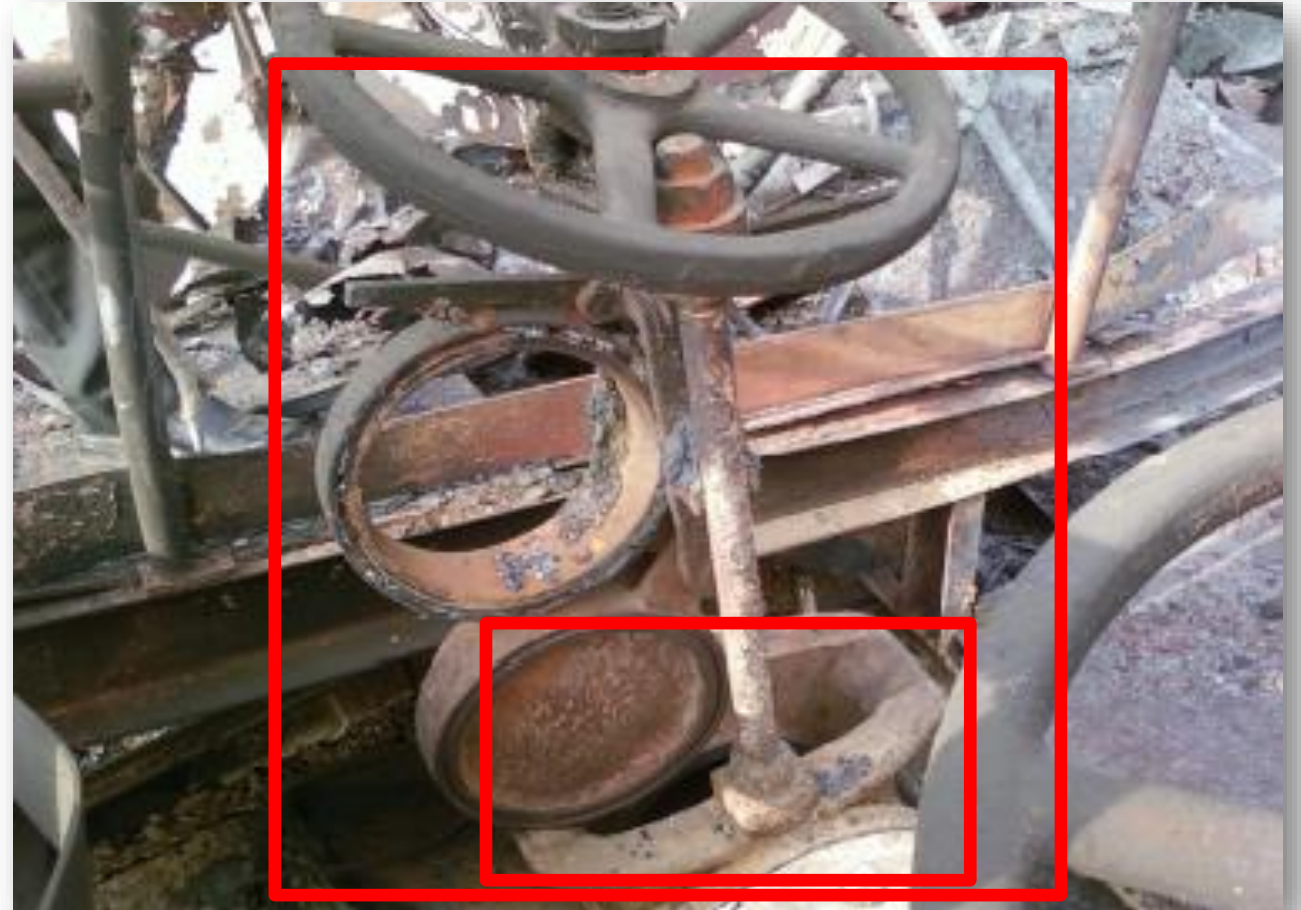
# Source of Spillage

- Source of leak was a 'Blind Hammer Valve' on the tank outlet
- Changing from blocked to open required a short period where the top is open to the atmosphere
- Valve upstream isolating the storage tank opened
- Fuel driven out by tank hydraulic pressure

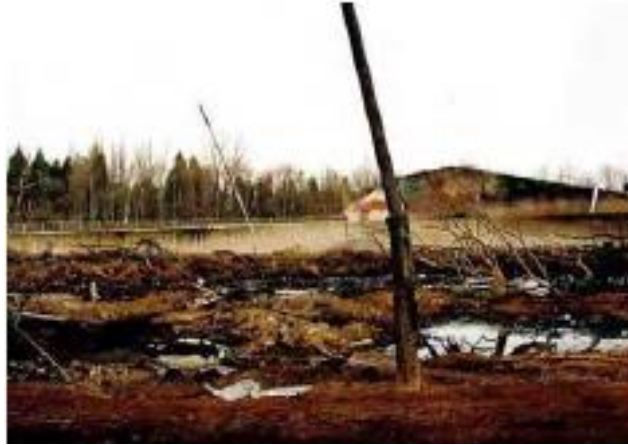
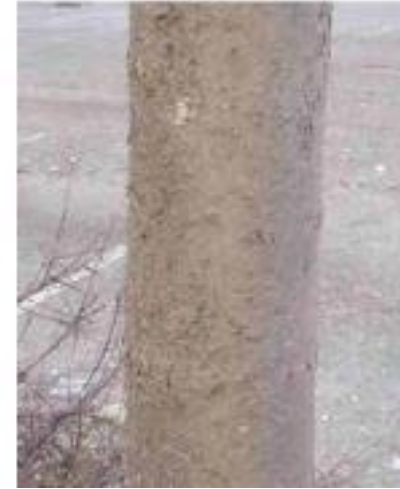
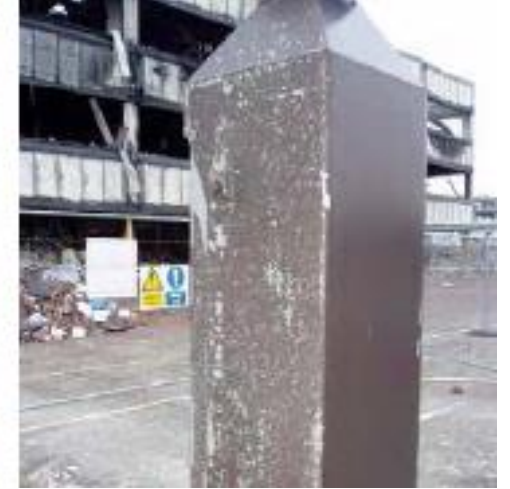
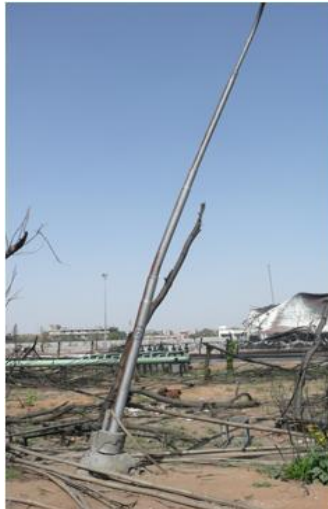
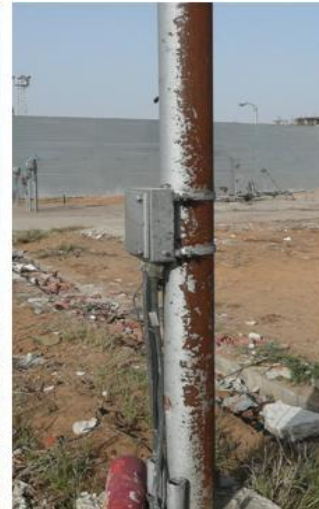
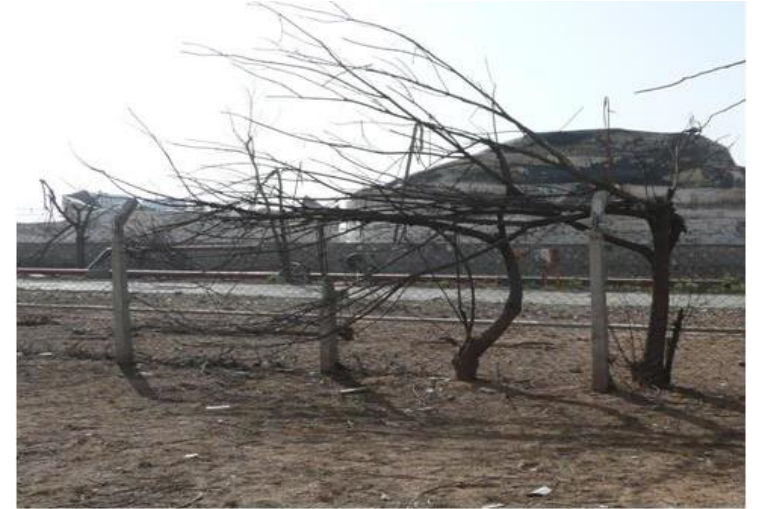
# Directional Indicators

- Observed throughout clouds in Buncefield and Jaipur incidents
  - Bent or leaning lampposts
  - Trees scorched on one side
  - Branches on trees snapped and bent over in one direction
  - Scoured paintwork on one side of posts

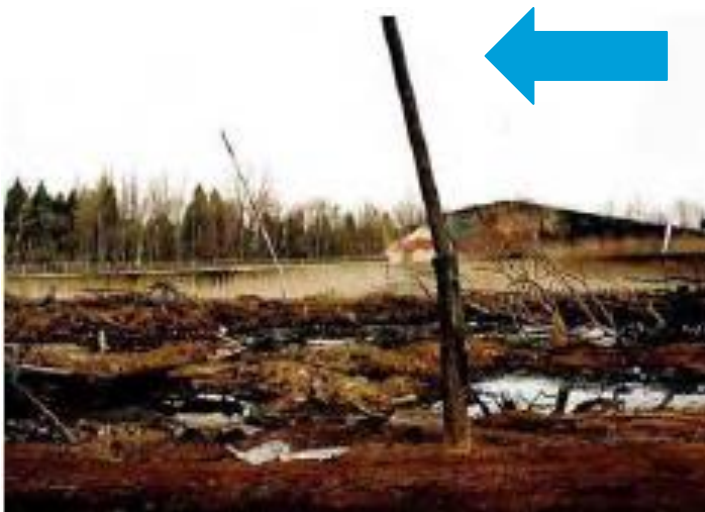
# Initial Investigation

- Early Buncefield report gave initial assessment of the directional indicators
- Suggested three explosion events!! (Indicated by the red and blue arrows)

Assumed  
direction of  
explosion

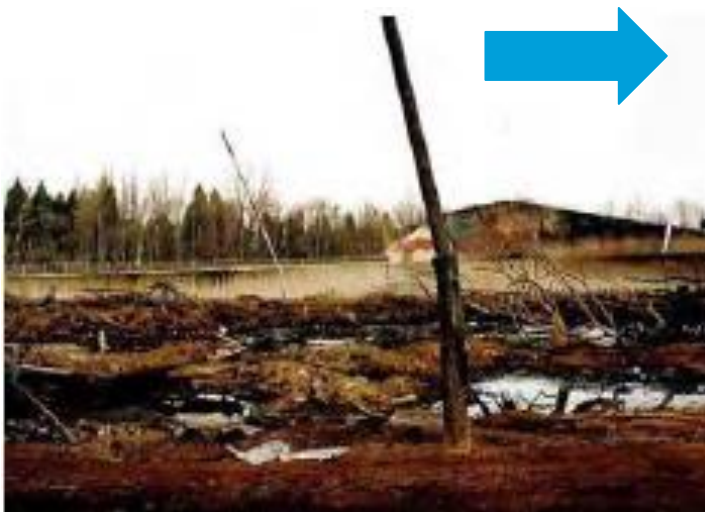
# Directional Indicators

- Experimental work showed significant reverse flow
- Modelling confirmed net force in reverse direction

Re-interpret as  
opposite direction of  
explosion

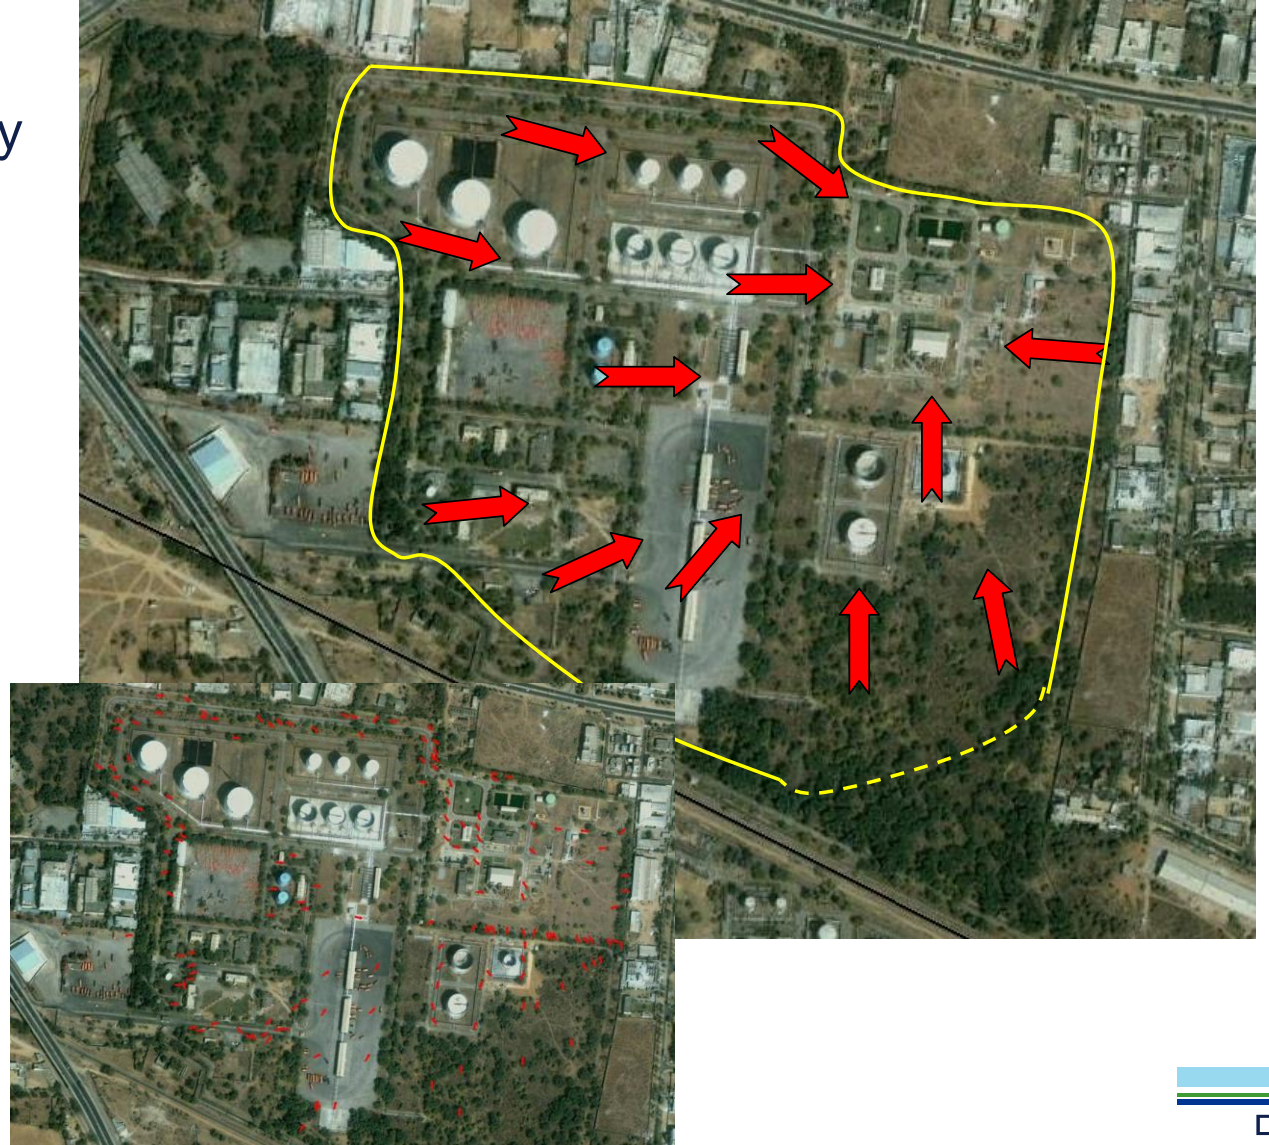
# Directional Indicators - Jaipur

- Large red arrows show summary of many directional indicator measurements
- Point towards a single source, as in Buncefield
- Indicates location of DDT
- Most likely due to flame venting from an explosion in a building

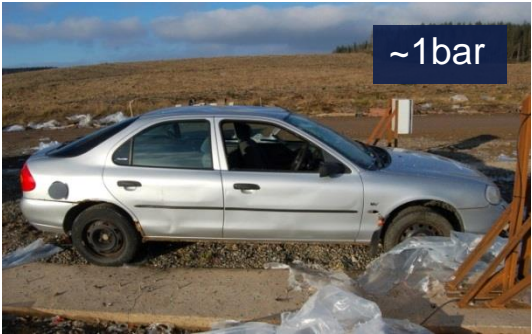
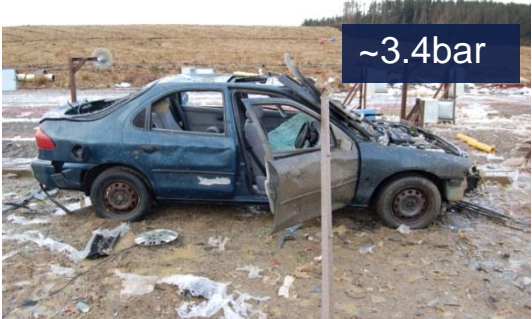
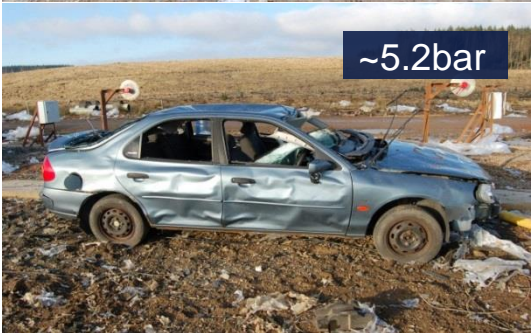
Outside the Cloud

# Damage to Cars – Short Duration Shock Loadings

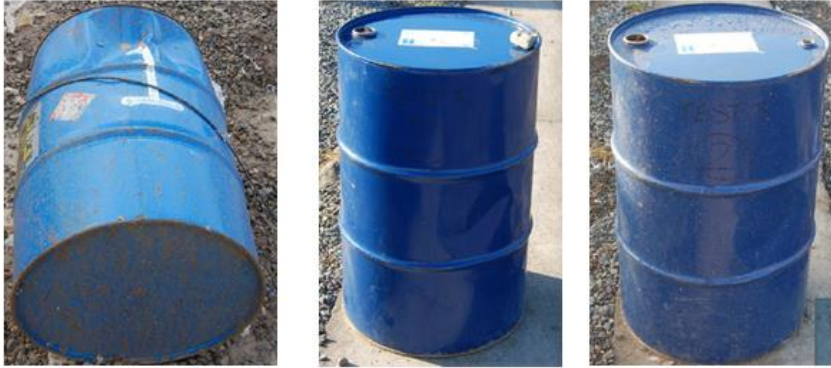
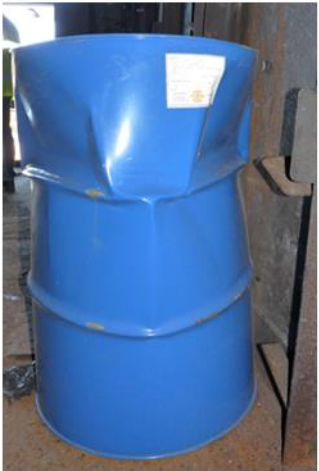
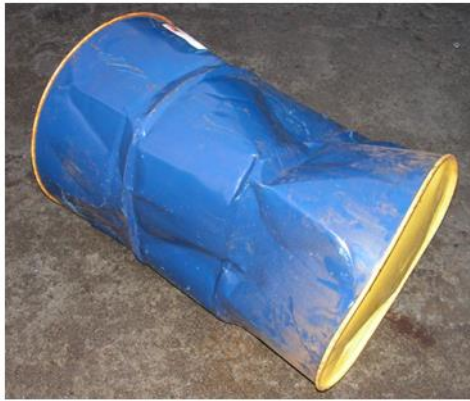
# Damage to Oil Drums

Shock loading up to 4.4bar

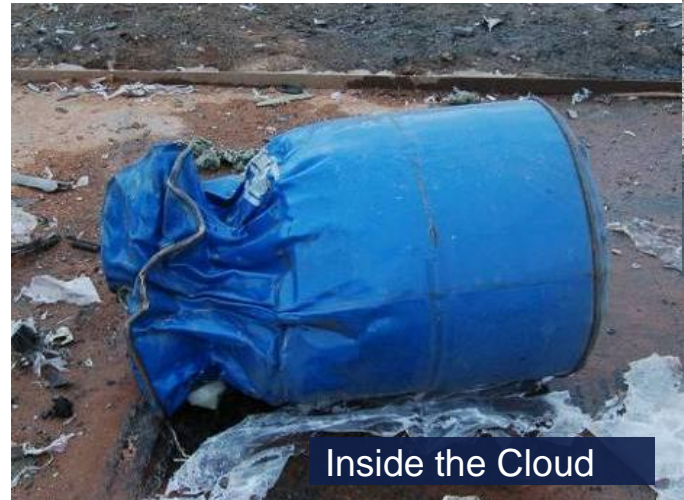
Deflagration loading up to 1.8bar

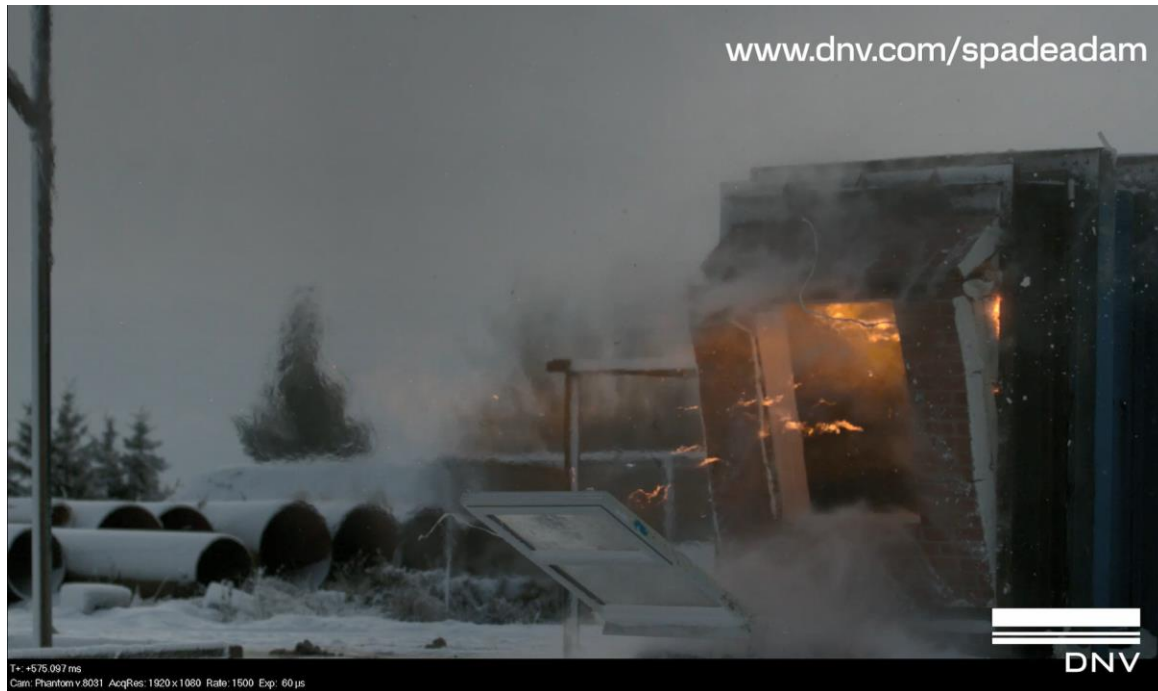
Methane (10%vol layer)

Methane and Hydrogen releases at same pressure and with same hole size

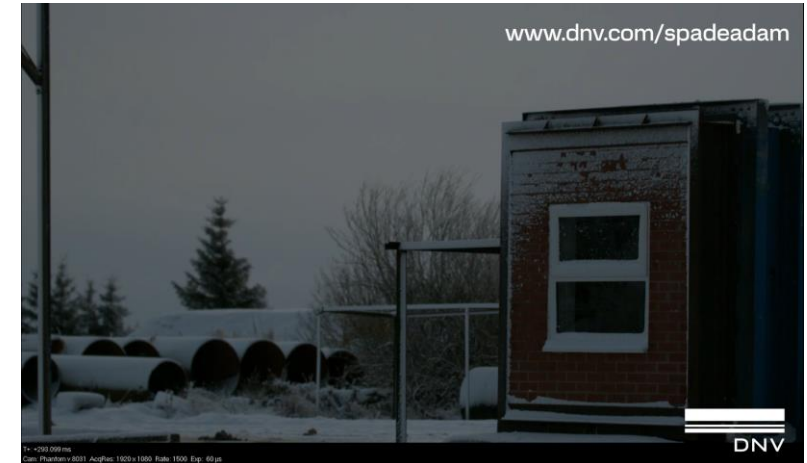
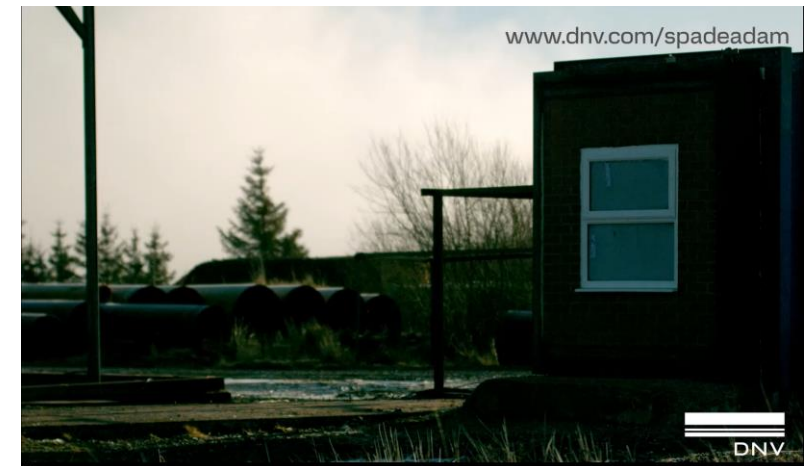
- Pressures in hydrogen experiment far exceeded the minimum required failure pressure of window and wall.
- Why?

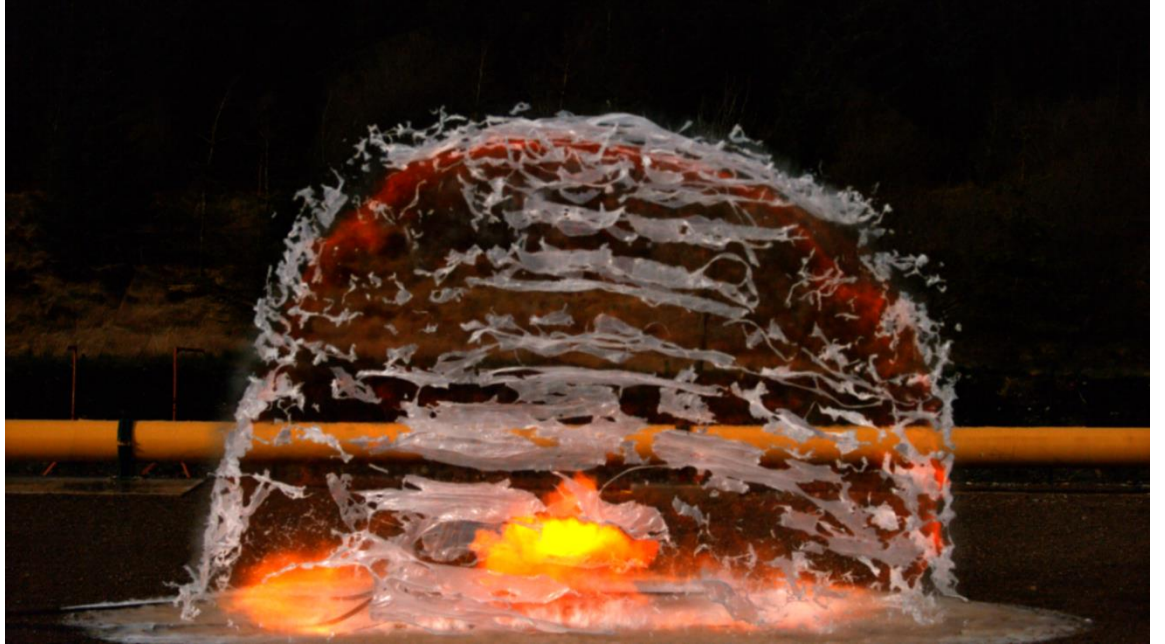
# Detonation

- Shock wave of 20 bar compresses fuel mixture to auto-ignition temperature
- Immediate combustion of fuel provides energy to maintain the shock wave
- Self sustaining and will propagate through the flammable mixture at 1800 m/s

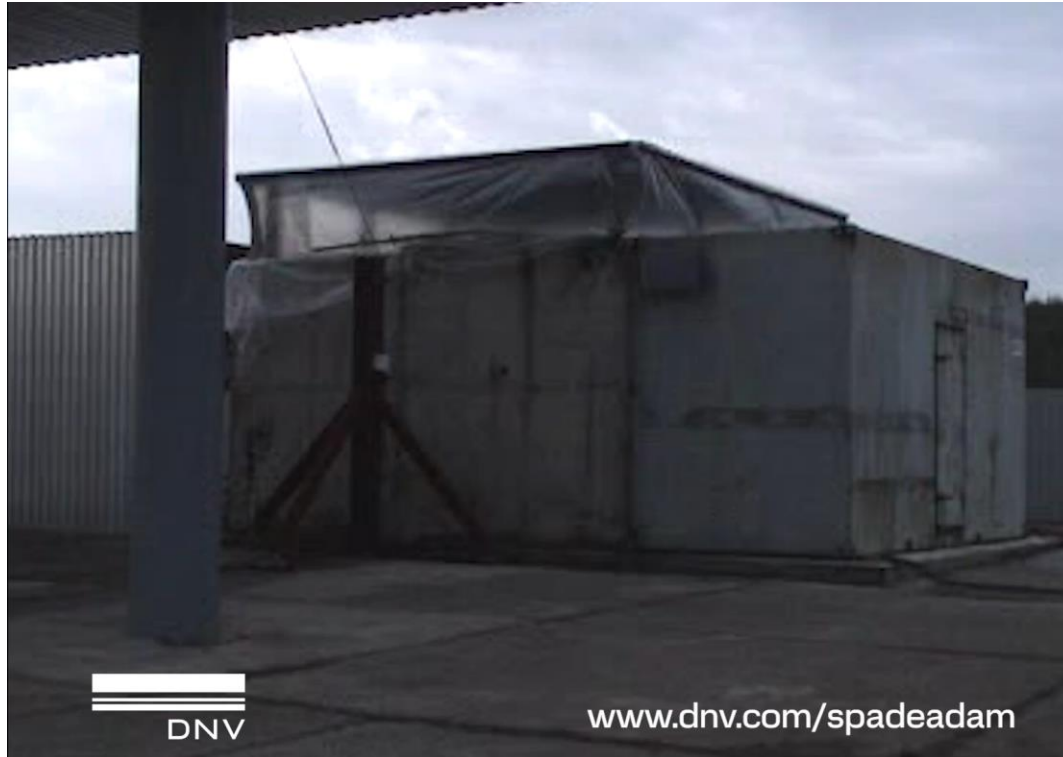
8% H<sub>2</sub>

- Fuel concentration also affects the burning rate and, as a consequence, the maximum pressure
- Illustrate with tests in a mock H<sub>2</sub> refuelling station

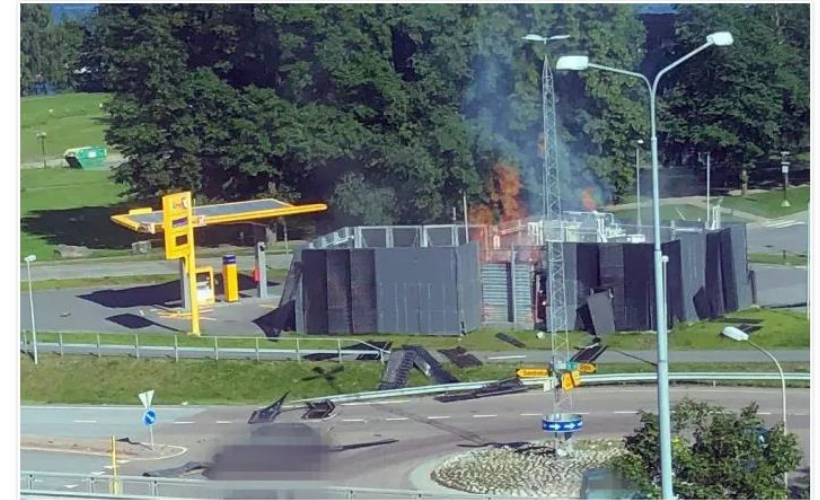
## Recent explosions shutdown hydrogen vehicle refueling in NorCal and Norway

Explosions at a hydrogen fueling depot in Northern California and at a retail station in Norway have left owners of fuel cell cars in those regions without their usual source of refueling.

Monday's explosion in Sandvika, Norway near Oslo occurred at a [hydrogen station operated by the company Uno-X](#) adjacent to a major shopping center at around 5:30pm local time. As a result, some of the company's other fuel cell stations have been taken offline until an investigation reveals more information about the cause of the explosion.
