AS-BUILT HAZOP

EPSC Process Safety Conference
December 2023
Maastricht

SABIC OLEFINS6 PLANT – OVERVIEW

OLEFINS6 RECONFIGURATION PROJECT – SCOPE

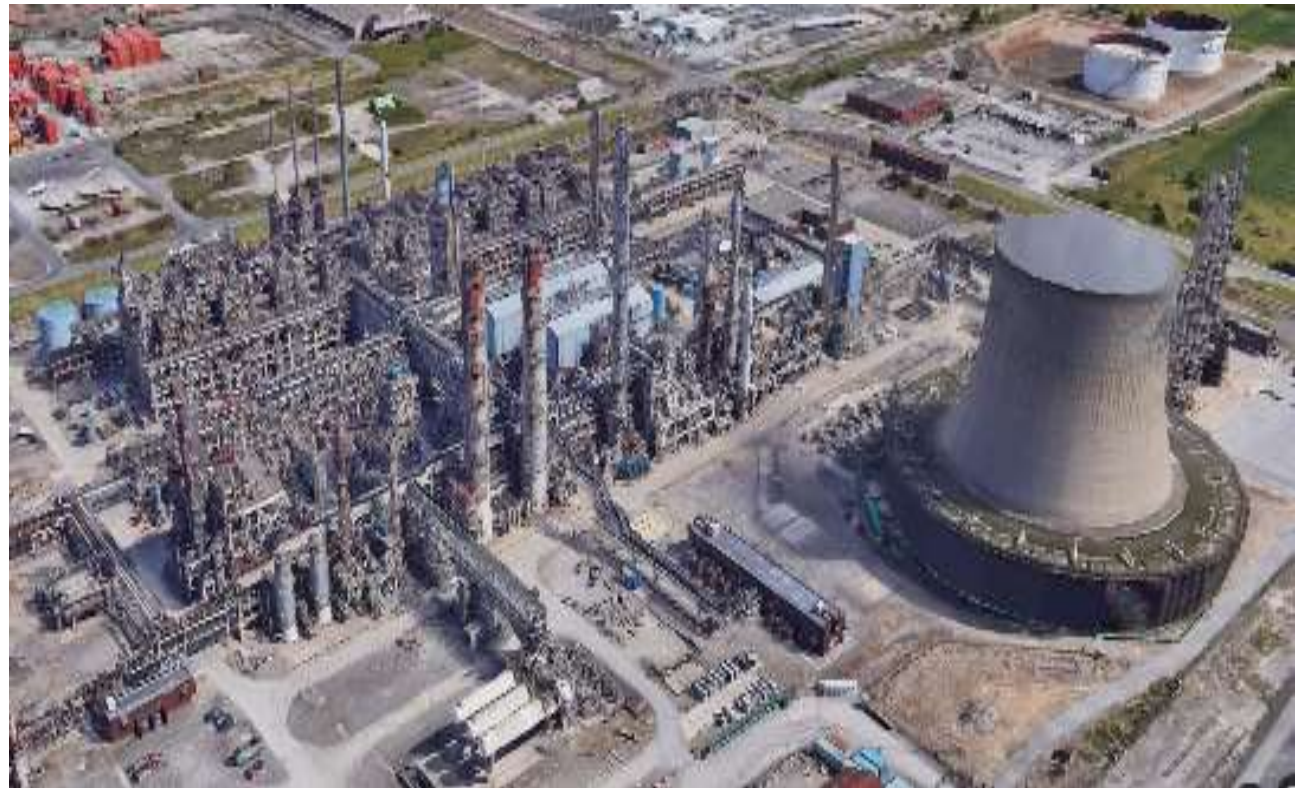
History

- Commissioned 1980
- Ethane feedstock commissioned 2017
- 2020TA postponed
- 2022 construction commenced on reconfiguration project

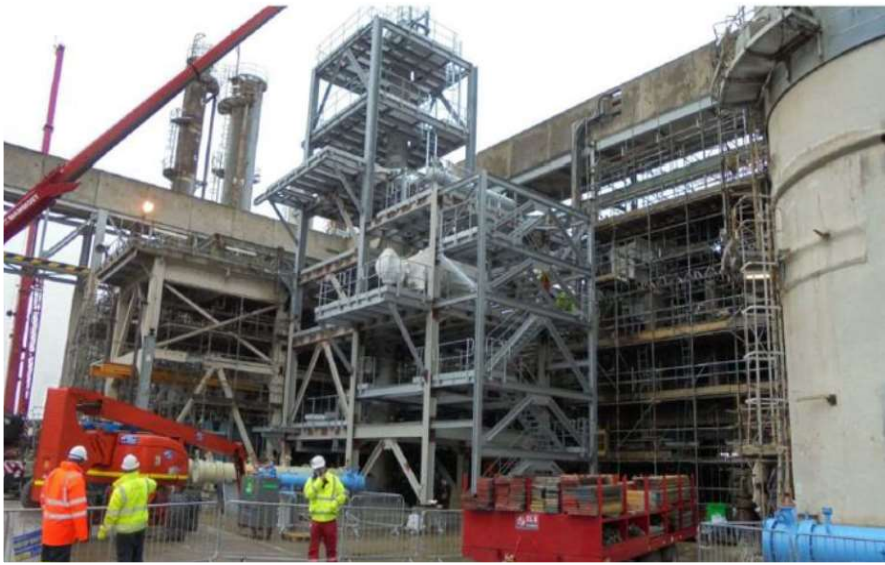
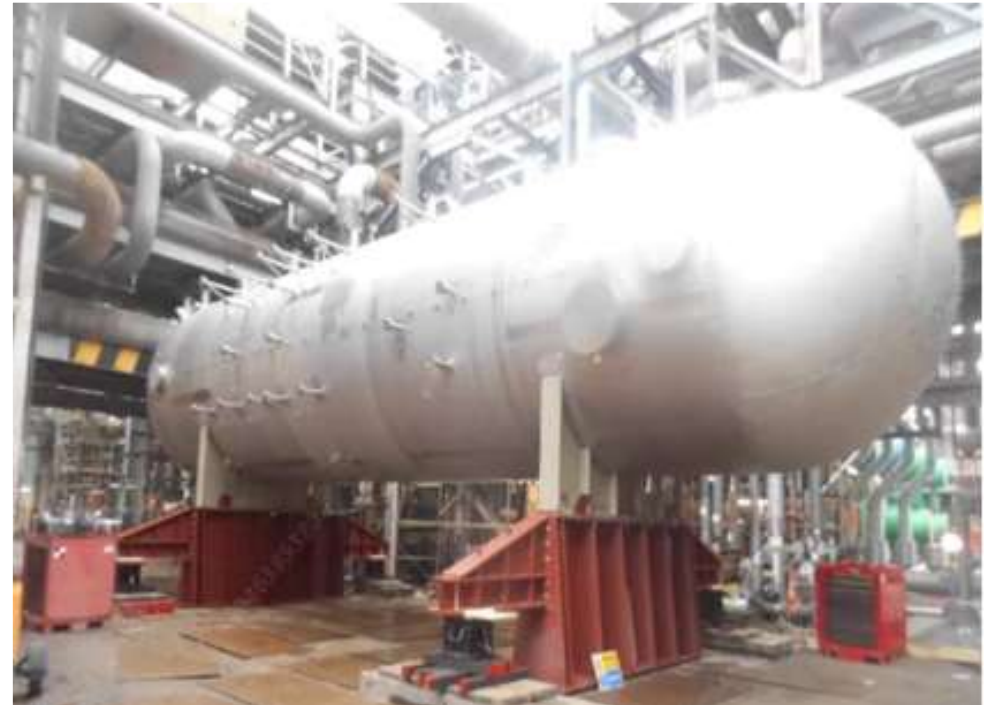
- Multi-million pound investment
- Deep cut and carve
- 260 redundant equipment items
- 11 main equipment items modified

- Significant impact on much of the plant
 - New equipment
 - Repurposed equipment
 - Redundant equipment – tie-outs
 - Physically unchanged but process changes
 - Impact on safety systems
 - Very broad scope – most P&IDs have changes on them
 - Adequacy checks on equipment affected by the changes
-

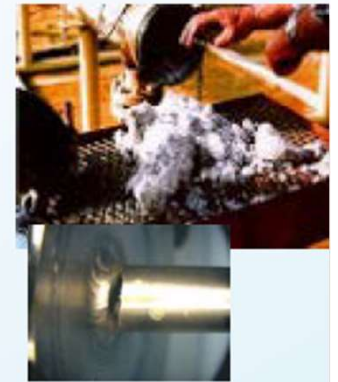
Thermowell Crack

At an off-shore gas plant a leak from a high-pressure pipe occurred at the location of a thermowell, starting a fire in the insulation.

The velocity in a gas cooler heat exchanger was increased, resulting in resonant vibration of the thermowell, causing a fatigue crack.

- Hydrate formation in a cooler, caused a blockage and doubled the gas flow in the parallel cooler.
- High flows around a thermowell caused vibration that resulted in a fatigue failure.
- Small bore tubing (< 1 inch) is sensitive for fatigue cracks. Examples: thermowell in a high flow system, pressure sensor near a compressor, drain near a chattering PSV.
- “Resonance” or “Fatigue” can be useful guideword in a HAZOP or design review
- Fixation and Gussets can help to strengthen design

- Excess flow through a heat exchanger creating high vibration during transient conditions
- Vibration leads to tube failure with low temperature embrittlement and overpressure risks
- HAZOP actions raised to address risk
- As-built HAZOP improved clarity of safeguards to ensure correct operator action
